CC5™ Bulk Rolls

Tiszafüred,
eastern Hungary

KÖTIVIZIG

CC5™ used to remediate a 200m long section of a damaged concrete canal

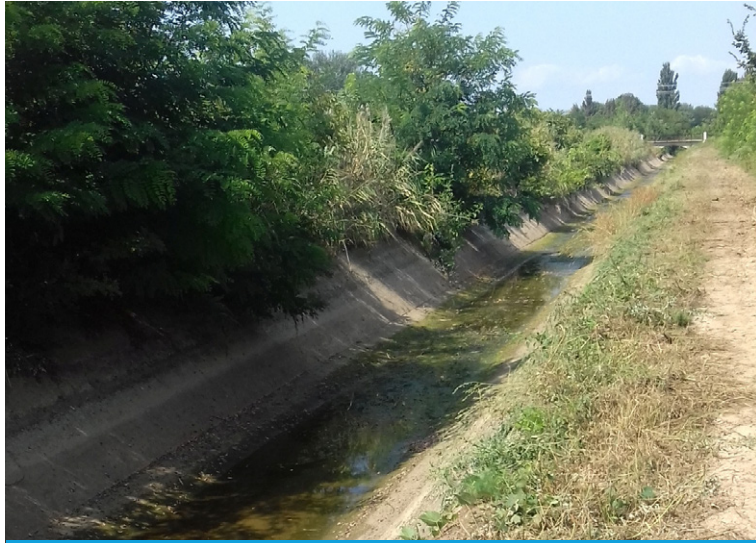
Several stretches of the canal showed severe damage to the concrete in places, which were drastically impacting the hydraulic performance of the canal and causing fairly severe leaks.

Canal prior to works

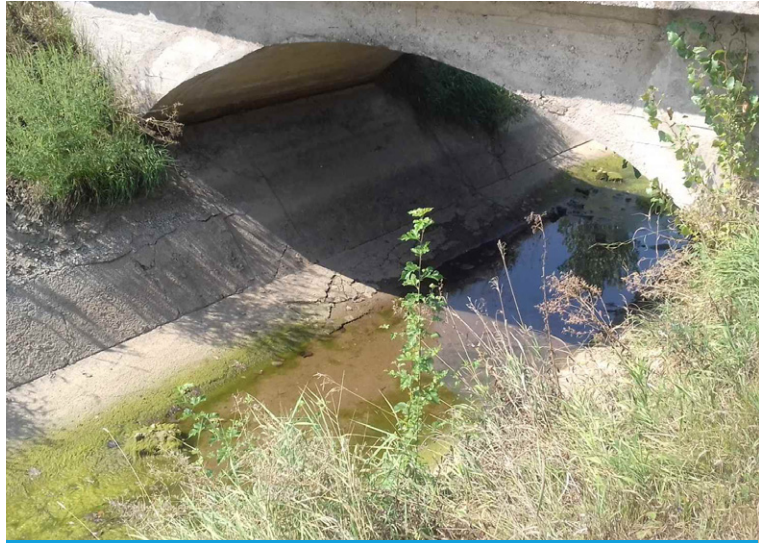
Section of canal below a bridge

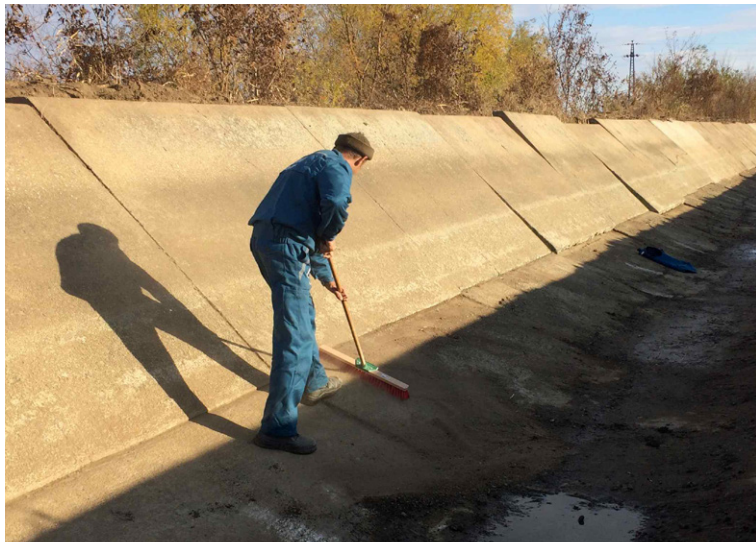
Removing dust and debris with sweeping brush

To prepare the canal for installation, vegetation and any sections of damaged, crumbling concrete were removed. The concrete was then brushed to remove any further debris and dust, and cracks and voids were filled. Anchor trenches were excavated along the shoulders of the canal, which would later provide a termination point for the edges of the CC material. Once the bulk rolls of CC were delivered, they were deployed from a spreader beam and the material cut to size and brought to site in man-portable rolls for easier on-site transportation, management and installation.

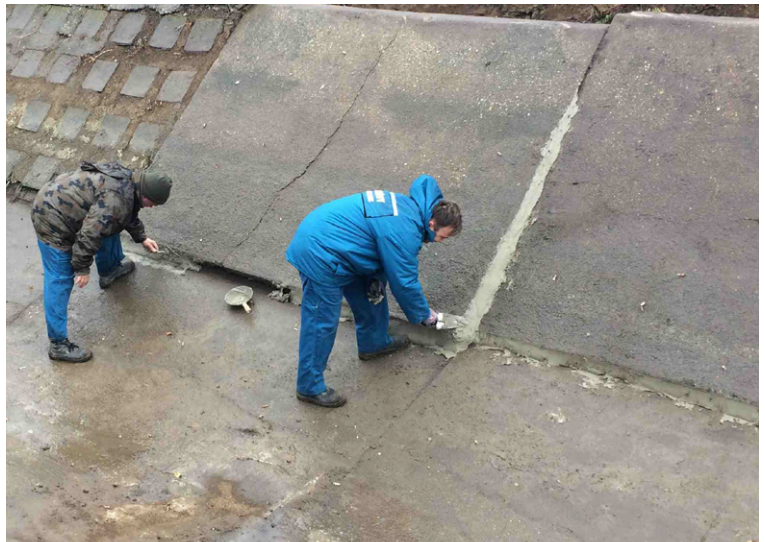
Filling cracks and voids in concrete canal

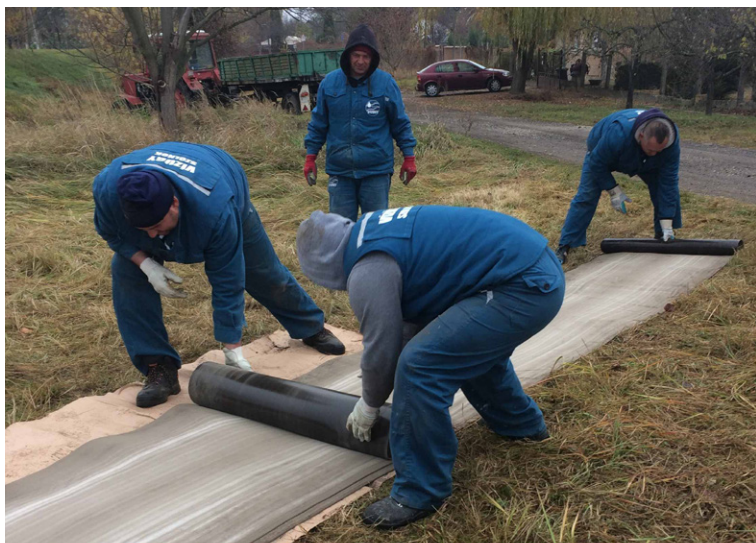
Batching CC for easier delivery to site

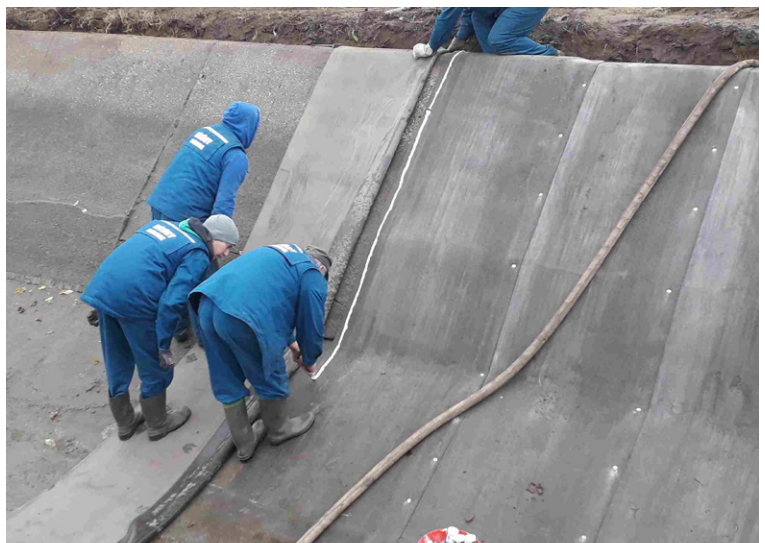
Joining CC overlaps with sealant and expanding bolts

The CC was laid transversely across the channel, from shoulder to shoulder, with material edges secured within the anchor trenches using ground pegs. Subsequent layers were overlapped by 100mm, shingled in the direction of water flow. The material below overlaps was hydrated and then sealed with an adhesive sealant and holes drilled through the CC and into the concrete below. Expansion bolts with washers were then inserted to fix the material to the canal. The leading and trailing edges were terminated onto the concrete canal using steel termination plates and expansion bolts. Following installation, the CC was hydrated using 1000L IBCs, pumps and hoses, and the anchor trenches backfilled.

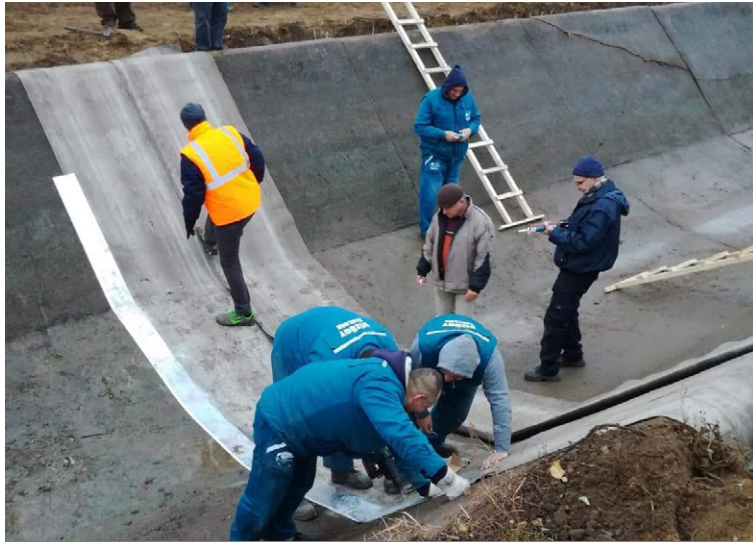
Termination of CC to concrete using steel bars and expanding bolts

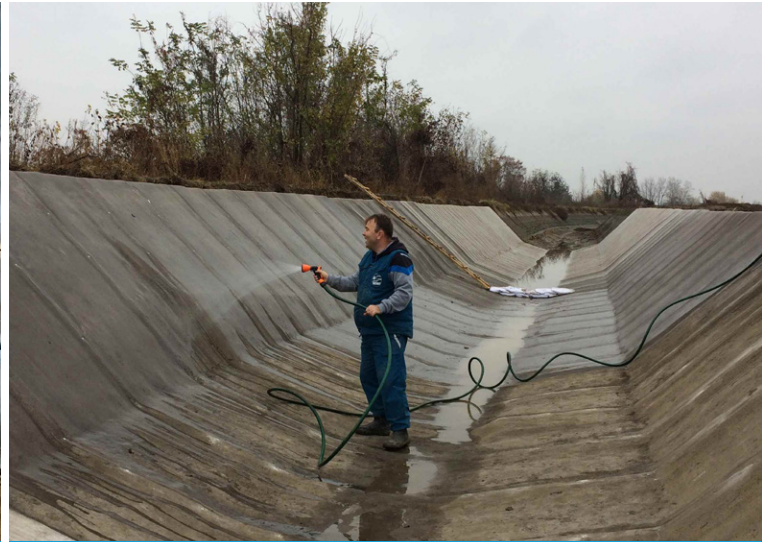
Hydration of CC

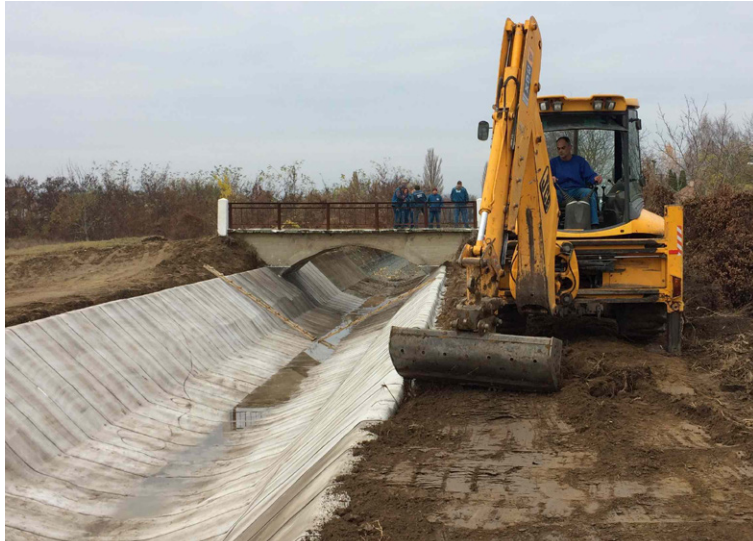
Backfilling anchor trenches

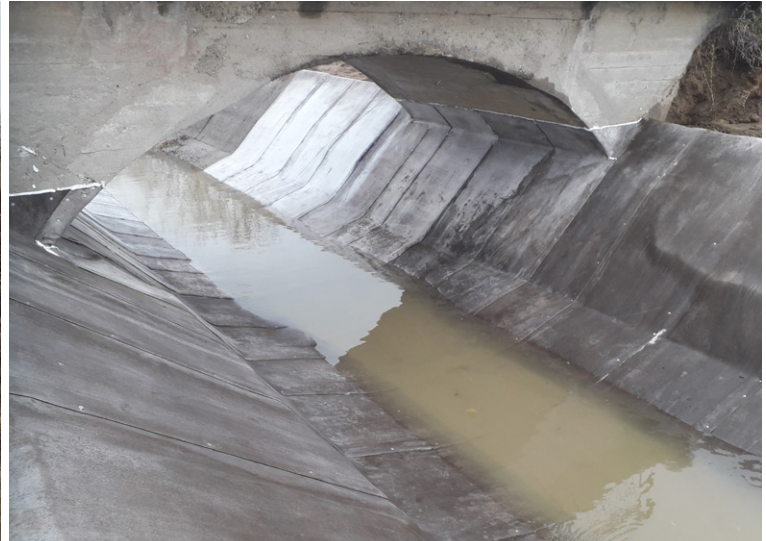
CC termination around bridge

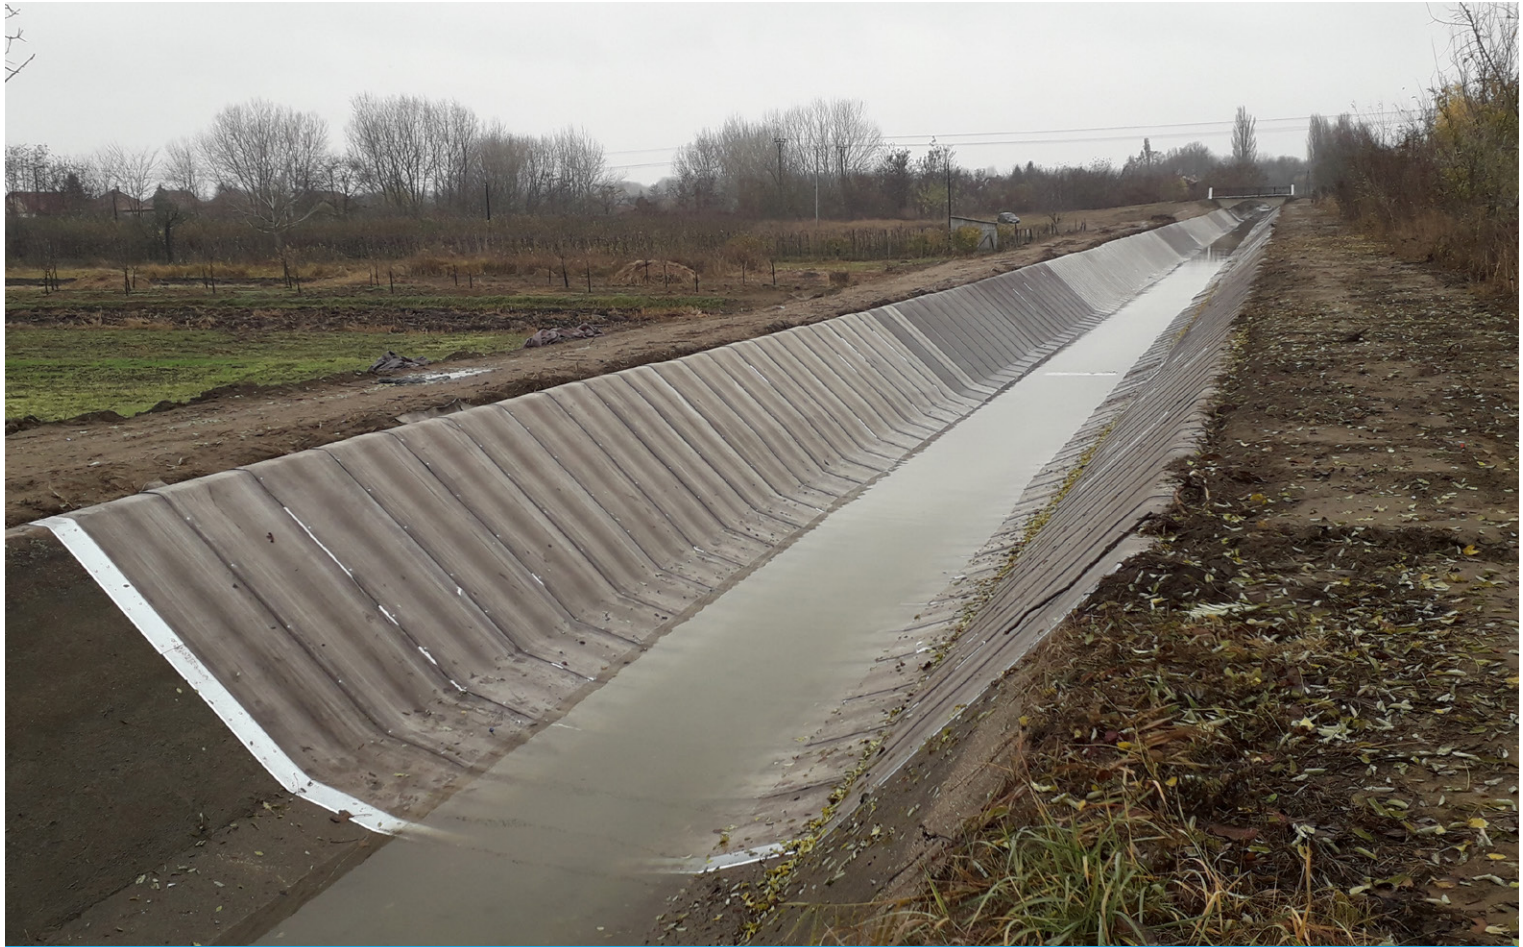
*Completed remediation installation*

A total of 2000m² of CC5™ were installed in less than 6 days by a team of 10. The installation was a success; the CC will now be evaluated for a season. If the client is happy with CC's performance, the material will be considered for the remediation of other leaking sections on this canal as well as sections of their regional irrigation channels network. The installation was carried out by KÖTIVIZIG's Kisköre Section Engineering's employees. This resulted in cost savings for the client, as they did not have to employ specialist contractors.
