Project Info

CC8™ Batched Rolls

İkizdere, Rize, Turkey

CC8™ was used to line and protect the interior of a damaged water diversion pipe at a hydroelectric plant in Turkey.

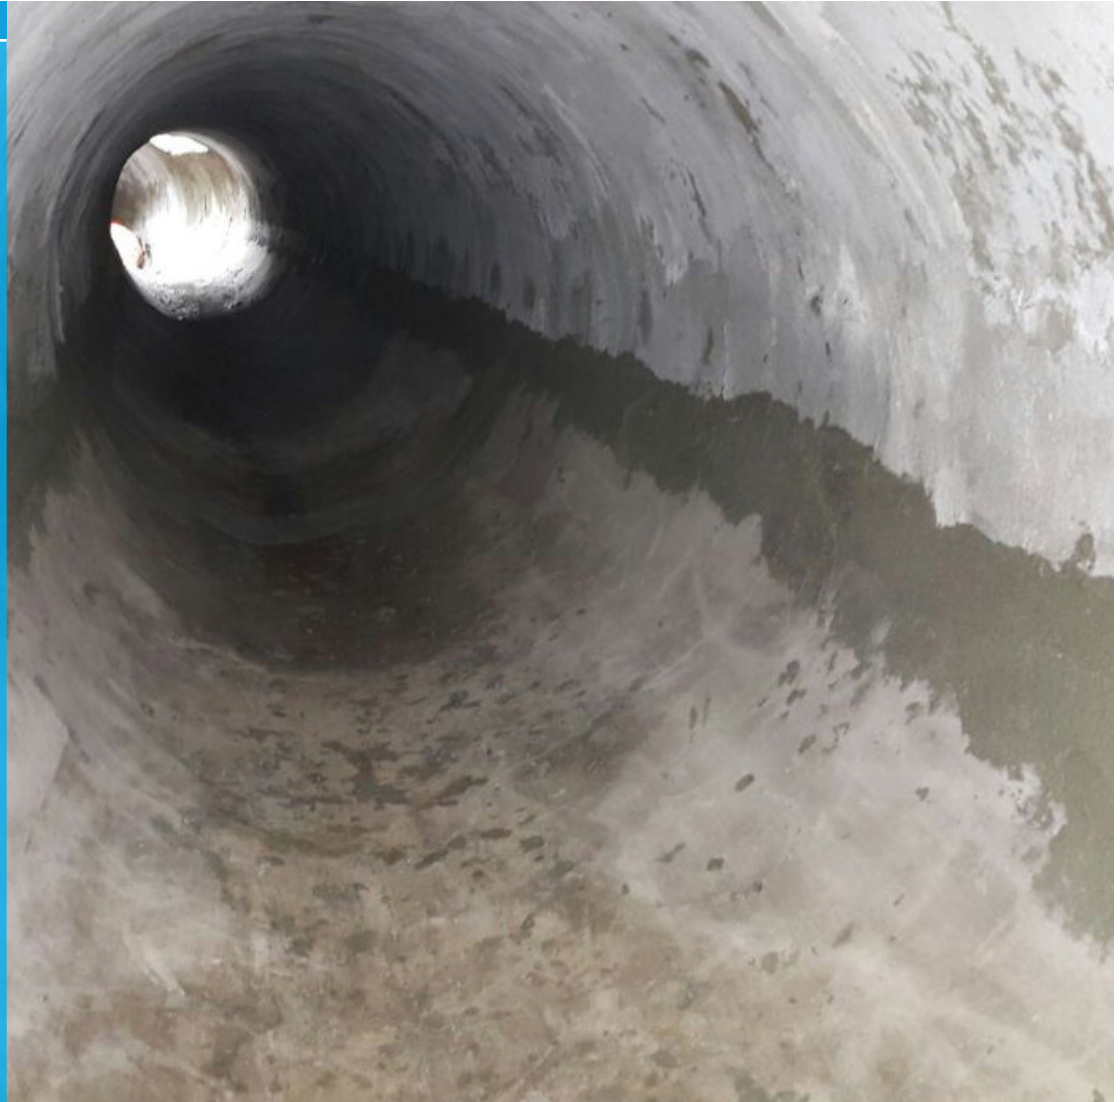
A completed section of the water diversion pipe at the İkizdere hydroelectric plant in Turkey

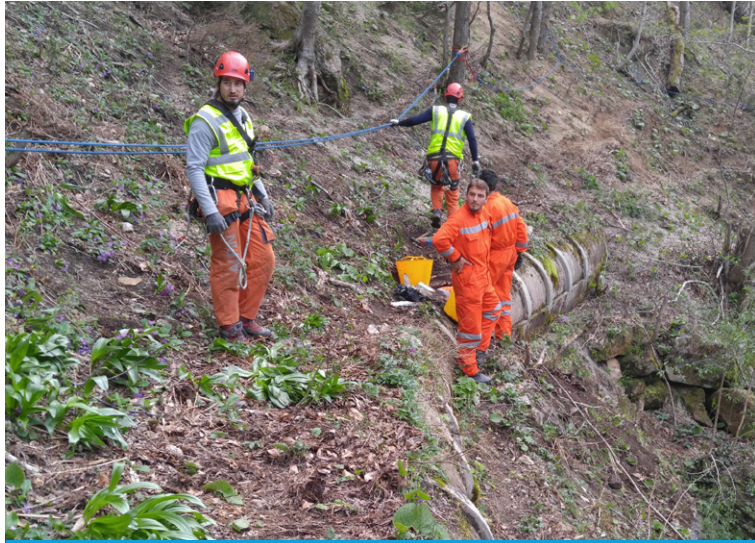
The pipe functions as a water diversion pipeline from the İkizdere hydroelectric plant, owned by Zorlu Energy Group, which operates in Turkey, the Middle East and Asia. The pipeline, originally constructed using concrete, had badly deteriorated and were in need of remediation.

The outside of the pipeline was overgrown with vegetation

To prepare the pipeline for the installation of the CC material, the surface of the concrete was cleaned and any vegetation that had grown through or on the concrete was removed. Some cracks had formed, and there were large holes in places, leading to waterloss; these were repaired using high performance mortar.

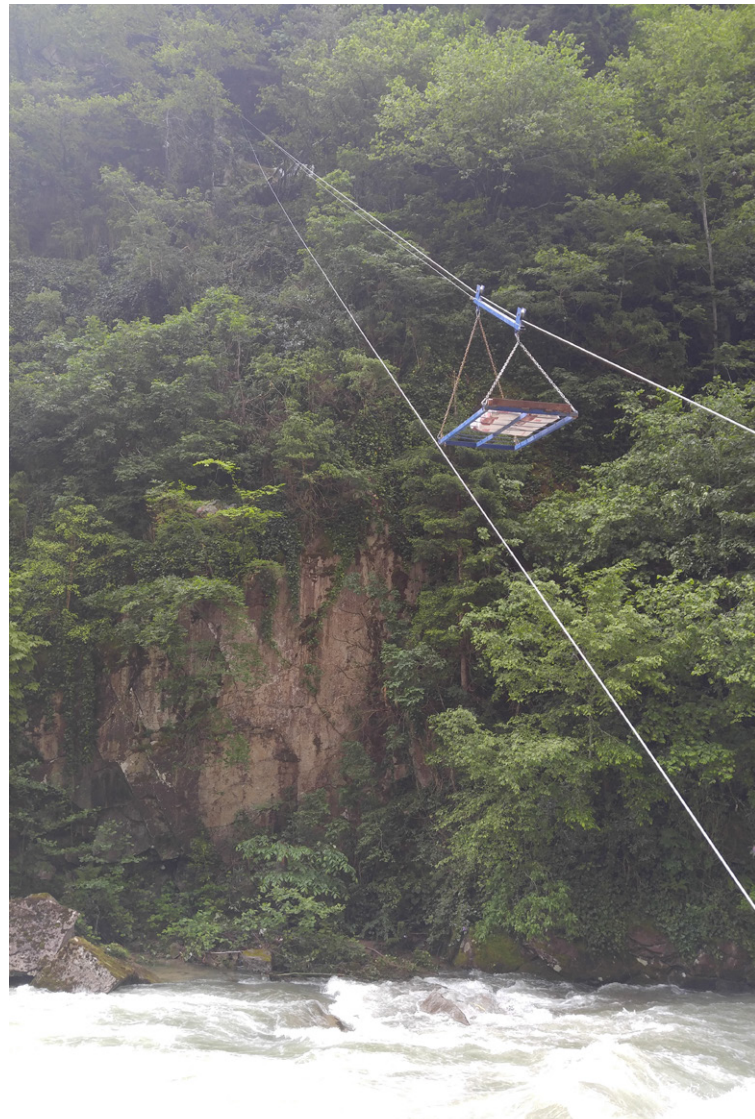
The batched rolls had to be winched to the site on a makeshift cable car

The CC batched rolls were transported to the site via the cable car system, and the material unrolled and passed into the pipelines in manageable sections. The installation team had limited space and clearance in which to work within the pipeline, with its circumference measuring just 900mm, and its total length measures 1,970m.

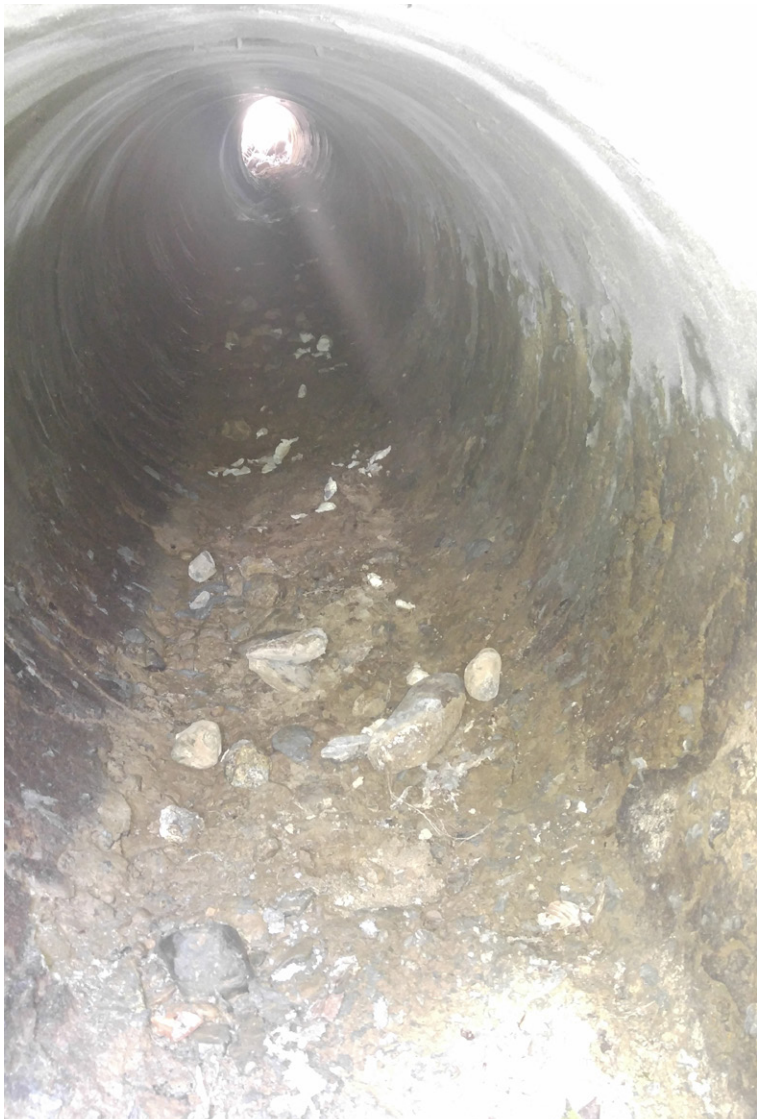
The inside of the pipe had to be cleared of rocks and debris prior to works

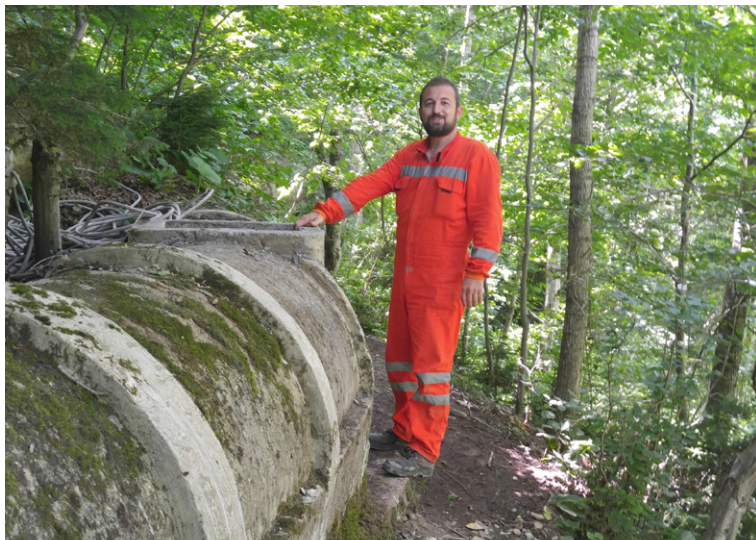
The only access was through access holes at the top of the pipe

The installation team accessed the pipeline through access holes found at intervals along the top of the pipe. The material was also fed in this way and the team unrolled and laid the CC material longitudinally along the pipe. The CC was fixed to the pipe using screws at 200mm intervals, and along the overlaps of material lengths. At the edges, where the material meets the concrete pipeline wall, CT1 sealant and grout mortar was used to create a water-tight seal and prevent water ingress. This was completed along the entire length of the pipeline. Once the installation was complete, a hose was fed into the pipeline access points and the CC material was hydrated.

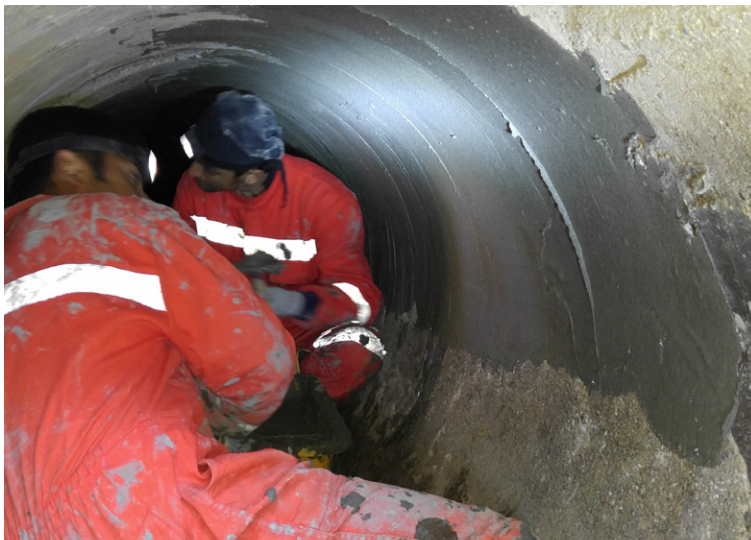
Repair works were carried out with mortar prior to installation

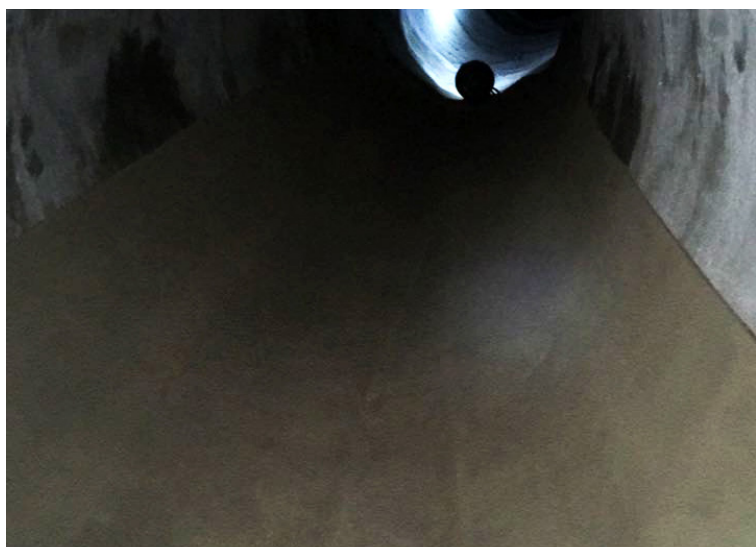
The CC was laid longitudinally and fixed with screws

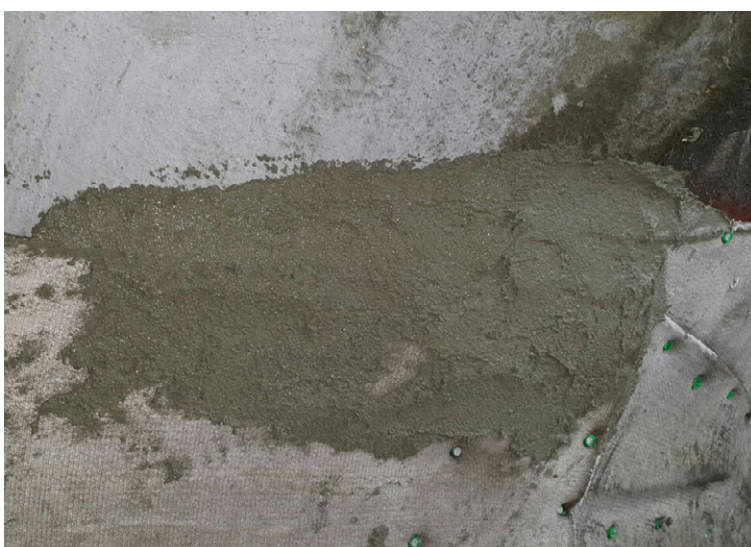
Mortar and sealant was used to prevent ingress at the edges of the CC
