CC8™ Bulk Rolls

Loch Goin Reservoir,
Eaglesham, Scotland, UK

CC8™ was used to remediate a dilapidated concrete reservoir spillway channel at the Loch Goin Reservoir.

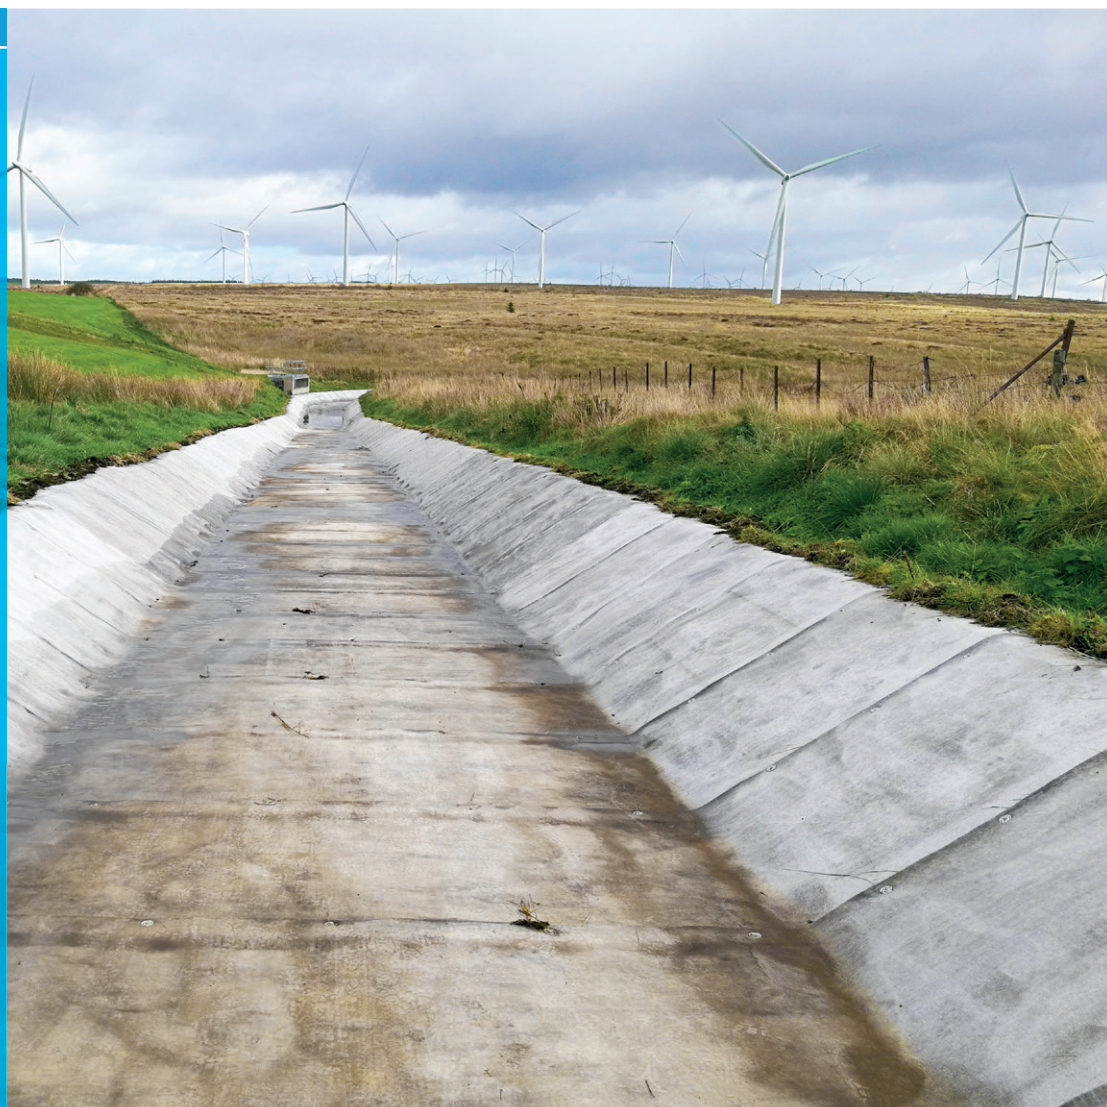
Completed installation

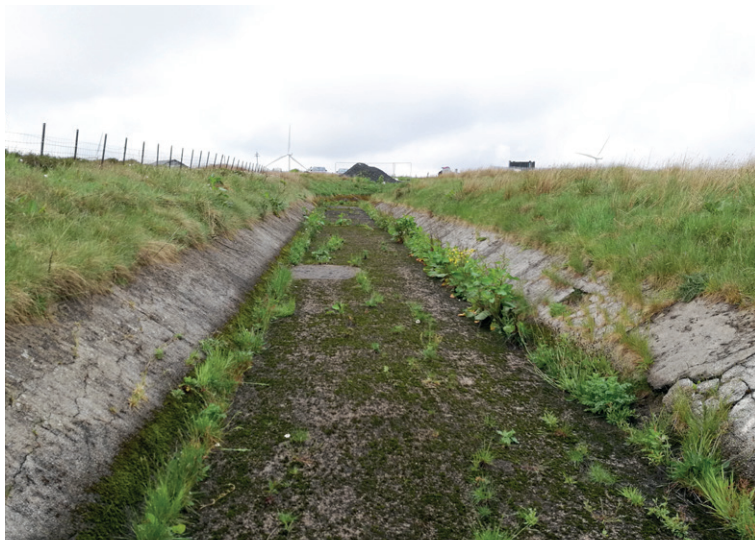
The spillway structure principally comprises of an unreinforced concrete channel cast insitu. The condition of the spillway was poor in significant areas and some localised repairs had been carried out in the past. The deterioration to the structure is consistent with erosion and frost damage. Rather than using conventional concreting techniques, CC was chosen on a cost and time basis as well as a trial for future this new technique.

Original concrete spillway channel

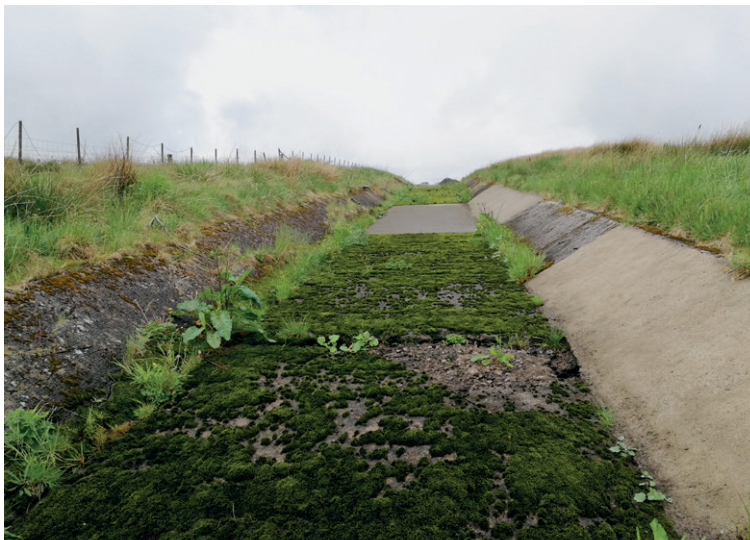
Algae & vegetation growth with existing concrete slabs damaged

Prior to the installation of CC, the flume was pressure washed to remove vegetation and minor repairs were carried out using a flexible cementitious mortar to fill any voids in the concrete, ensuring intimate contact between the CC and the concrete substrate. Access to the site was restricted and the existing bridge over the spillway was deemed unsuitable for construction traffic.

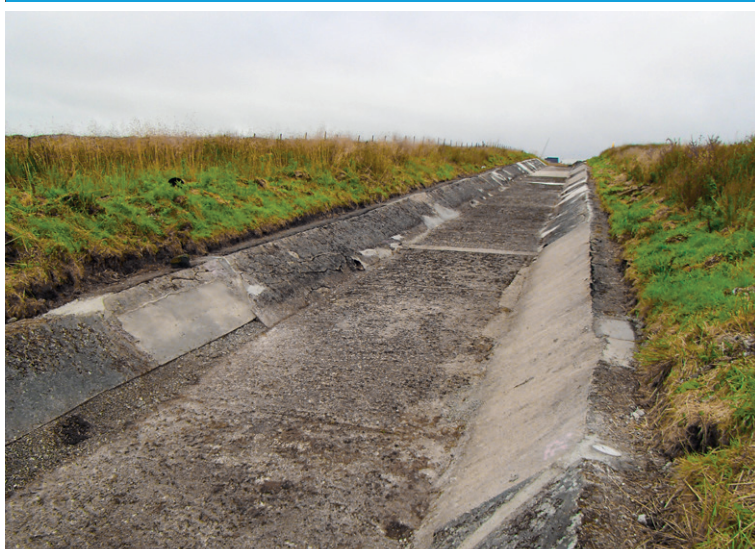
Vegetation removed & voids filled with flexible cementitious mortar

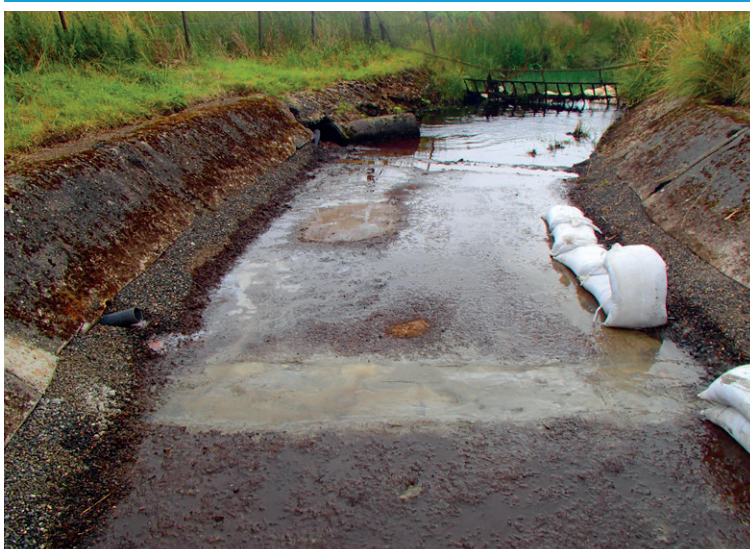
80mm perforated pipe installed to divert underlying water back into channel

Each length of CC was laid transversely, with adjacent layers overlapped by 100mm in the direction of water flow and fixed in place using 37mm Hilti nails with 25mm diameter washers shot fired at centres not exceeding 600mm. In order to prevent any build-up of hydrostatic pressure between the original concrete slabs and the CC, the engineering consultant specified that the side slope and channel invert transition points should be broken out and an 80mm perforated pipe installed to divert underlying water back into the spillway channel at regular pipe discharge points.

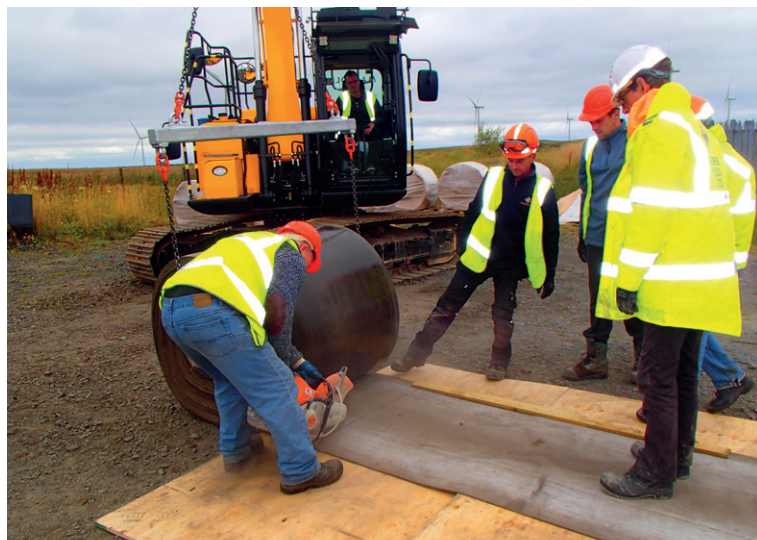
CC8 roll dispensed with spreader beam & cut to length off site

CC8™ (8mm thick) material was specified as there would be significant water velocities in the spillway, particularly on the steeper channel sections. The contractor decided bulk rolls of CC8 would be the most appropriate choice for the installation. However, due to the restricted access, the contractor used an angle grinder to cut the material to profile width. The smaller, batched rolls were then mounted onto a trolley and hand wheeled into the spillway.

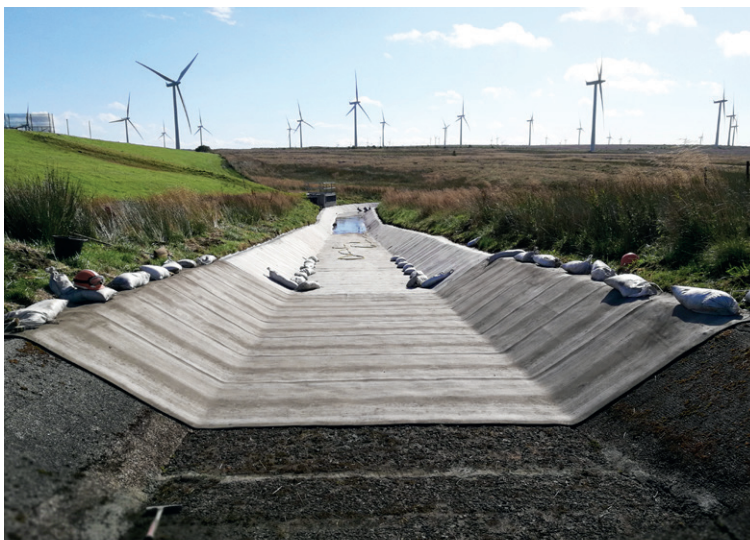
CC batched lengths laid transversely across the channel

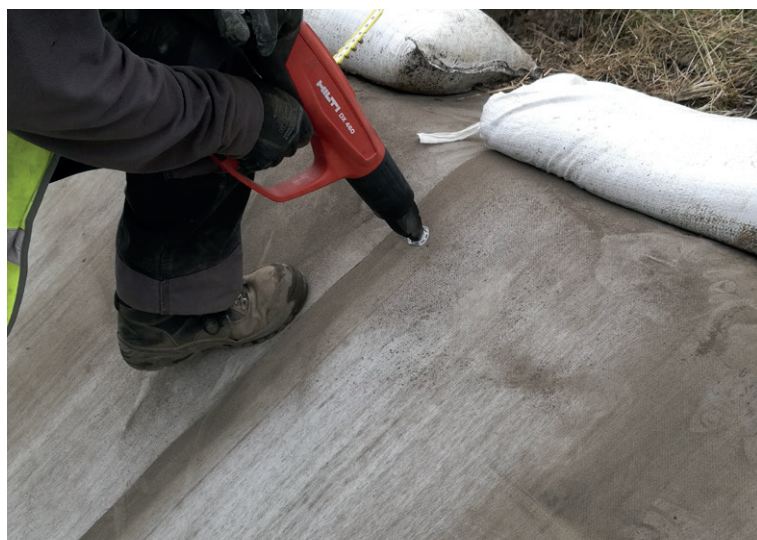
Hilti nails shot fired at 600mm centres

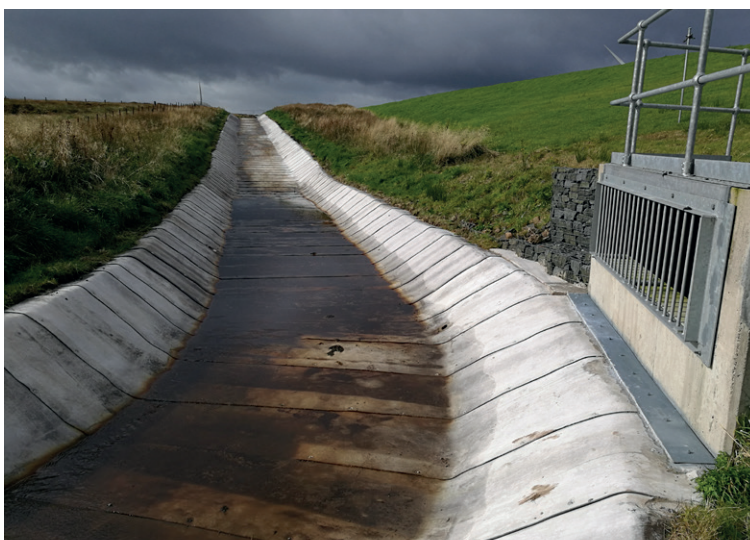
CC lined spillway channel with steel batten bar termination at siphon outlet

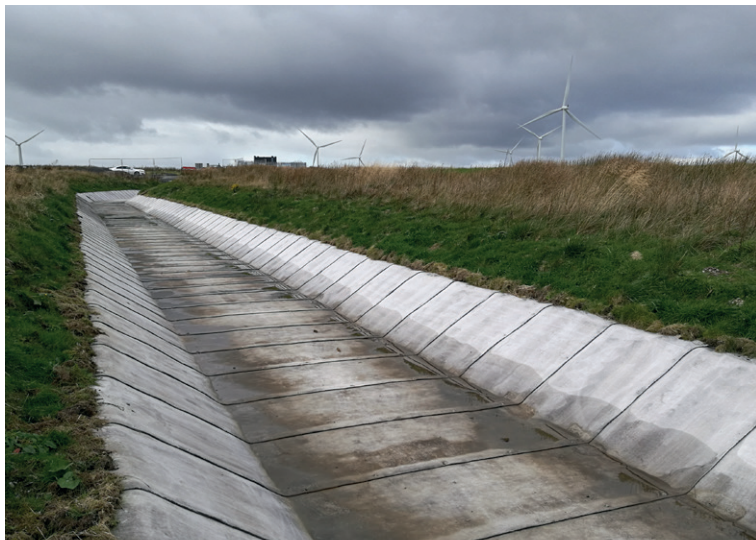
Anchor trenches backfilled on either side of channel

In addition to this, the CC joints were left unsealed and free draining to create natural weep paths to allow water ingress into the spillway. Once installation was completed, the edges of the CC on either side of the spillway were then completely buried within anchor trenches in order to prevent surface water undermining the material.

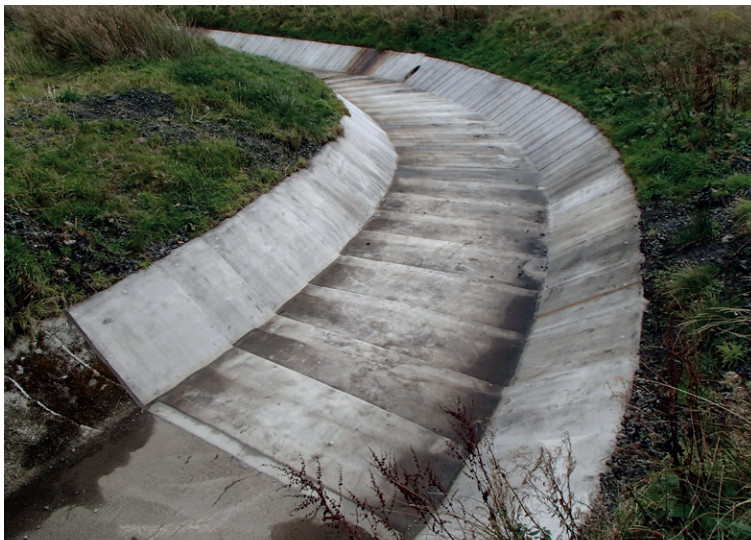
CC terminated into anchor trench and backfilled with concrete

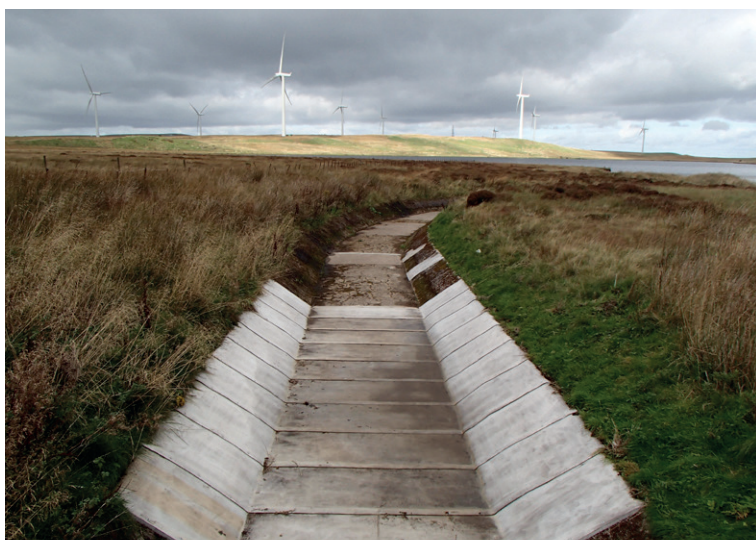
Localised damaged areas of the channel remediated with CC

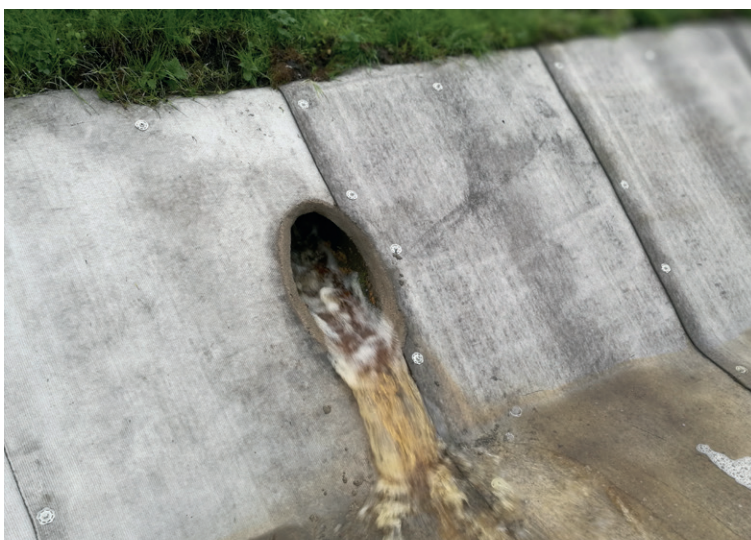
CC easily cut & grouted around pipe discharge points

The CC was able to easily accommodate significant variations in slope and profile, along with interior and exterior pipe protrusions and perforated pipe discharge points. CC also has a very low wash out rate and low alkali reserve meaning that it was not required to treat the run off from installation.

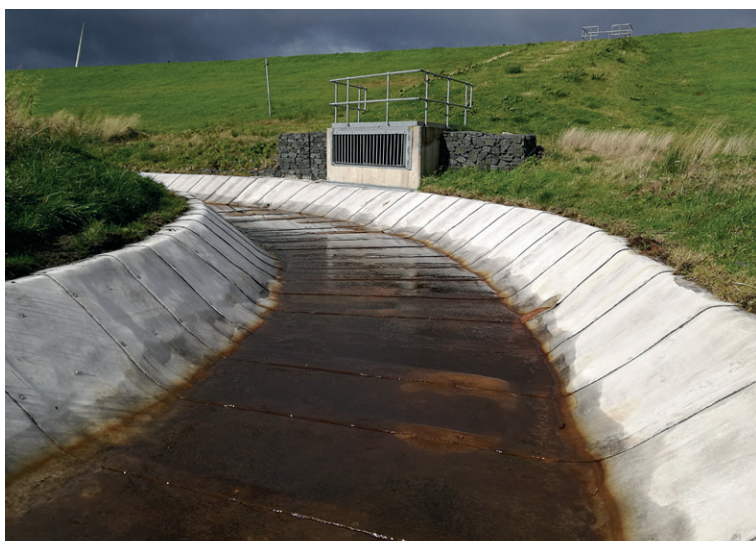
CC accomodating corners

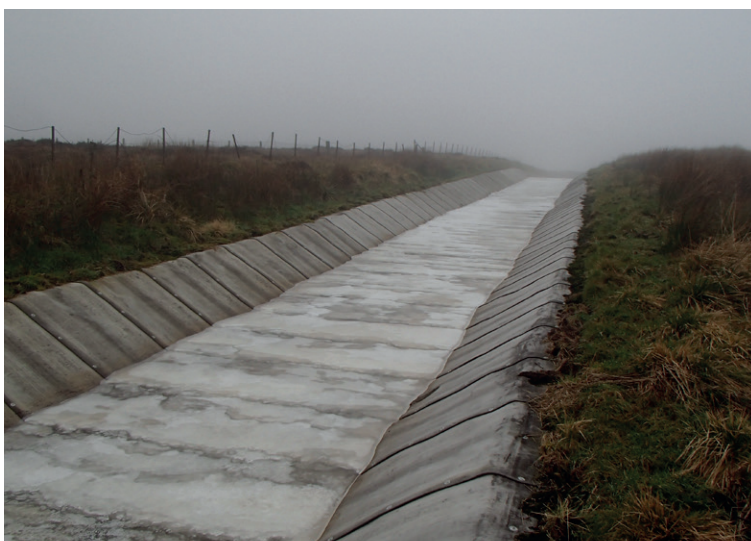
Frozen sections of channel

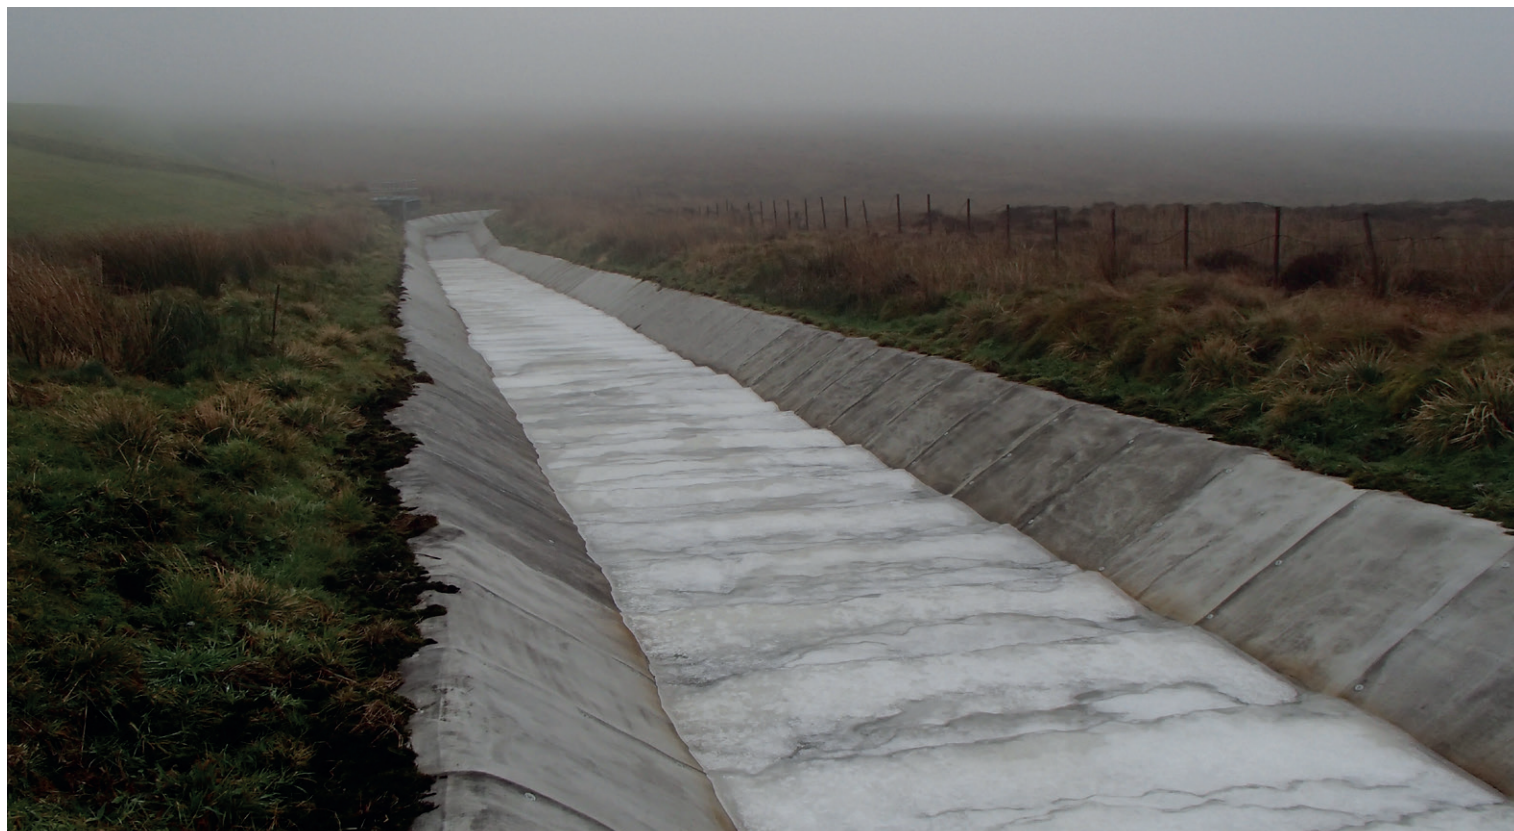
CC lined channel during winter period showing no signs of degradation

The client was impressed with the speed and ease of installation and are monitoring how the material handles future freeze-thaw conditions, abrasion resistance and environmental weathering. Scottish Water is satisfied that the CC material will provide a long-term solution that greatly increases the operational life of the structure and mitigates the need for costly periodic maintenance repairs in the near future.
