## Project Info

CC5™ Bulk Rolls

Marula Mine, South Africa

CC was used to remediate an existing dam embankment at the Marula Mine in South Africa.

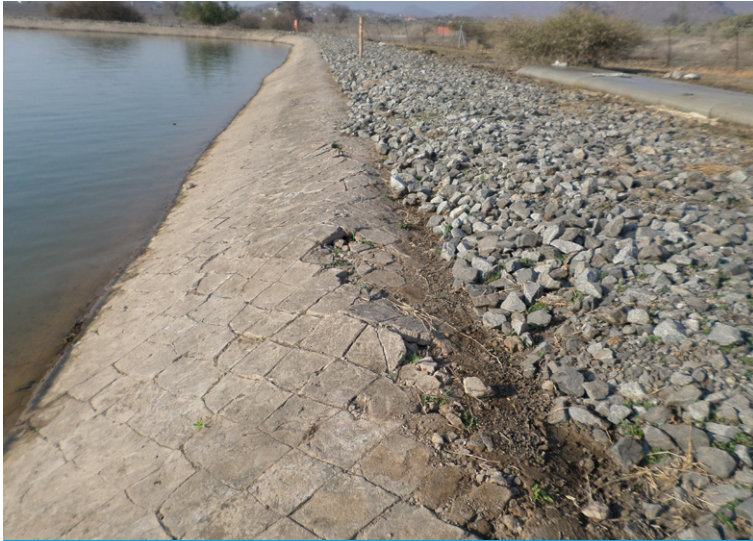
The existing dam was previously constructed using a concrete filled geocell, which had become damaged over time. As the individual geocells had been filled with concrete independently, there was no continuity in the lining. This had led to significant cracking between the geocells themselves as the liner was unable to sustain differential settlement of the dam embankments.

*Dam embankment prior to works*

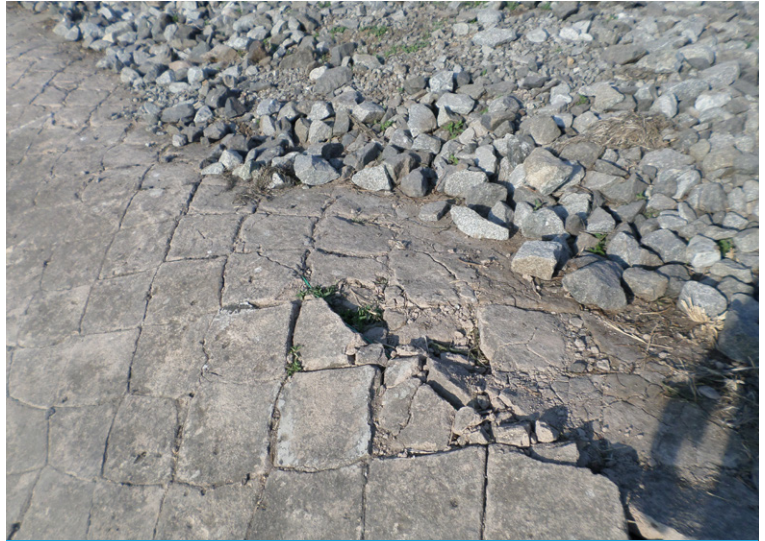
The cracking at the crest of the embankment had resulted in a significant gap between the geocells. These cracks provide a leak path, resulting in further settlement of the embankment, but also a trip hazard for those requiring access for inspection and maintenance of the dam. It was determined that a quick and cost-effective remedial solution was required for refurbishment of the lined dam perimeter and crest.

*Significant cracking was found at a number of points around the dam*

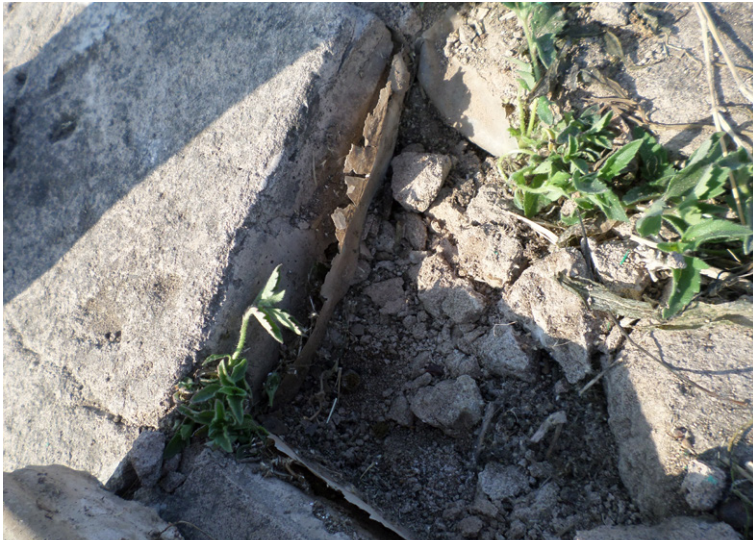
*Geocell section showing significant damage where concrete has broken up*

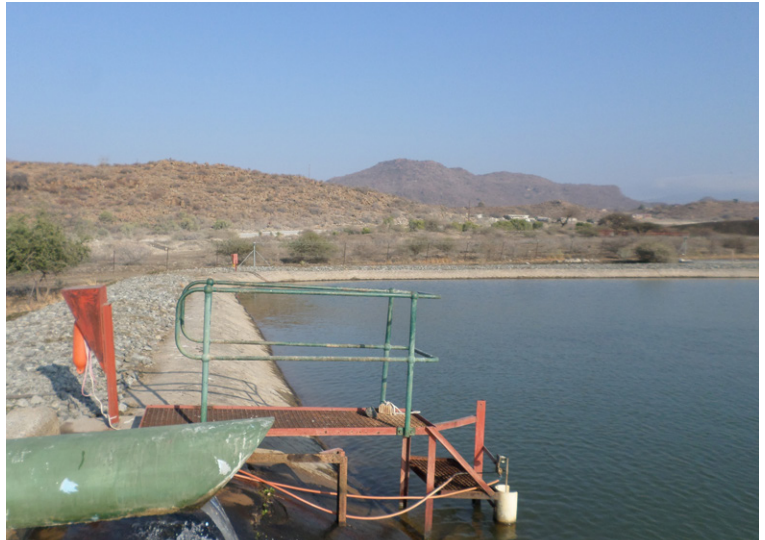
*Dam prior to works*

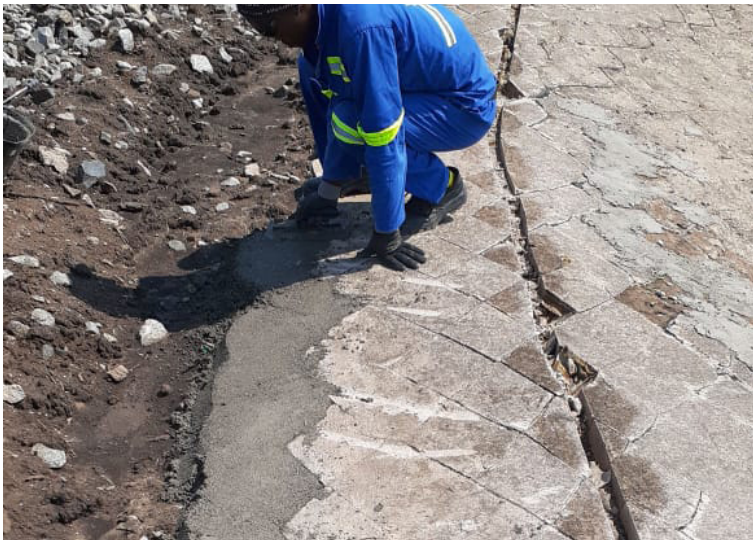
*Large cracks were filled with cement-stabilised gravel*

Prior to installation, all sharp and raised edges of the underlying concrete filled geocell had to be ground down with an angle grinder to prevent puncture of CC's PVC rear surface. Large cracks were filled with cement-stabilised gravel and compacted flush with the existing surface. At the crest of the existing lining, a slot approximately 50mm wide was cut and the internal material removed. This gap was then filled with more compressible cement-stabilised gravel to allow movement of the substrate at either side of the crest.

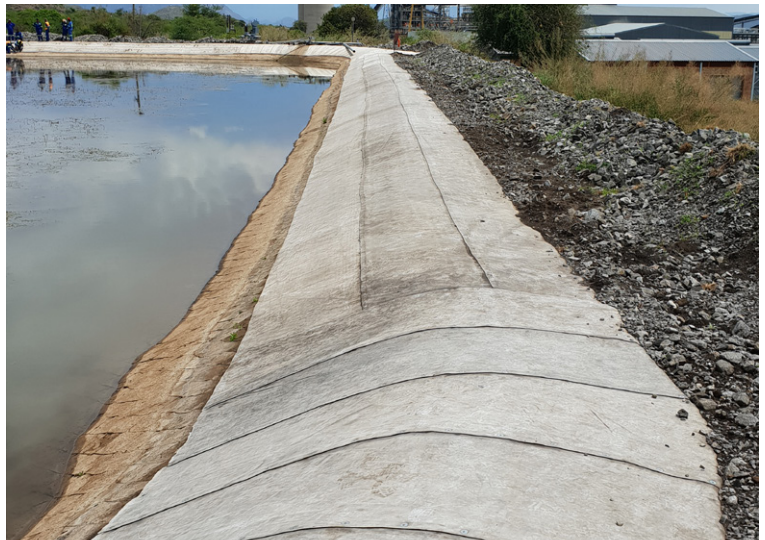
*Transverse and vertical layups used to accommodate the shape of the dam*

Once ground preparation had been completed, lengths of CC5™ were laid in a longitudinal layup on the straights of the dam sides and transversely on the corners of the dam for ease of installation.

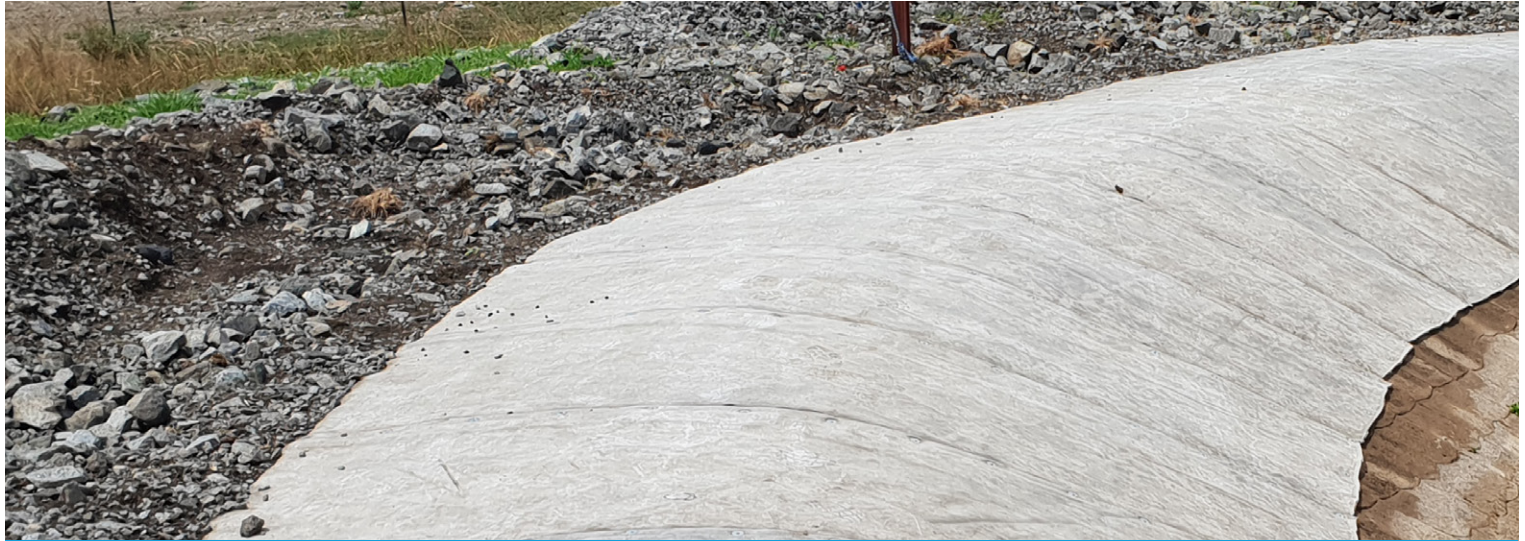
*Upper edge of CC lengths captured in anchor trench*

On the internal face termination, CC5™ was positioned below the stainless steel plate to allow for slip caused by thermal expansion and contraction. On the external face, the CC was terminated in a shallow anchor trench and secured to the substrate using ground pegs positioned at 2m intervals and then backfilled with non-erodible gravel.

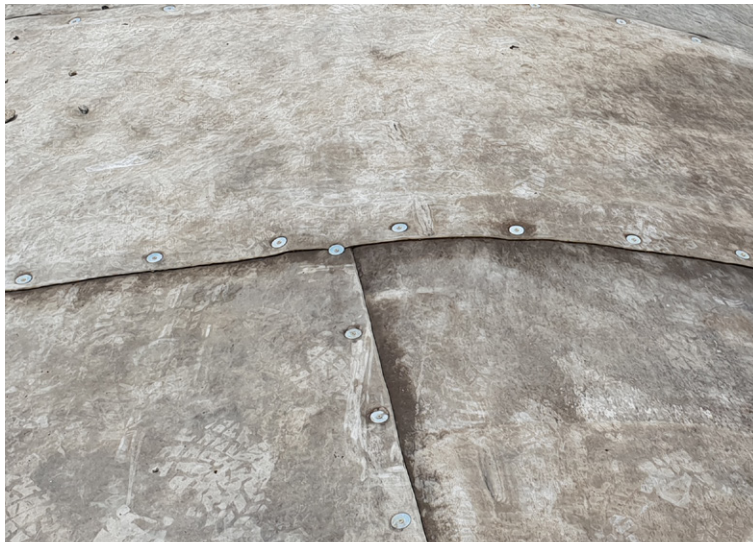
*Stainless steel wedge anchors used to fix CC to concrete below*

Subsequent layers were overlapped by a minimum of 100mm and these overlaps were thermally bonded using a Leister Triac hot air welder. The overlaps were then fixed to the underlying concrete with stainless steel wedge anchors at 200mm centres, positioned 50mm from the overlap edge.

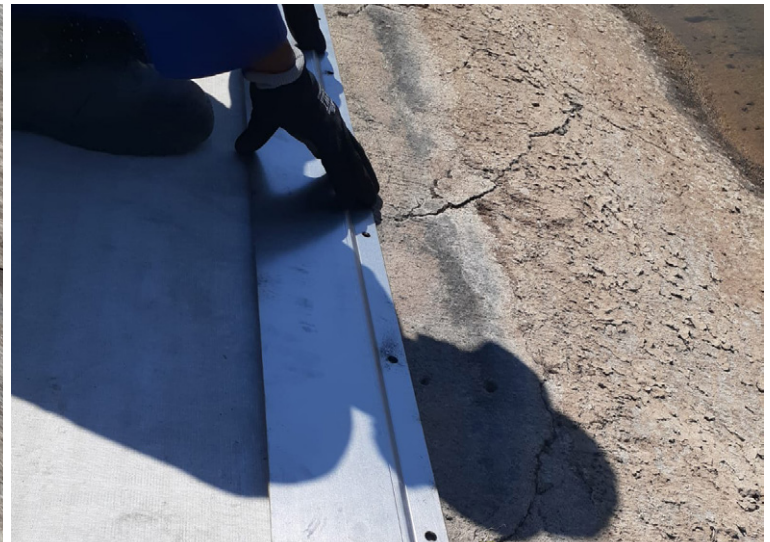
*Stainless steel plate allowing expansion and contraction beneath*

The environmental conditions on this site are typically hot to very hot. As a result, the potential for thermal expansion and contraction of the CC5™ relative to the underlying concrete also had to be taken into consideration to ensure that the CC did pull out from the edge fixings. For this reason, CC was terminated under a 150mm wide stainless steel cover plate at the toe, allowing for a maximum slip of 50mm of the CC5™ beneath.
