CC5™ Bulk Rolls

Olivehurst, California, USA

Caltrans District Three Maintenance Dept.

CC used to remediate an existing concrete channel required to control road surface water runoff

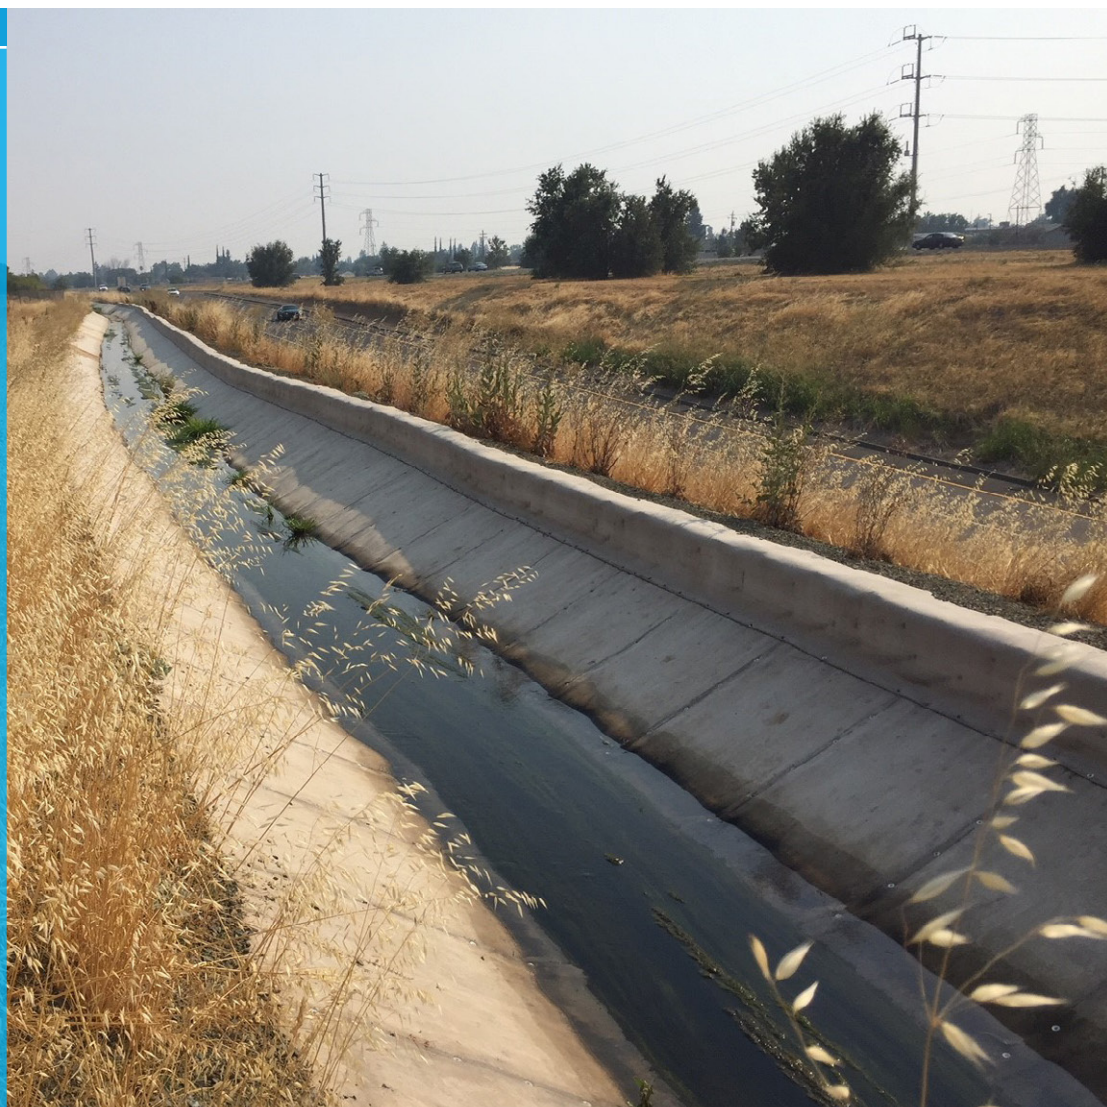
Completed channel revisited

The transportation engineer for Caltrans District Three revisited the site two months after the completion of the project and was pleased with how the CC looks and was satisfied by its performance. The department is also looking at using CC for other applications, including culvert lining, swale and channel protection, weed suppression below guardrails, and slope protection.

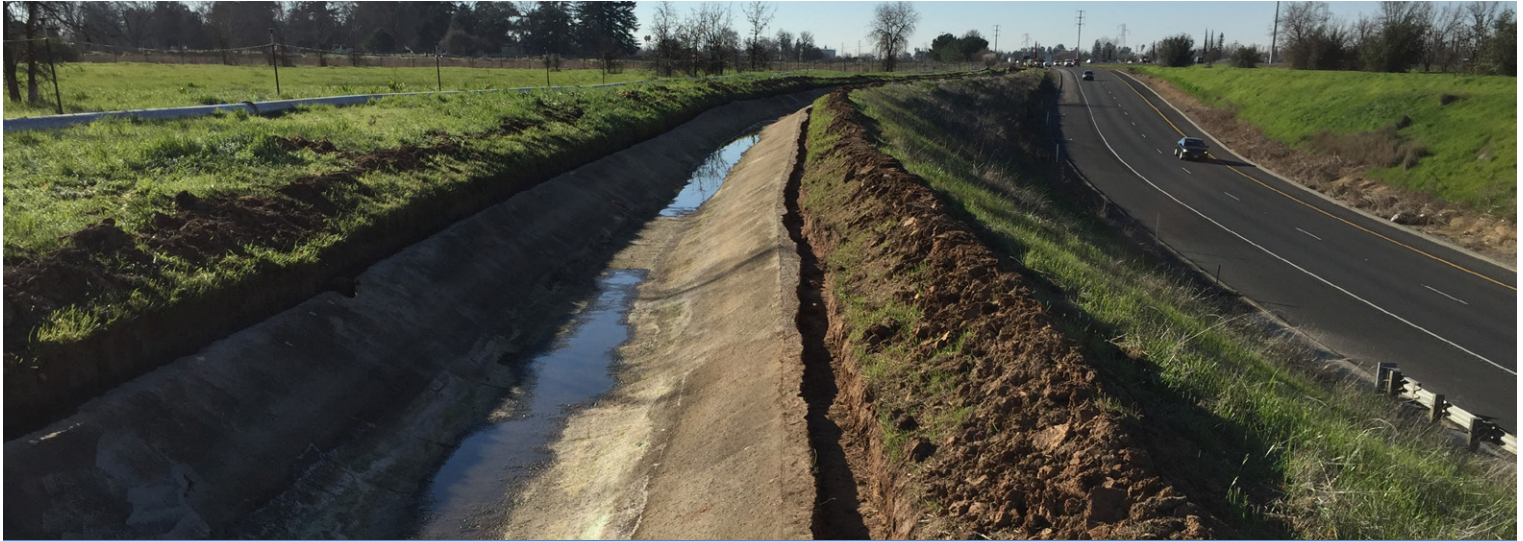
Channel prior to installation

The existing channel was de-vegetated, anchor trenches created at the shoulders of the channel and major cracks and damaged sections were filled with a quick-set concrete fill material to avoid voids below the CC material.

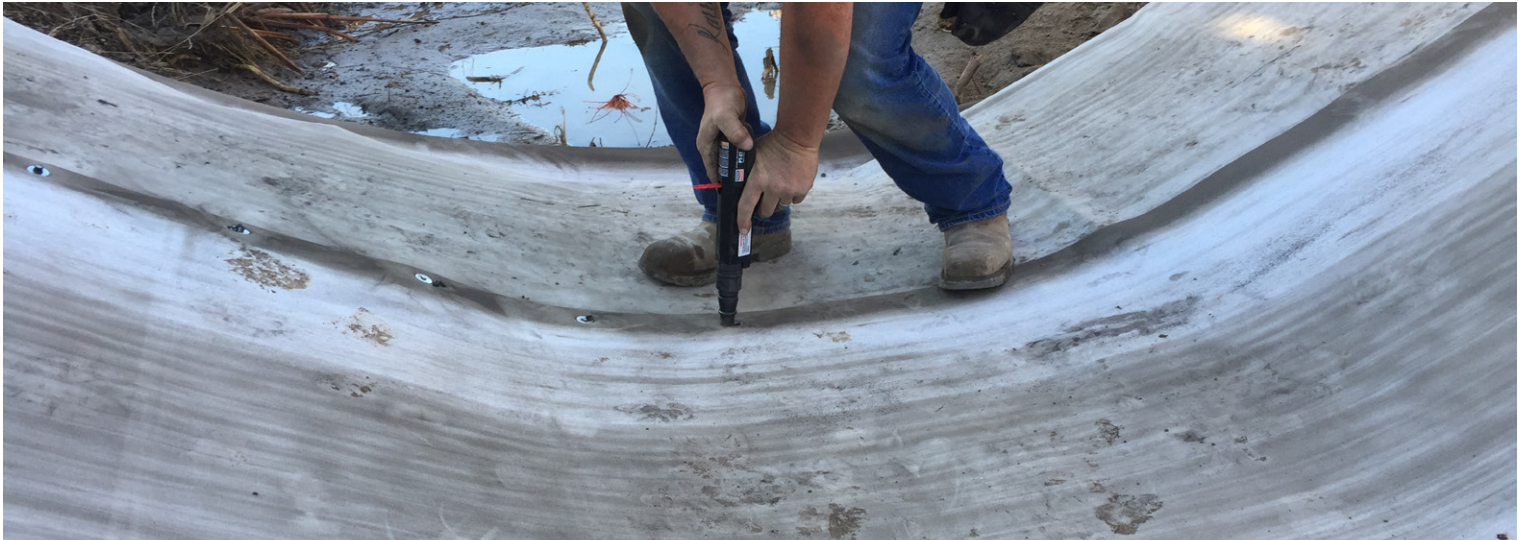
Joining of overlaps

The CC was then deployed from crest to crest, with overlaps facing the direction of waterflow to prevent ingress. The edges of the material were captured within the anchor trenches while overlaps were sealed using caulk and fixed to the existing concrete swale using masonry nails.

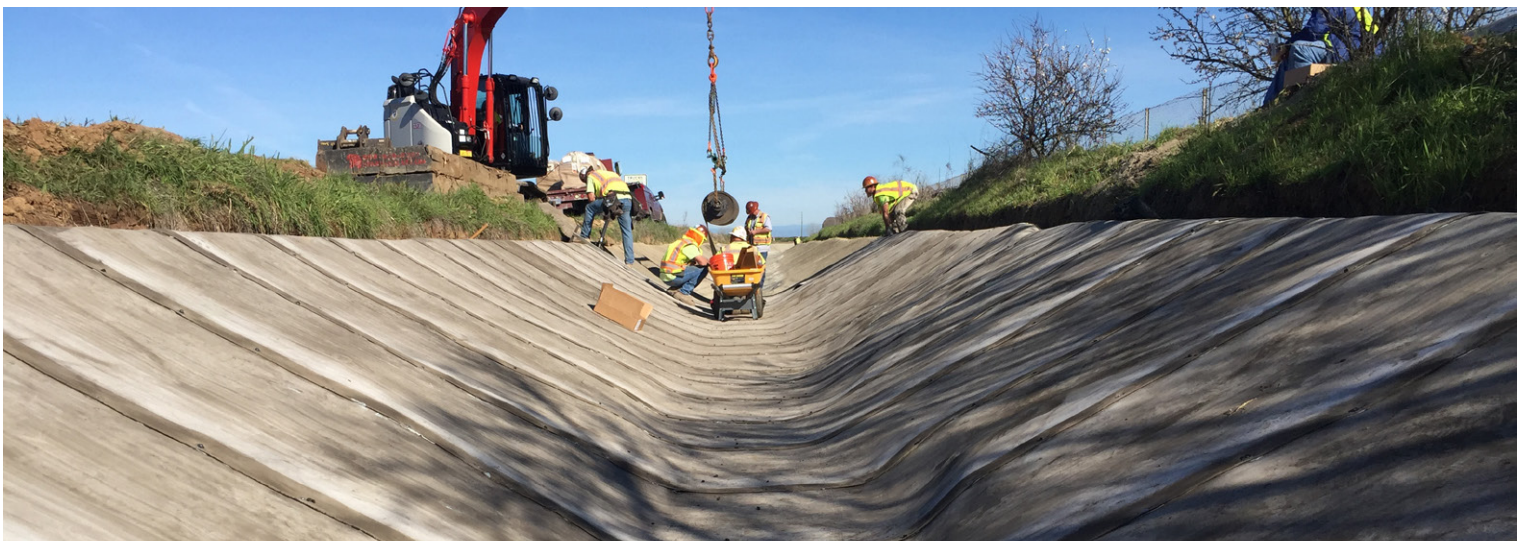
Deployment of CC bulk roll

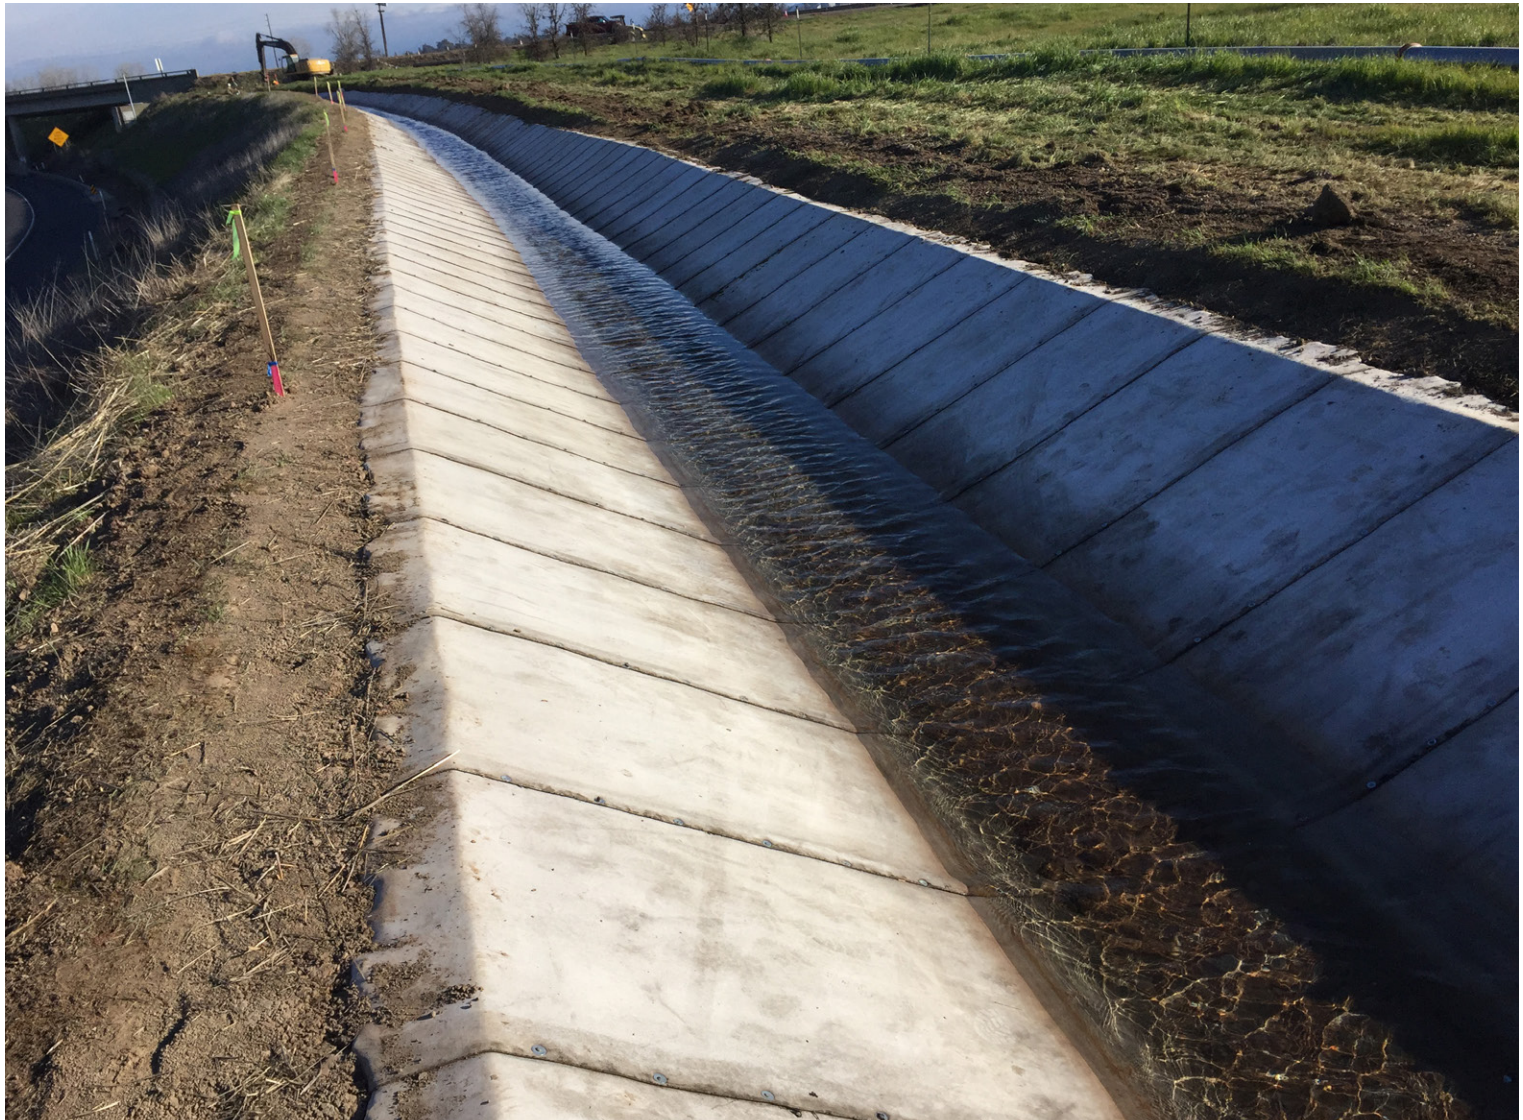
Completed channel
