CC5™ Batched Rolls

Pasir Gudang,  
Johor Bahru, Johor

CC5™ used to  
remediate slope, guard  
rails and footpaths  
around a recreational  
lake

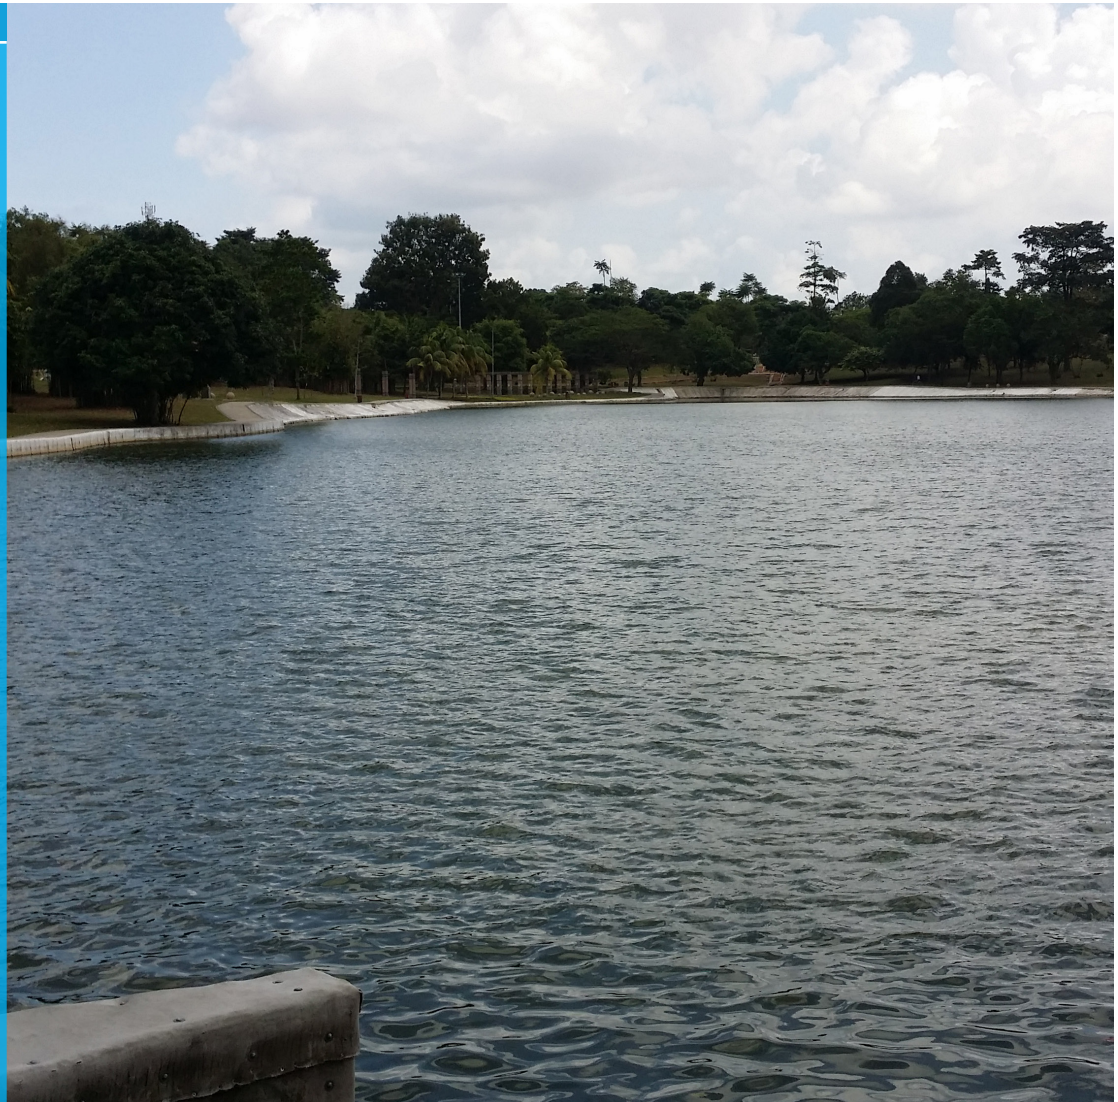
*Completed installation in Pasir Gudang Bahru, Malaysia*

In September 2017, Concrete Canvas® GCCM\* (CC) was used to remediate a number of slopes, guard rails and footpaths surrounding a recreational lake in Pasir Gudang, Johor Bahru in Johor, Malaysia.

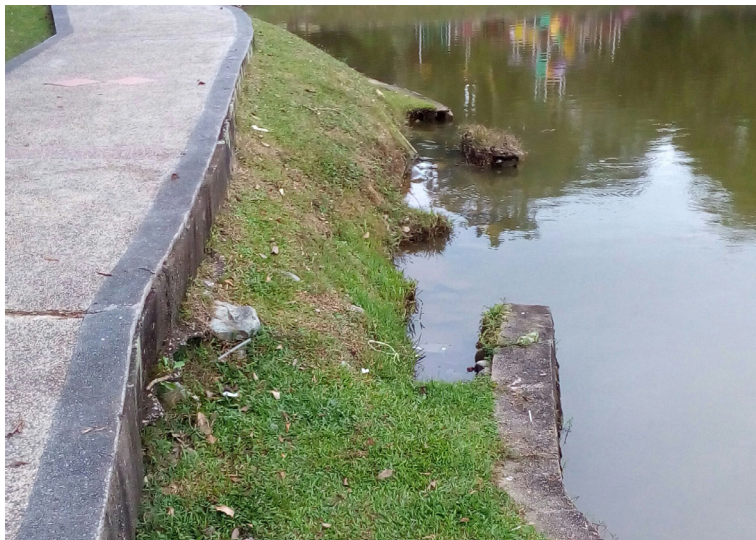
The lake is used for recreational purposes and sees a vast number of visitors throughout the week due to its central location to the town. The slopes around many parts of the lake were deteriorating and allowing water from the lake to seep into the soil and destabilise the concrete foundations of guard rails. Most of the concrete walls had cracked and broken, and soil around them was collapsing into the lake, creating voids which were becoming dangerous for visitors. Due to the erosion caused by the water loss, the footpath was also in need of replacement.

*Sections where erosion has caused the soil slope to collapse into the lake*

Prior to commencement of the CC installation, the slopes were levelled and cracks and damage to the existing retaining concrete walls were remediated using gabions which were submerged into the lake alongside the wall. The void between gabions and slopes were filled with rocks until the surface was level with the adjacent slope. The CC was then laid.

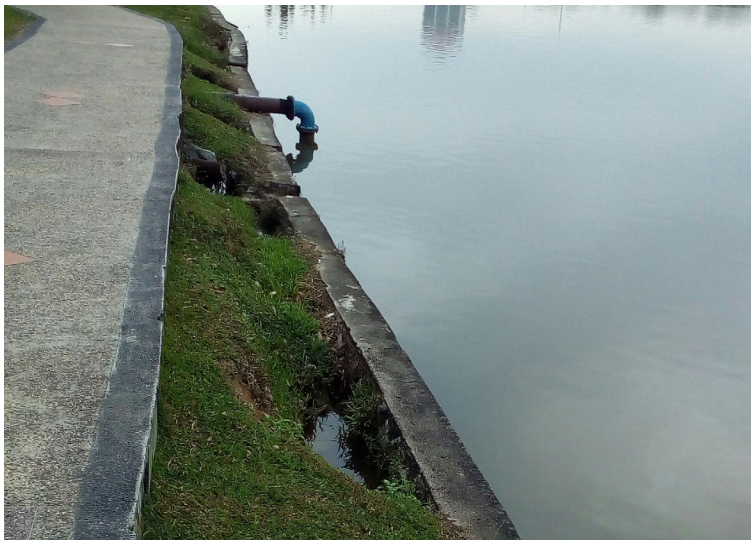
*Voids created by erosion behind retaining walls*

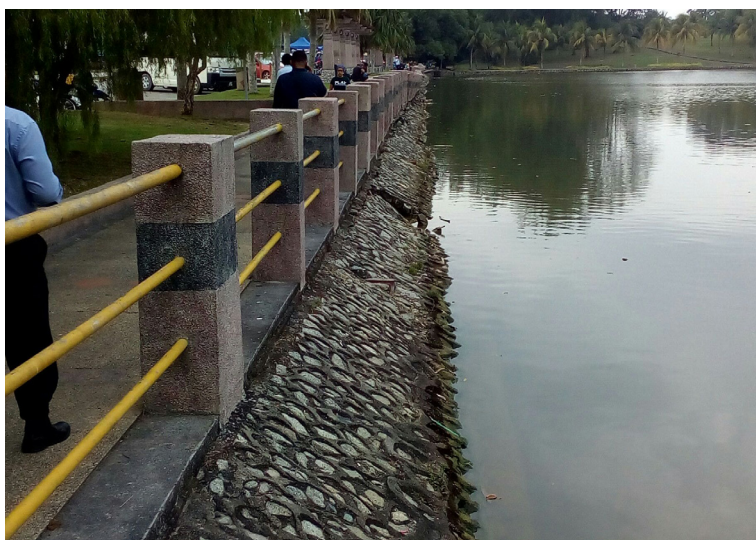
*Original rip-rap slope sections*

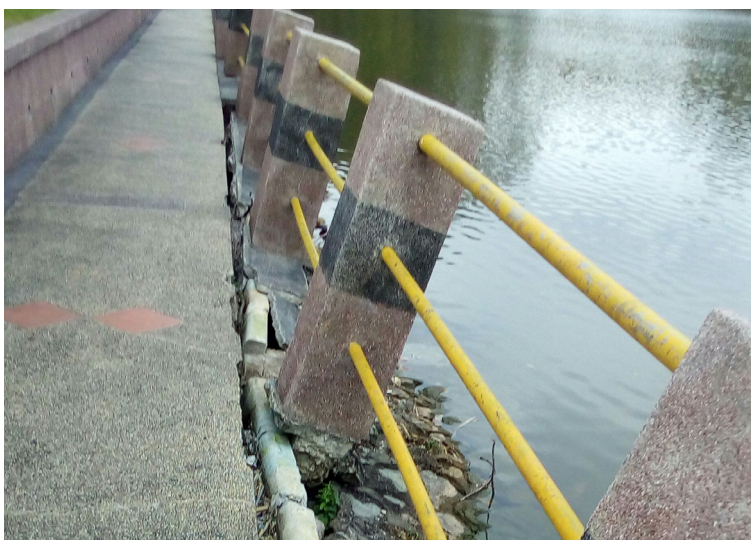
*Guard rails collapsing into lake due to erosion*
