CC5™ Batched Rolls

Tonnoy, Meurthe-et-Moselle, France

CC5™ was used to remediate a failing section of a concrete canal to prevent leakage and water loss

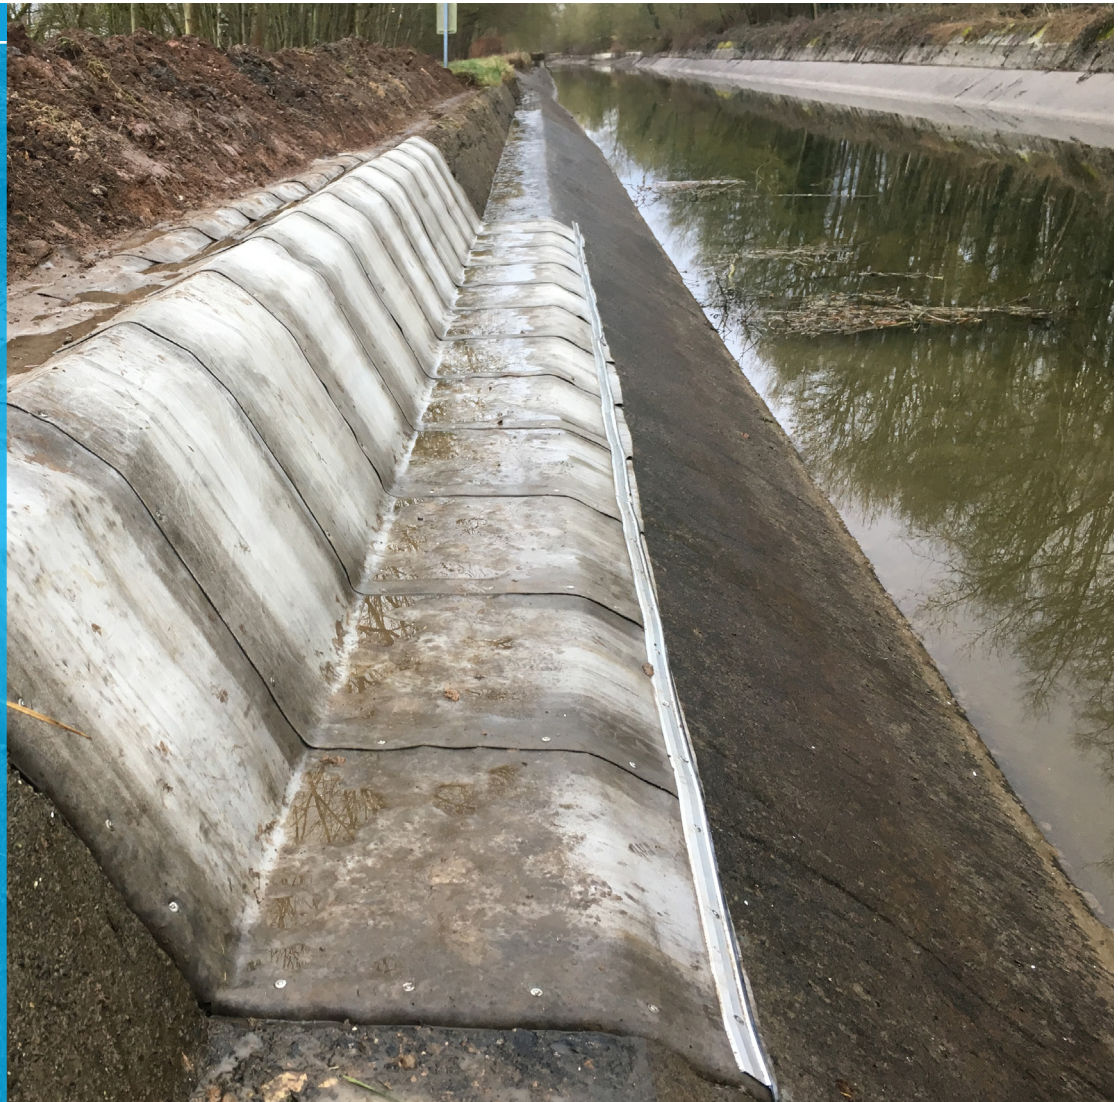
*The completed canal remediation trial installation in Tonnoy, France*

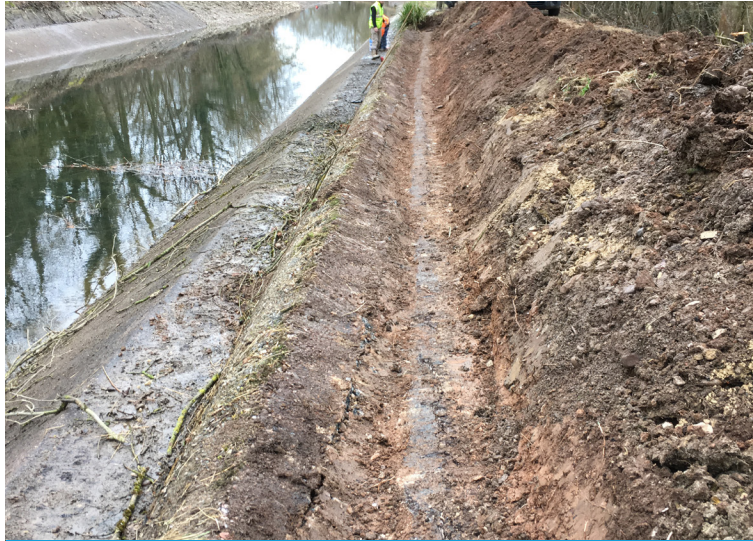
An anchor trench was dug above the failing concrete prior to installation

In preparation for the installation, an anchor trench was dug at the crest of the slope and the failing concrete was brushed to clean it. The CC was then delivered to site in batched rolls of CC5™. The CC was unrolled and laid transversally down the bank of the canal, covering the failing concrete section. The leading edges were fixed using pegs into the anchor trench at the crest of the slope and the material was mechanically fixed into the concrete using Clearfix and expansion bolts every 40 to 60cm. The ends of the CC material were then fixed to the original concrete canal bank using a steel clamping strip and further expansion bolts. This method was repeated along the trial section of the canal bank. Once the installation was complete, the CC was hydrated using water from the canal.

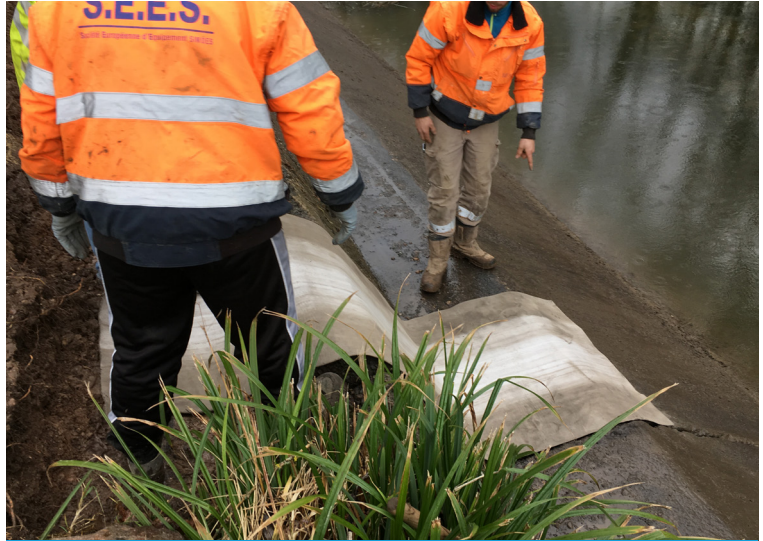
CC was laid transversely down the failing concrete bank

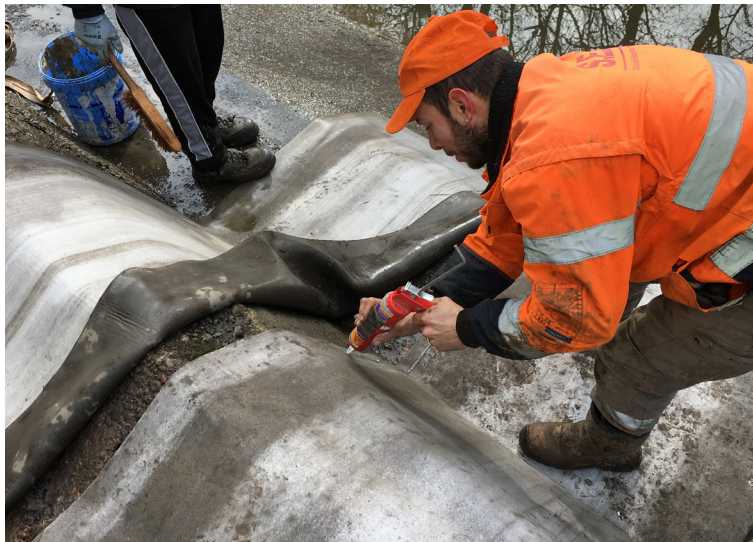
Clearfix was used to fix the CC material overlaps

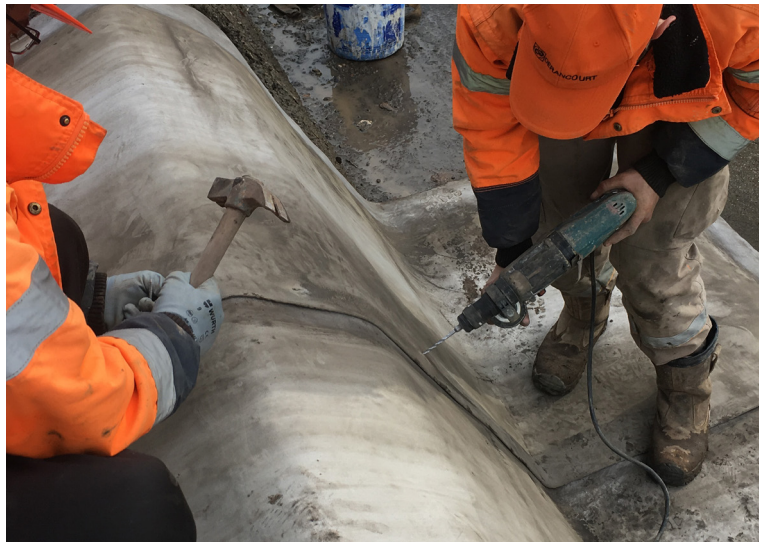
Holes were drilled through the CC and concrete before bolts were inserted

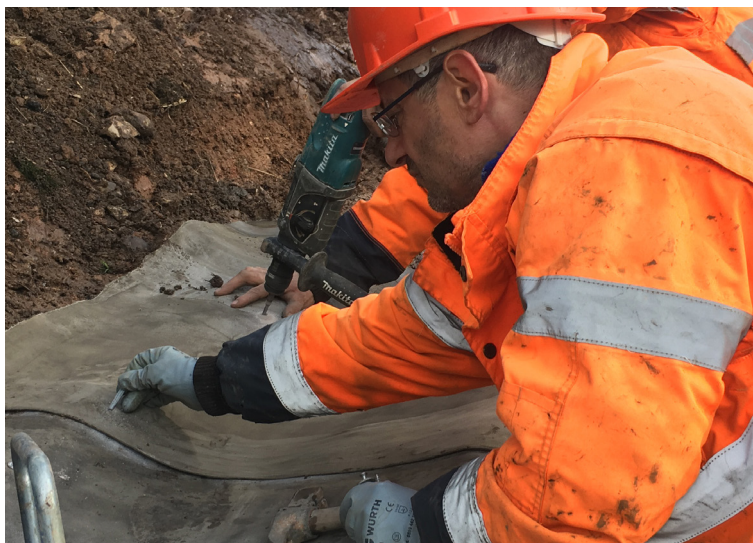
Insertion of the expansion bolt through the CC and into the drilled concrete

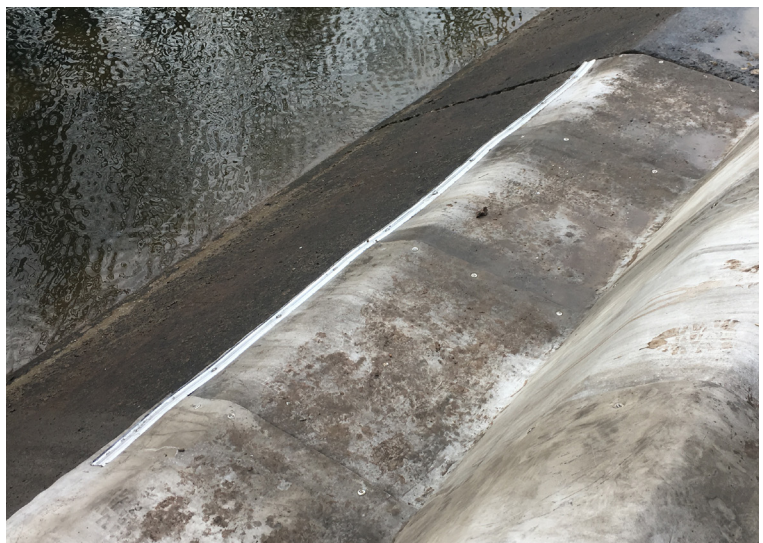
The bottom edge of the CC was fixed using bolts and a steel clamping strip

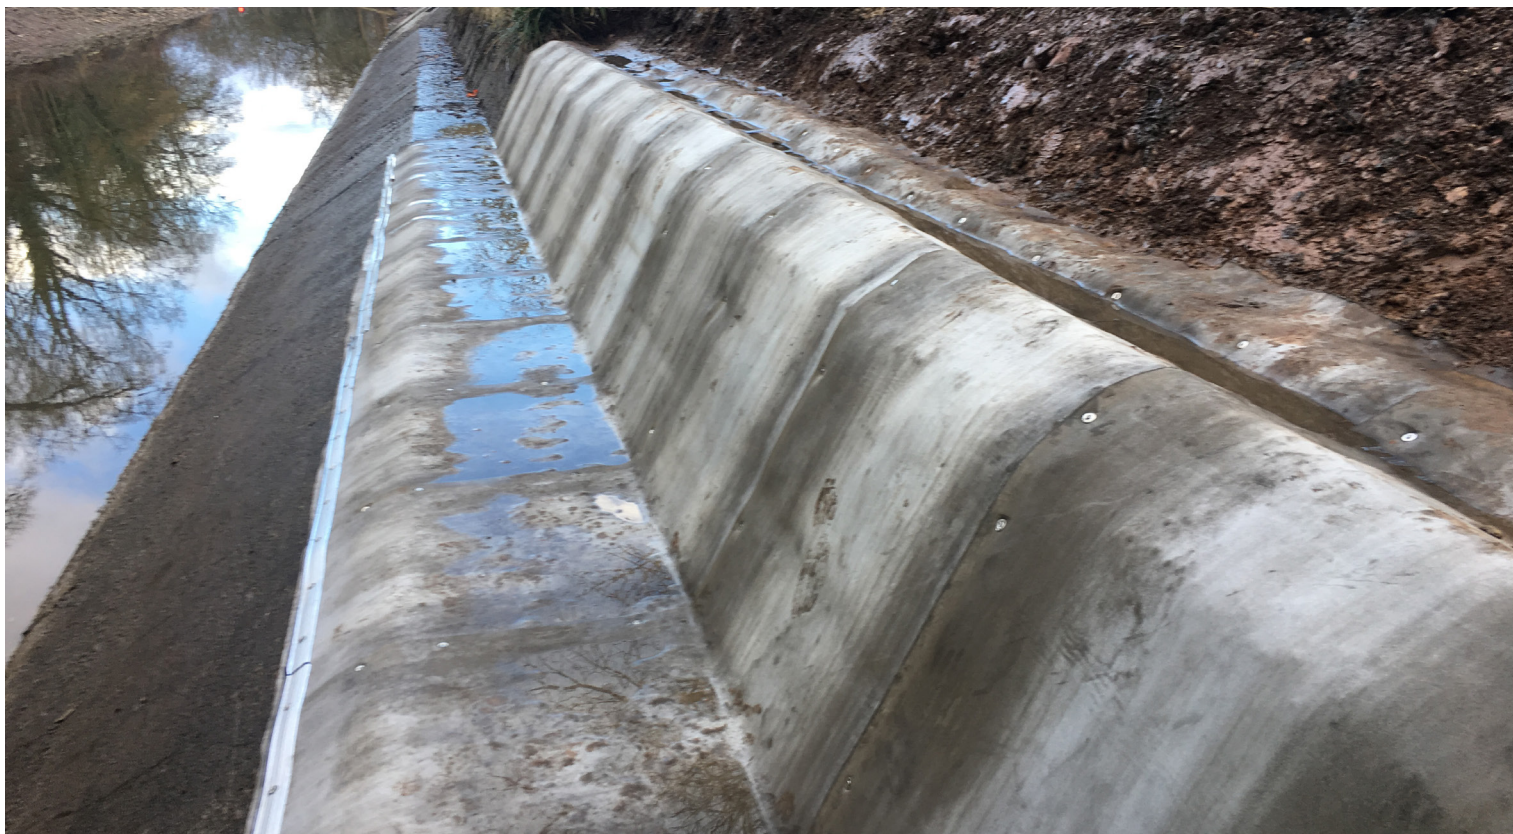
*The completed trial installation*
