CC8™ Bulk Rolls

Warblington, Havant, UK

Graham Attrill Civil Engineering for ESCP

CC8™ was used to provide remedial protection to sections of a seawall in Warblington, Havant

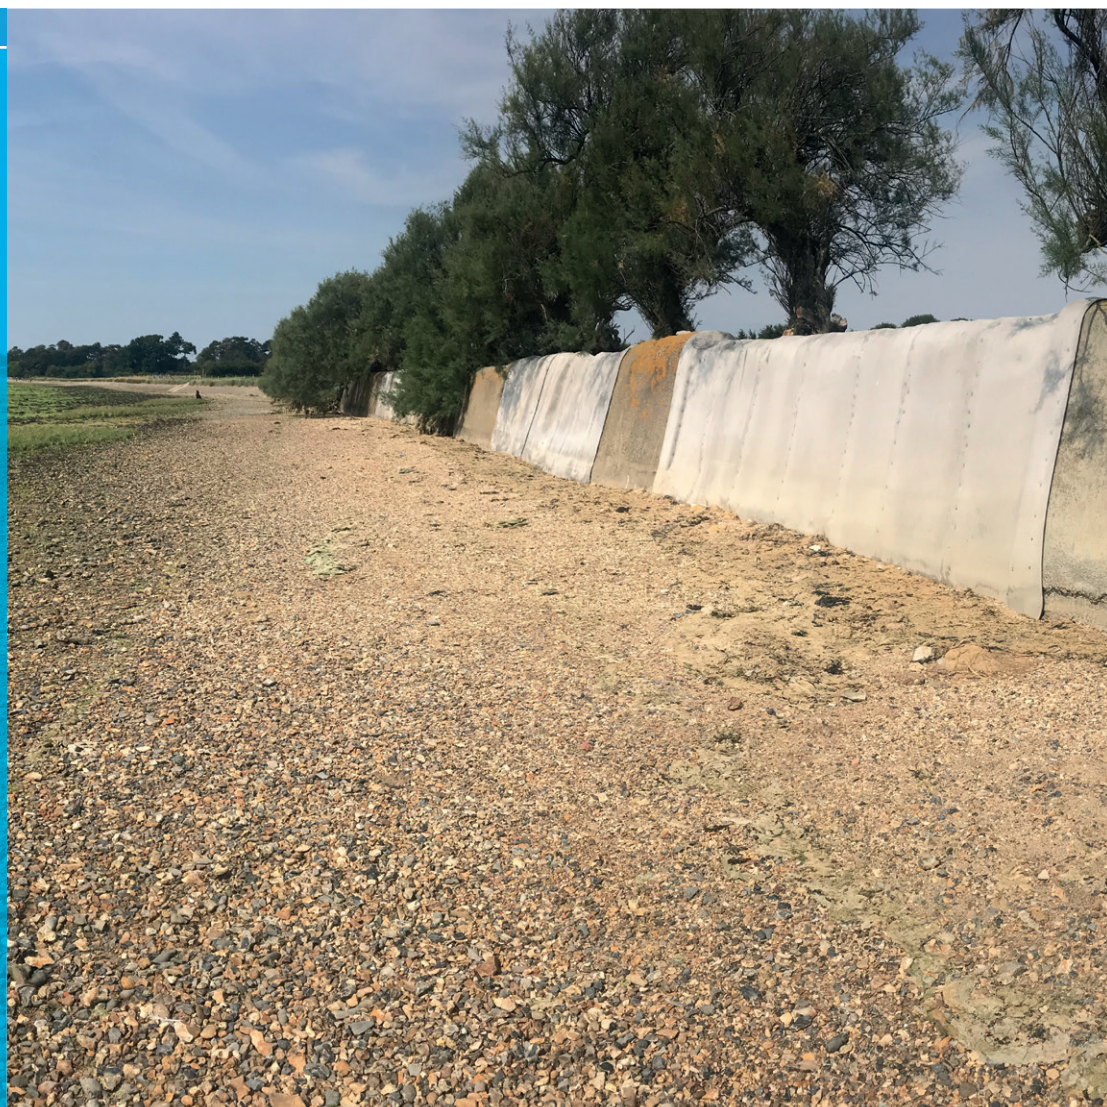
Completed sections of seawall repair installation

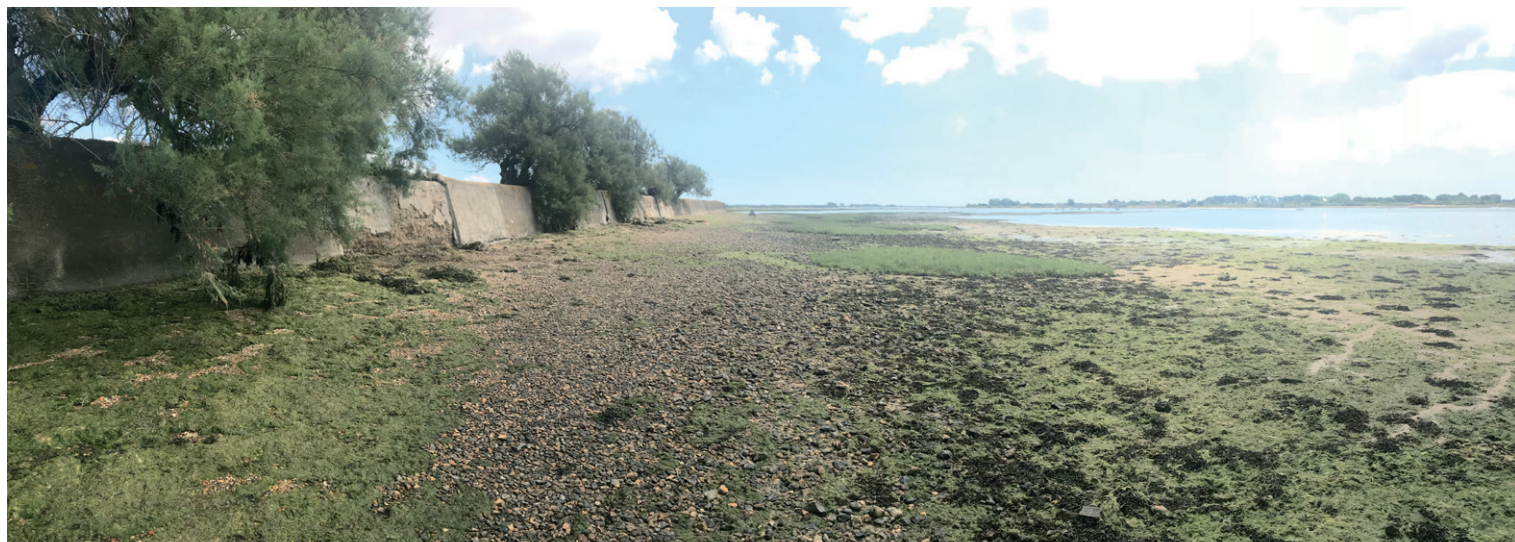
The original sea wall had been sprayed with concrete over 10 years ago, but expansion joints were not included and sections of the wall had cracked with some of the sprayed concrete falling away. CC was therefore used to 'patch' repair the failed sections.

*Site and damaged seawall prior to installation*

Prior to installation, the surface of the wall was brushed to remove any moss or loose concrete, and large voids filled with grout to create a smoother profile and ensure a flush installation. The CC was deployed from a spreader beam from behind the wall, then sealed and fixed using masonry bolts at 200mm intervals along joints and wherever required to secure the material to the wall and minimise void space between the material and wall surface. The CC edges were also sealed and fixed to the existing concrete to prevent ingress. Once installation was completed, a bowser was used to hydrate the material.

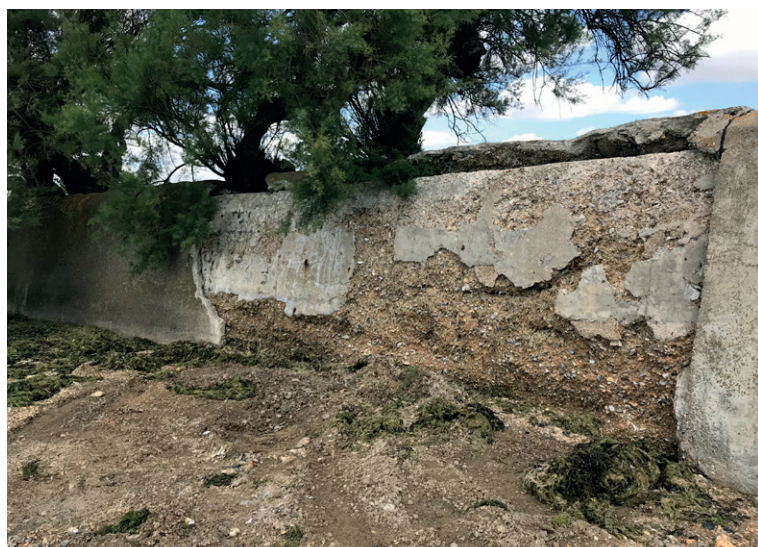
*Section of damaged sea wall*

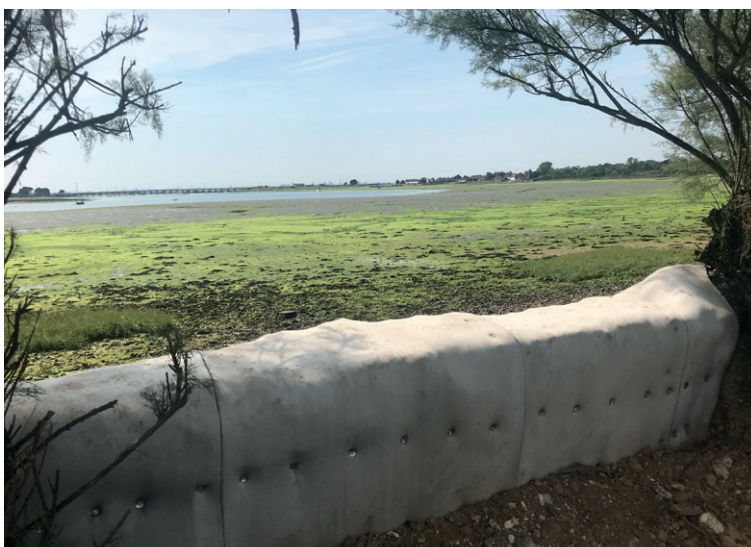
*CC first attached to the back of the wall*

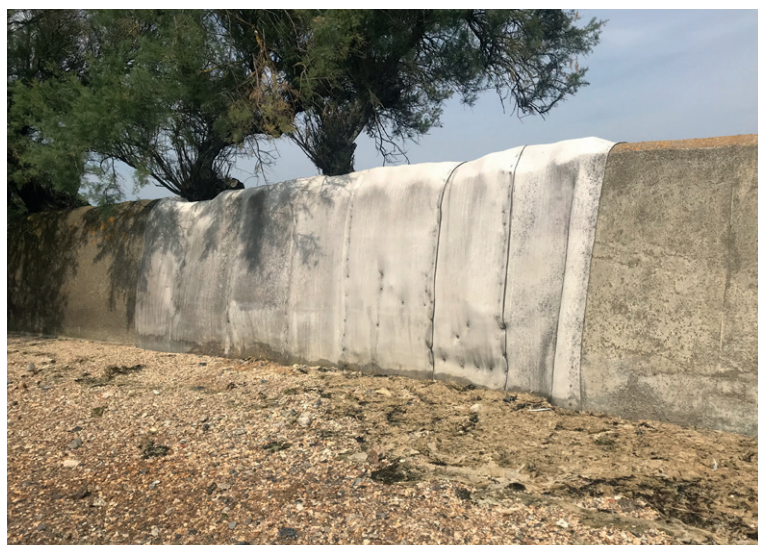
*Vertical layers of CC used to cover damaged sections*

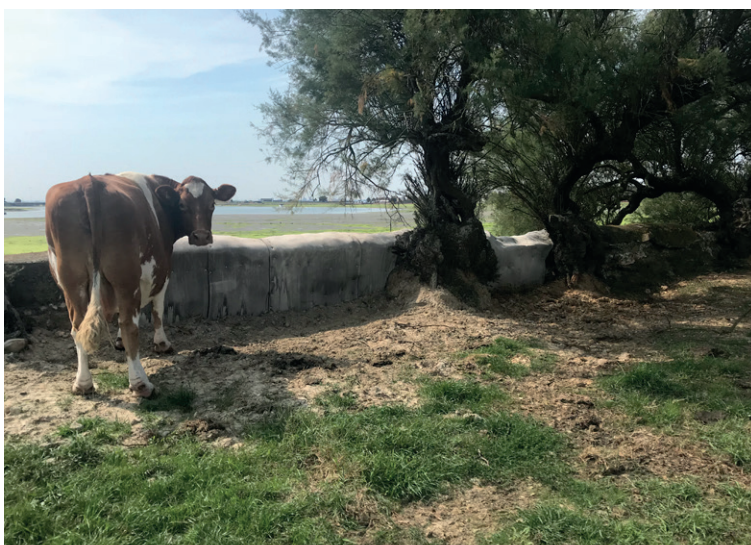
*CC protected sensitive environments*

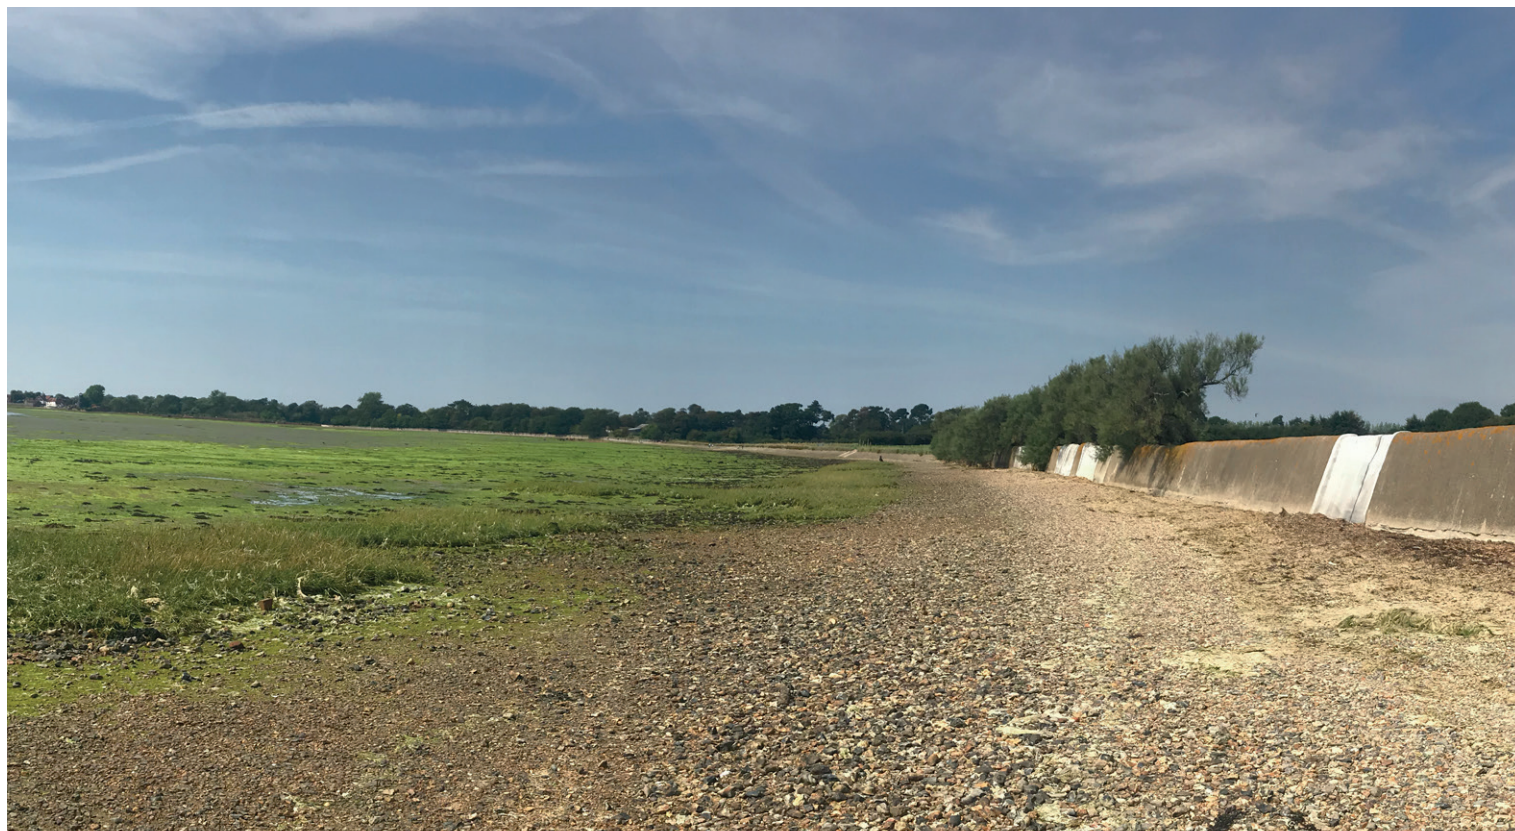
*Completed sections of seawall repair*

The installation was carried out in three days, with a total of 125m<sup>2</sup> of CC8™ used. The client is pleased with the outcome of the scheme, and the use of CC reduced time on site and logistical costs, as well as reducing disruption on the site. The material will prevent further damage to these sections of wall, with an anticipated durability in excess of 50 years for a Northern European climate.
