CC8™ Bulk Rolls

Barrio El Codito,  
Bogota D.C, Colombia

CC8™ used to stabilise  
and contain fines  
and debris during  
construction work at the  
foot of a slope.

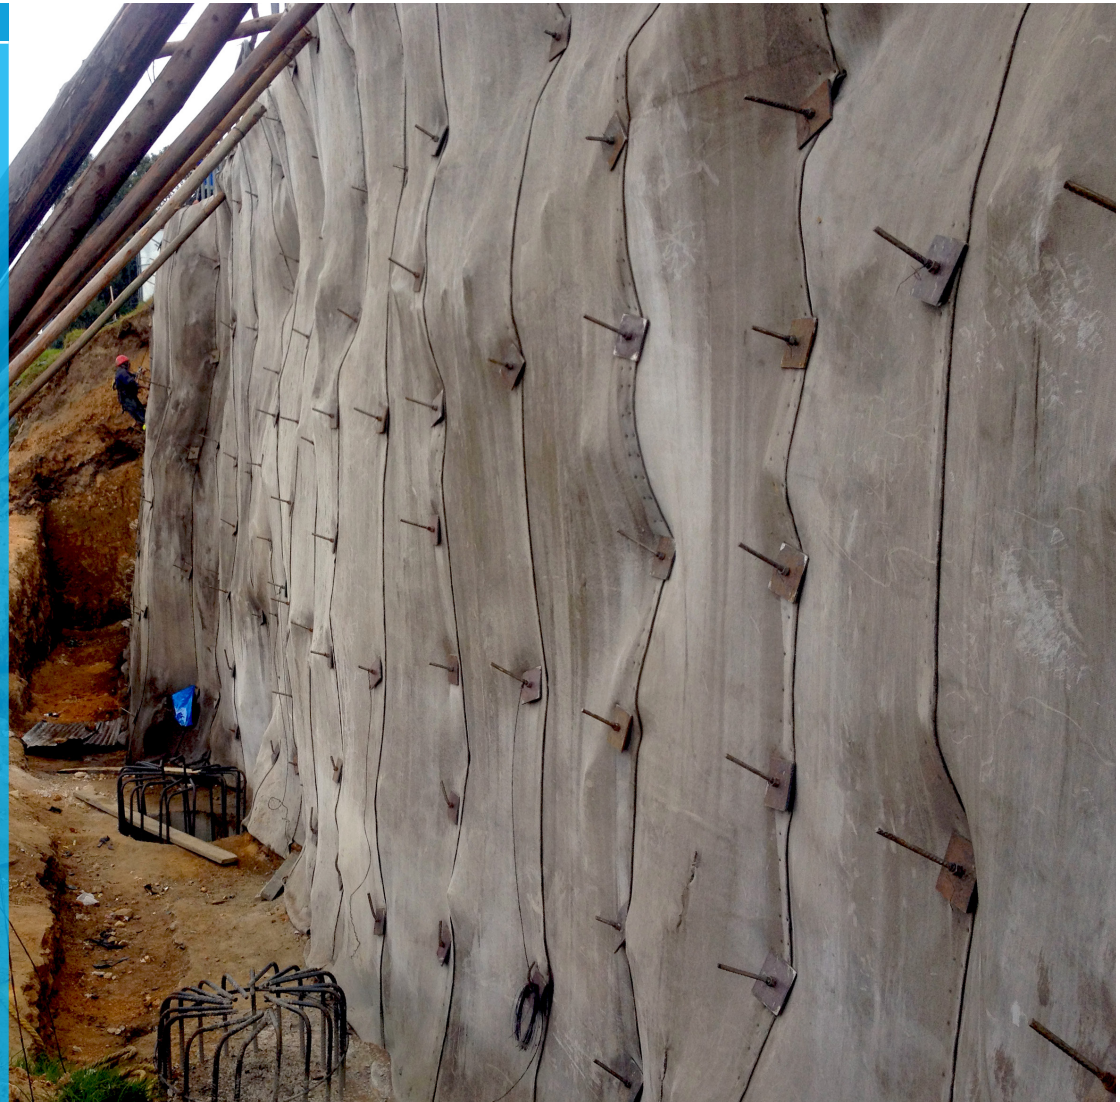
Completed slope

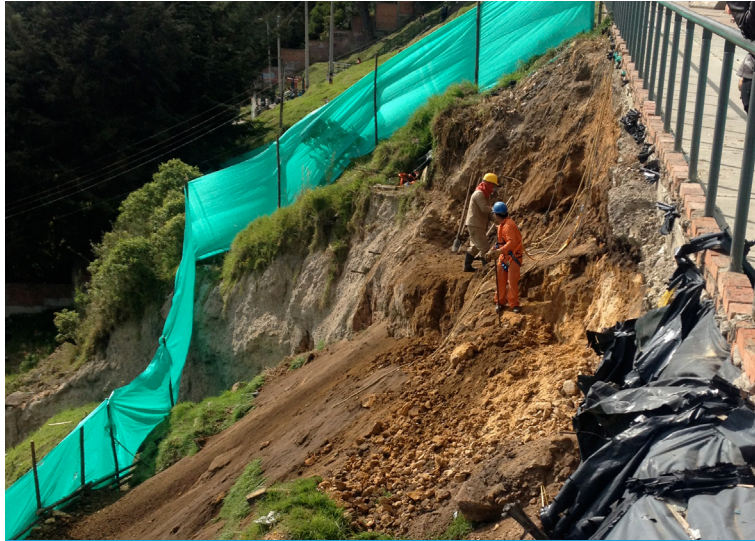
*Slope instability and slip posed a risk to an adjacent construction project*

In August 2013, Concrete Canvas® GCCM\* was installed by M2M as a slope protection and stabilisation measure in Barrio El Codito, Colombia. The slope had previously suffered from surface erosion and slip caused by weathering and vibration from the adjacent road. A solution was needed that could be installed quickly, preventing delays to adjacent construction work. Shotcrete had been considered but the equipment would cause issues with road traffic delays as well as safety concerns due to the associated rebound.

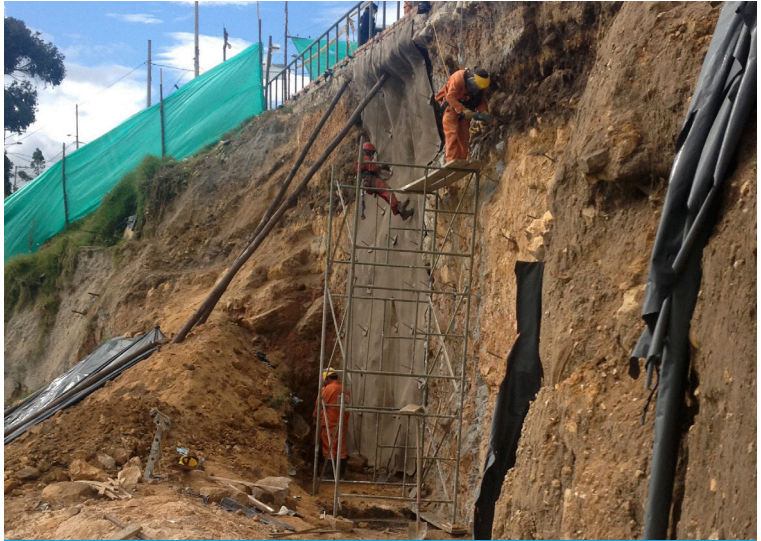
*CC8, unlike shotcrete, was able to be installed without heavy plant*

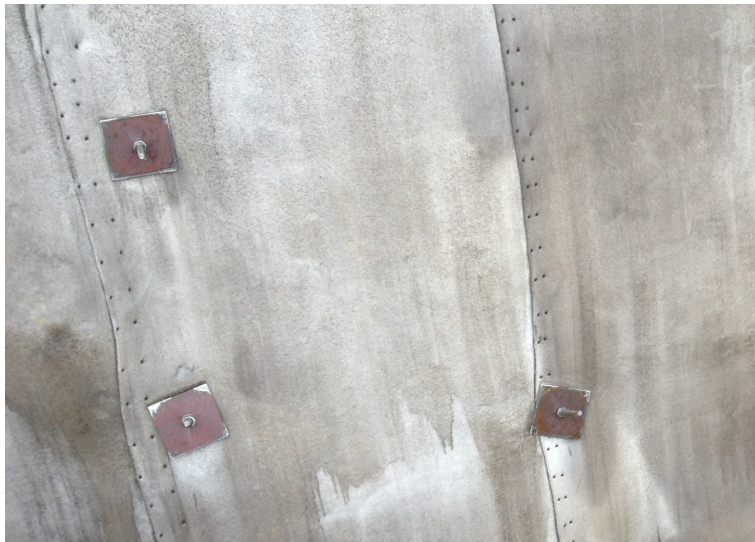
*Adjacent layers were overlapped by 100mm and screwed together*

Prior to installation, the site was cleared of any vegetation, loose soil, rocks and any other debris. Bulk rolls of CC8™ were then delivered to site and cut to length, eliminating material waste. The CC was fixed to the head of the slope using anchor bolts, before it was unrolled to the foot using a spreader beam and climbing equipment. Steel pegs were used to fix the material to the foot of the slope. Adjacent layers of CC were overlapped by 100mm and screwed in place at 200mm intervals. Soil nails with 200mm round-edge metal plates were then used to secure the CC to the slope and eliminate void spaces. The material was then hydrated using on-site equipment.

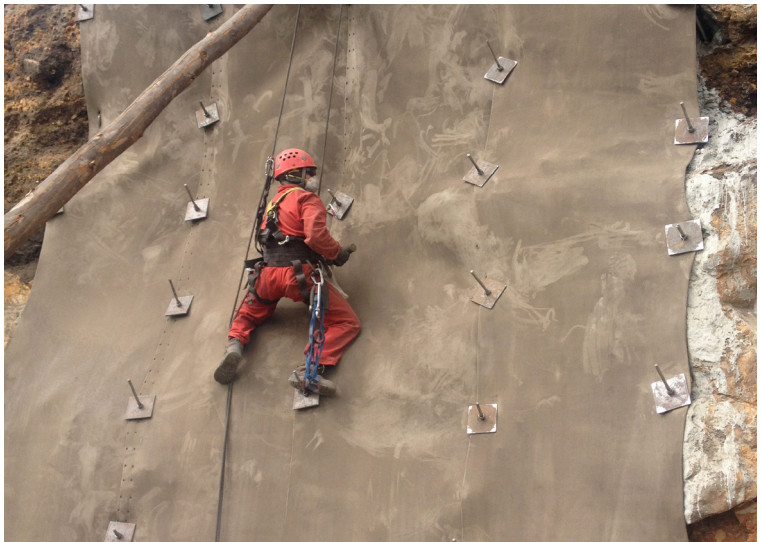
*Soil nails with 200mm plates were used to secure CC to the slope*

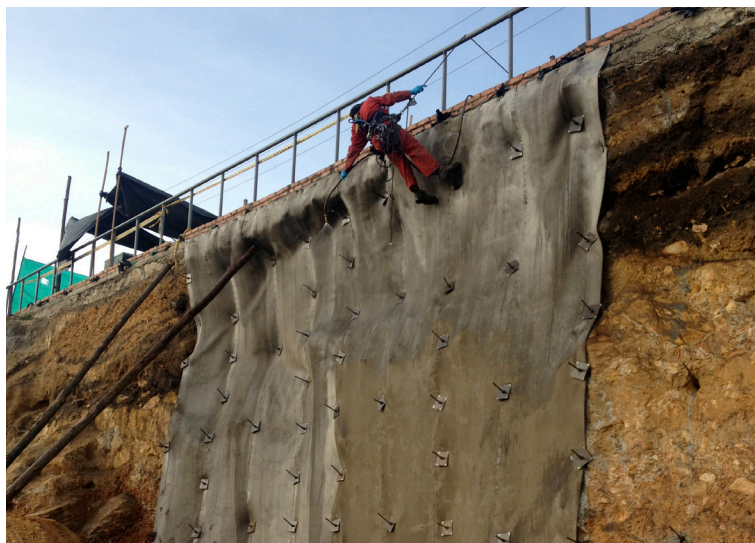
*CC was hydrated using a hose and climbing equipment*

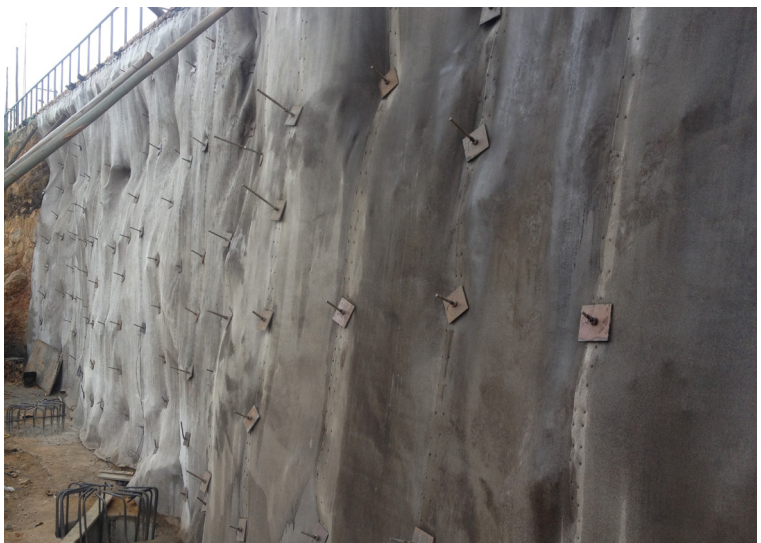
*CC lined slope section after hydration*
