## SLOPE PROTECTION

A road-side slope in Al Bahah, Saudi Arabia was posing a risk to road users and therefore required lining. Surface erosion caused by rainfall loosens the slope substrate, risking rockfall from the slope damaging the road and endangering road users. The slope measured 20m in width, with a height ranging from 5.5m to 22m.

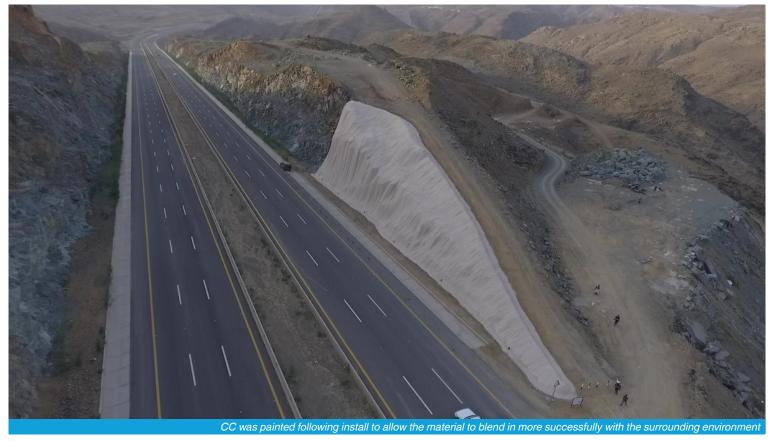
Bulk rolls of all three thicknesses of CC - CC5™, CC8™ and CC13™ - were delivered to site and when required, mounted onto a spreader beam and hung from a JCB and excavator for deployment. All three thicknesses were used on this project for evaluation purposes, allowing the client to monitor the performance of each for reference should they opt to use CC in future projects.

The rolls were lifted to the crest of the slope, with the leading edge placed in the pre-prepared anchor trench, secured using ground pegs and then rolled down the slope face. This method was repeated for the total width of the slope requiring lining, with subsequent layers overlapping the last by 100mm. The material was hydrated below the overlap, and the overlapped joints then screwed together using stainless steel screws at intervals of 200mm. At the toe, the edge of the CC was captured and secured within the anchor trench, as with the crest. Drainage pipes were also installed at the bottom of the slope to ensure the flow of rain and waste water. Once installation was completed, the material was hydrated using a water tank and hose attachment, and the anchor trenches backfilled using poured concrete and reinforced with steel bar beams. The CC material was later painted for a more natural look with the surrounding substrate.
