SLOPE PROTECTION

A road-side slope in Al Bahah, Saudi Arabia was posing a risk to road users and therefore required lining. Surface erosion caused by rainfall loosens the slope substrate, risking rockfall from the slope damaging the road and endangering road users. The slope measured 20m in width, with a height ranging from 5.5m to 22m.

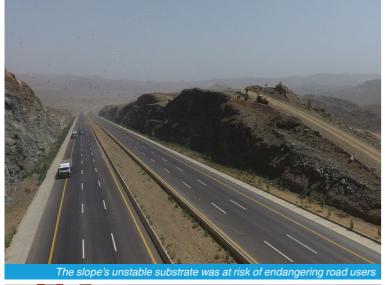
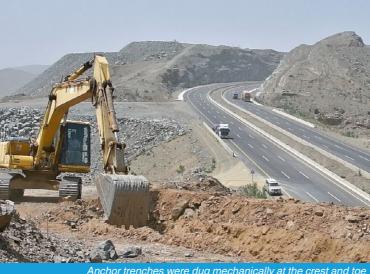
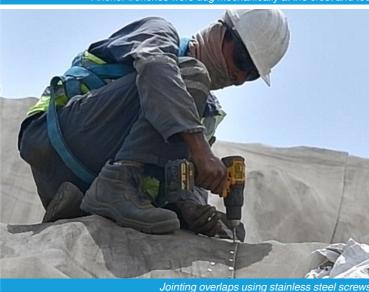
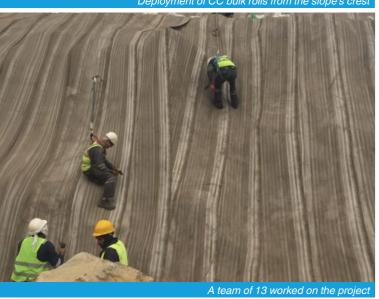
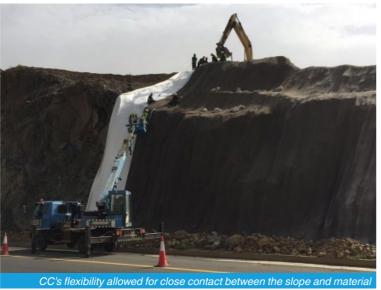
Bulk rolls of all three thicknesses of CC - CC5™, CC8™ and CC13™ - were delivered to site and when required, mounted onto a spreader beam and hung from a JCB and excavator for deployment. All three thicknesses were used on this project for evaluation purposes, allowing the client to monitor the performance of each for reference should they opt to use CC in future projects.

A geotextile was placed on the slope to protect the CC from snagging during deployment. The rolls were then lifted to the crest of the slope, with the leading edge placed in the pre-prepared anchor trench, secured using ground pegs and then rolled down the slope face. This method was repeated for the total width of the slope requiring lining, with subsequent layers overlapping the last by 100mm.

The material was hydrated below the overlap, and the overlapped joints then screwed together using stainless steel screws. At the toe, the edge of the CC was captured and secured within the anchor trench, as with the crest. Drainage pipes were also installed at the bottom of the slope to ensure the flow of rain and waste water. Once installation was completed, the material was hydrated using a water tank and hose attachment, the anchor trenches were backfilled using poured concrete and reinforced with steel bar beams. CC was painted after installation.
