SLOPE PROTECTION

In July 2012, Concrete Canvas® GCCM* (CC) was used to protect a steep slope in Bogota D.C, Colombia. The slope had suffered severe surface erosion and slip which threatened the integrity of the slope and the road at its crest, and risking damage to the houses at the crest and toe of the slope.

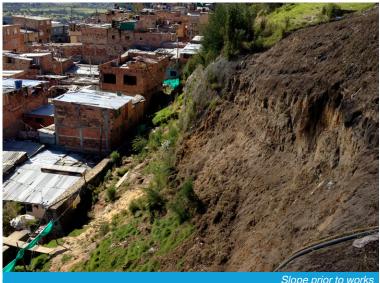
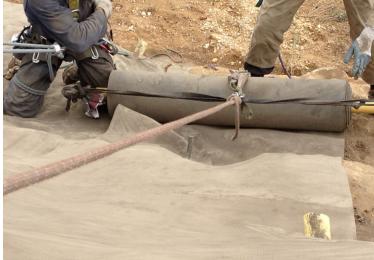
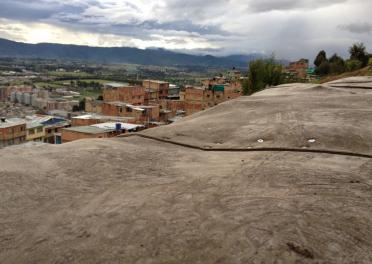
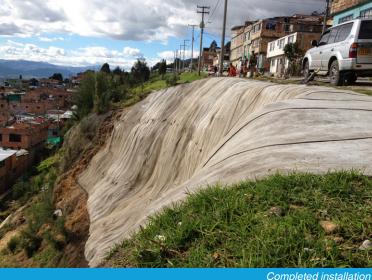
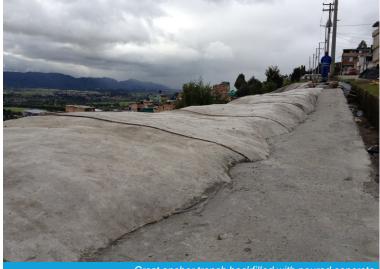
CC bulk rolls were delivered to the site and deployed using a spreader beam, with the installation team using climbing equipment to allow them to guide the material down the slope and safely and easily fix and joint the CC in place. Prior to installation, the team had installed soil anchors and drainage pipes. The leading edges of the CC lengths were pegged into an anchor trench at the crest of the slope, while overlapping layers of the material were jointed down the slope's face at 200mm intervals using screws. The CC was fixed to the slope itself using 200x200mm steel plates and soil anchors to ensure intimate contact with the substrate. Once completed along the width of the slope, the CC was hydrated and the anchor trench at the crest backfilled with concrete to prevent ingress and provide a neat termination.
