CC8™ Bulk Rolls

Recife, Pernambuco
Brazil, Bairro Imbura,
Brazil

CC8™ used to protect a
residential slope facing
severe erosion issues.

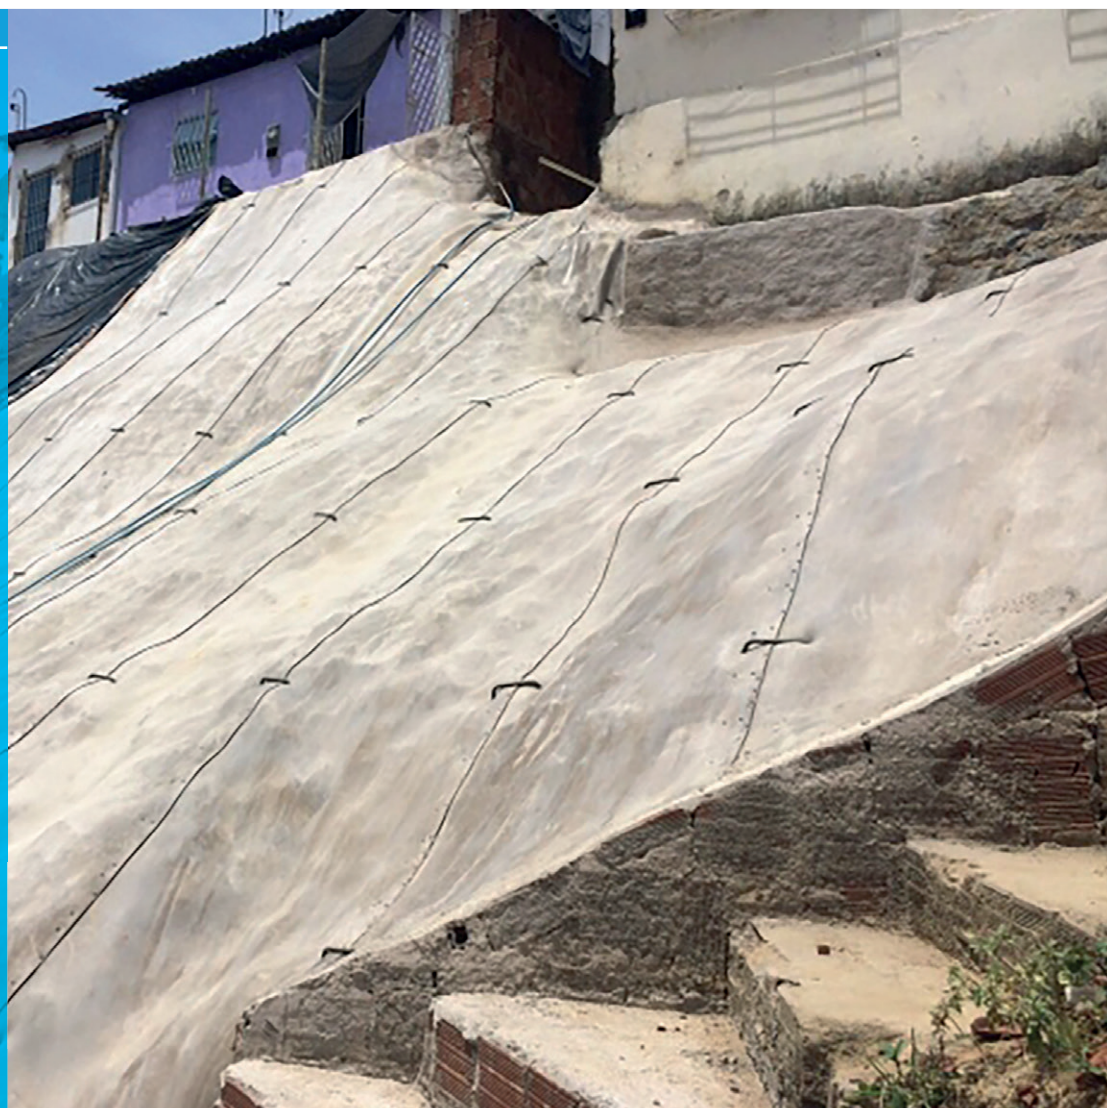
Completed installation

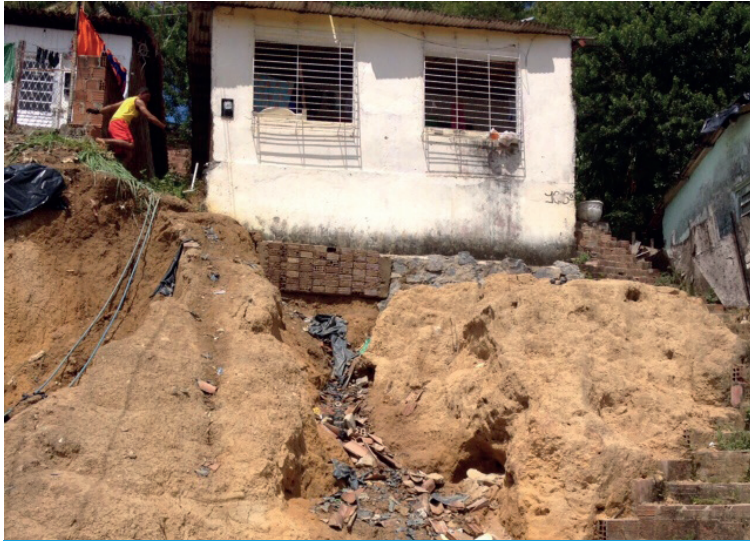
Extensive erosion of the slope

The slope was facing severe erosion problems which had led to the collapse of a house at the crest of the slope. Shotcrete was considered, but due to the varying profile of the slope and the site location this would have been logistically complex and was therefore ruled out. A gel and geotextile combination was also an option, however, it was decided this solution was too fragile to cope with the anticipated weathering erosion. Additionally, previous installations of this material had been subject to theft. Due to CC's resistance to impact, UV degradation and its estimated 50 year life-span, it was installed as a trial to assess its suitability for 1,400 similar projects within the municipality.

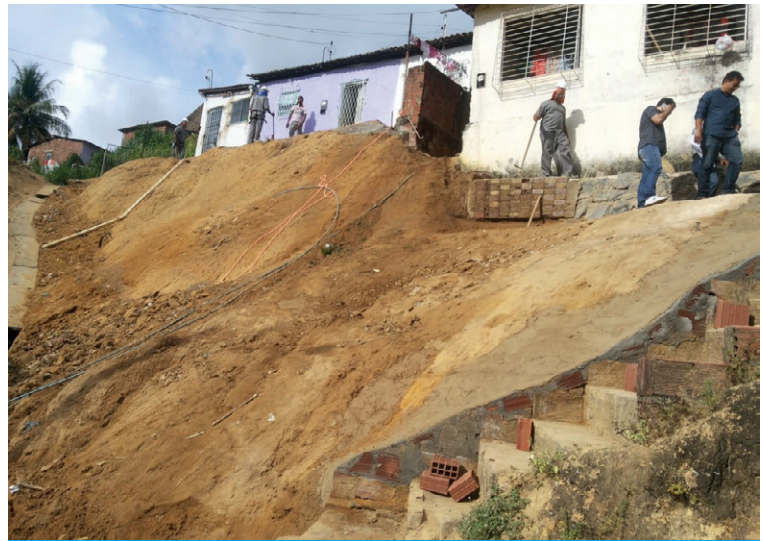
Ground preparation

The slope ranges in height from 5m to 12m and is surrounded by housing. Loose soil, rock and vegetation was removed and the surface re-graded to ensure intimate contact between the CC and the substrate. The nearby stairs and a masonry wall were repaired with concrete as part of the works. A bulk roll of CC8™ was delivered to site and mounted onto a spreader beam hung from a crane. For the smaller lengths, the CC was unrolled on the flat, cut to specific length and positioned onto the slope by hand, with the installation crew ensuring there was a 100mm overlap between layers. For the steeper, taller parts of the slope the CC roll was positioned at the top of the slope and spooled down, reducing the manual handling requirement.

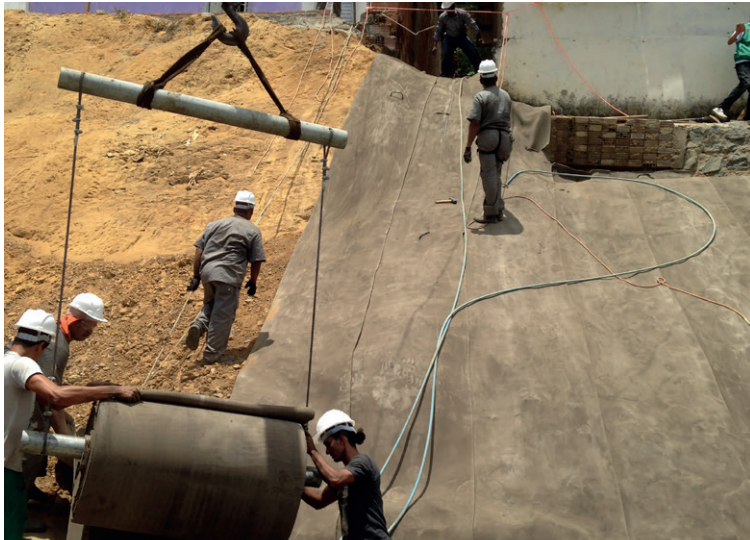
CC spooled down the slope

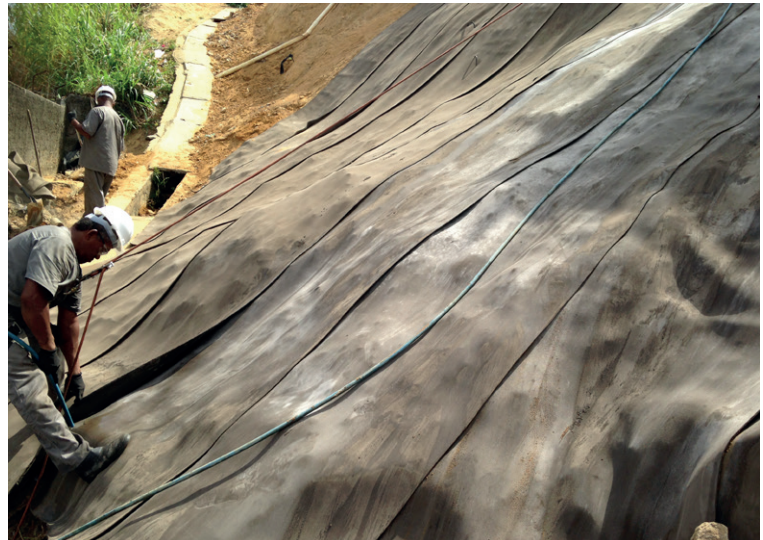
Hydrating under the overlap

The CC was initially fixed at the top of the slope to allow the installation crew to hydrate under the overlap before fixing and jointing. 400mm ground pegs were then inserted through the overlaps at 2m intervals to fix the CC to the slope. To joint the overlaps a double row of screws were applied at 200mm centres using an auto feed screwdriver, then hydration was completed using an 8000L bowser and hose with spray nozzle attached. A concrete mortar was used where CC terminated onto masonry infrastructure and, once set, the slope was painted to match the surroundings.

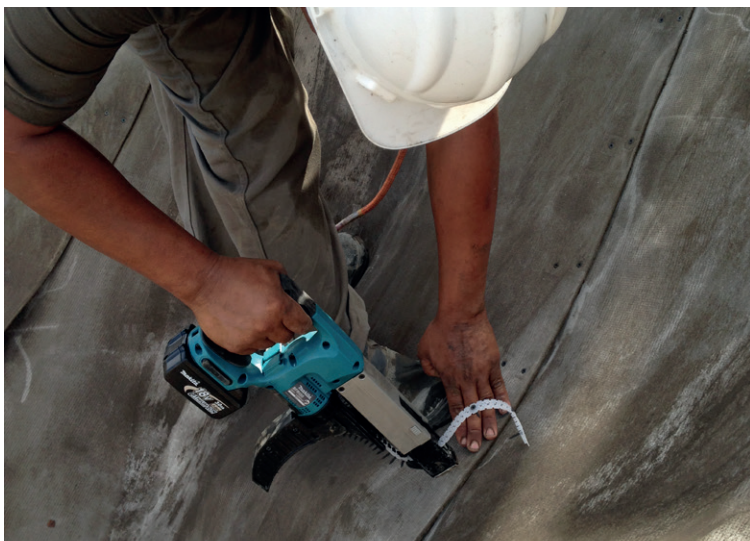
Joints were screwed every 200mm with a double row of screws

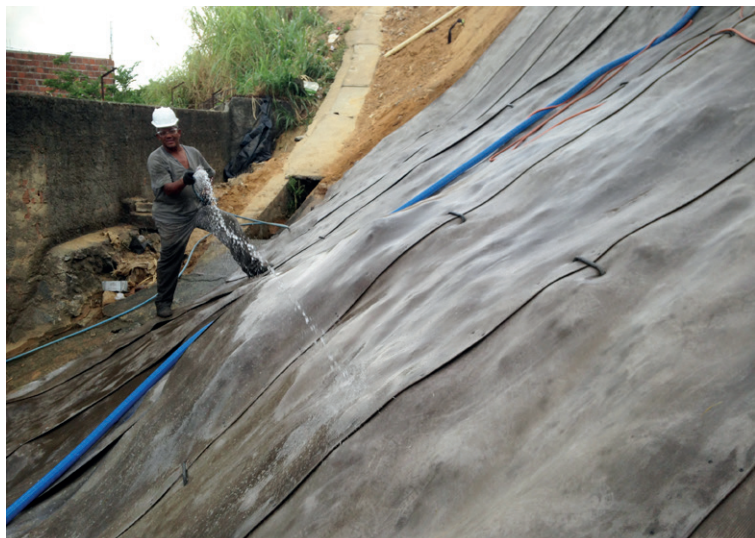
Hydration

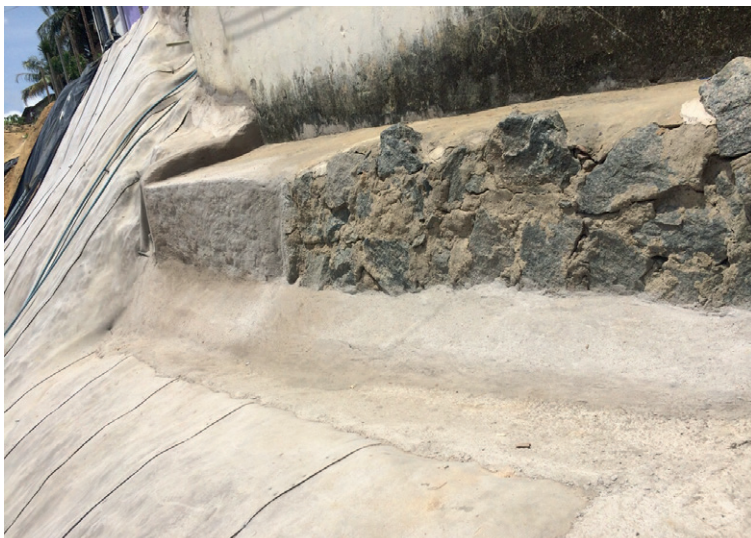
Mortar joint

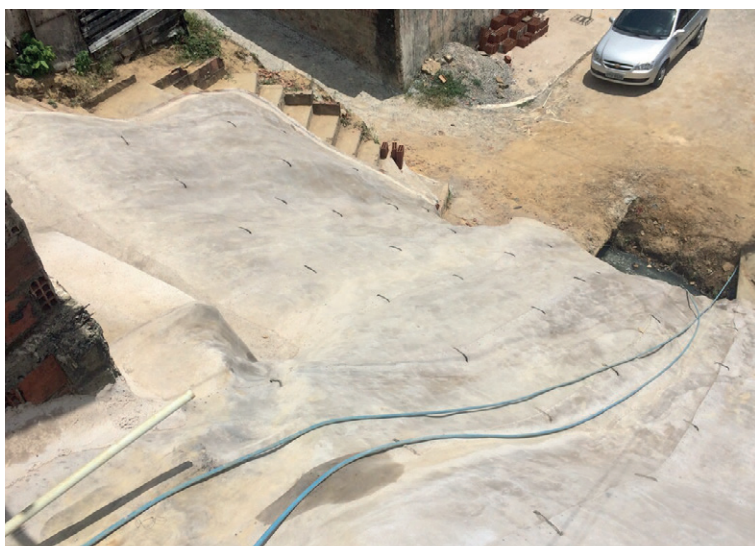
The finished painted slope

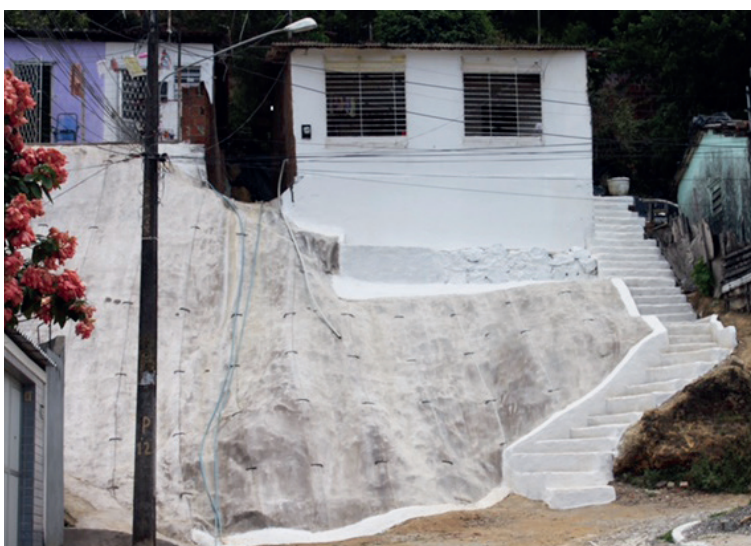
The finished project

125m² of CC8™ were installed in just 9 hours by a team of 6 supervised by SPI Brasil in temperatures of up to 35°C. The project was a huge success with the client calling it an 'innovative solution' that was faster and cleaner to install than shotcrete with less weight burden being placed on the slope. As a result of this project, CC has the potential to be listed in the Brazilian National suppliers system, showing that it has been approved for use by the state.
