Project Info

CC8™ Bulk Rolls

Itaara, Brazil

CC8™ used to prevent
erosion of soils at the
base of a transmission
tower

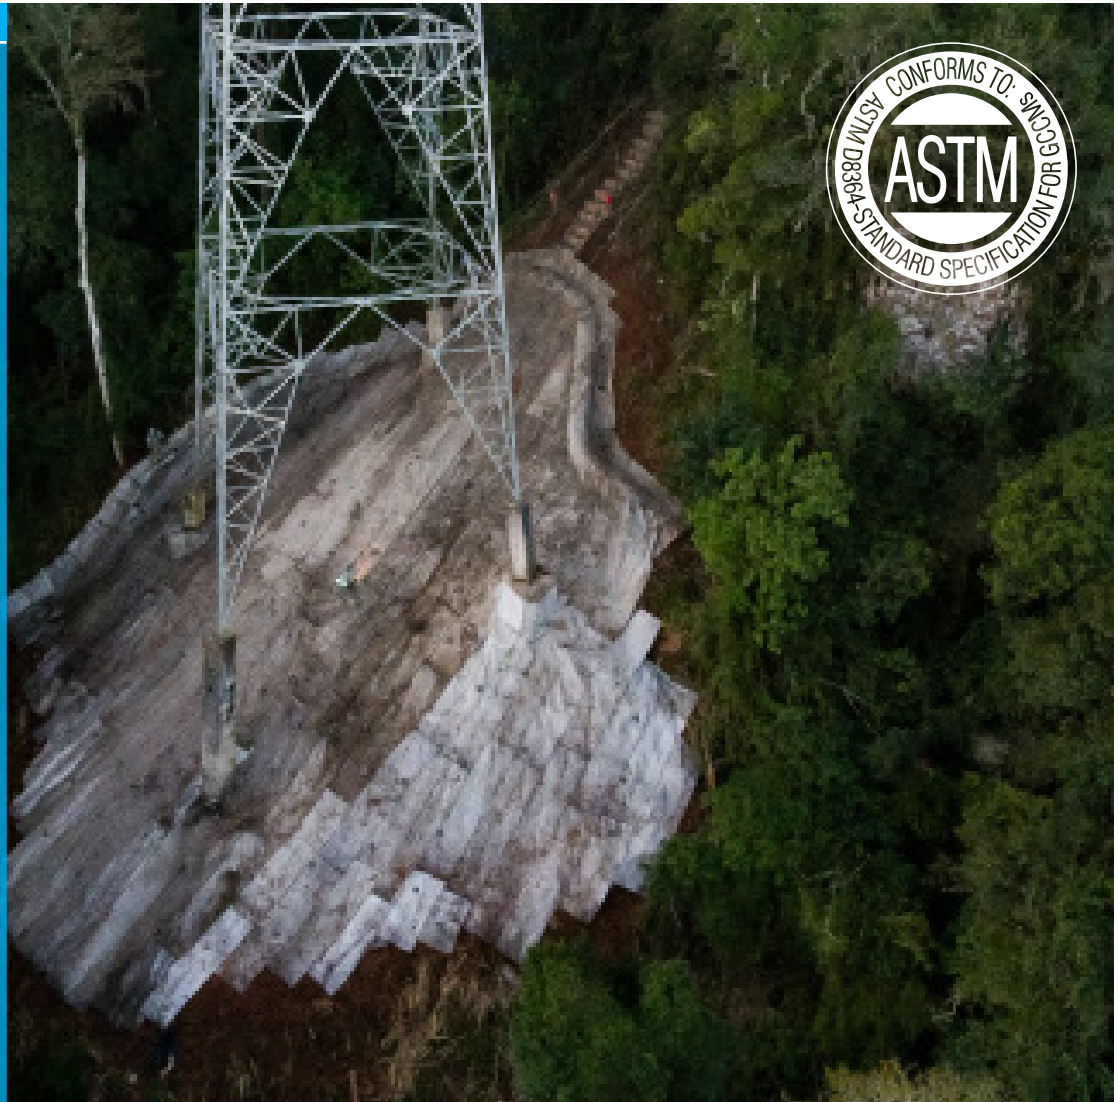
Installation in progress

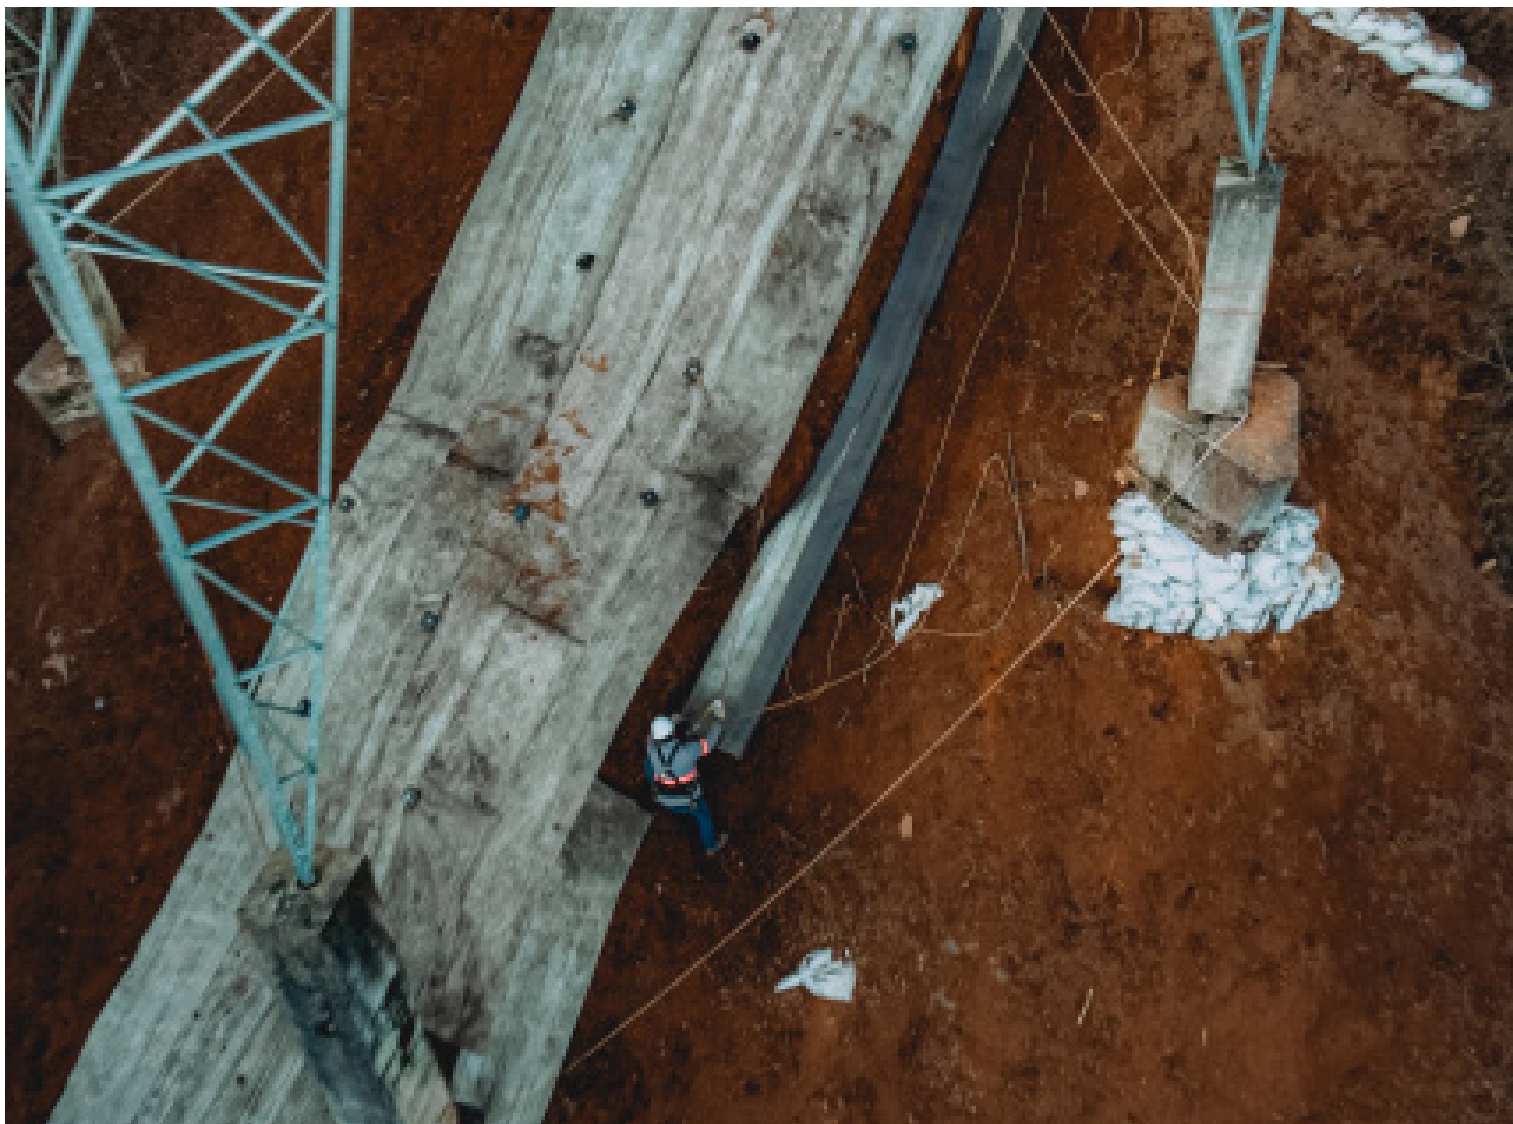
Process of installing CC

Prior to installation, sharp or unstable rocks were removed from the slope, along with vegetation, by using shovels, hoes and sickles. On the crest, a barrier was built with bags of soil-cement to act as a diversion channel for surface runoff. CC8™ Bulk Rolls were supplied for the project, but were batched on site to suit manual handling limitations when working on such a steep slope. The site batched rolls were transported by pick up truck before being moved into position by hand. The CC was fixed to the crest with anchor bolts and clamps, and adjacent layers were overlapped and jointed using stainless steel screws. Soil nails and anchor bolts were used to profile the CC to the slope and prevent the material from curing with voids beneath. For hydration, a water tank was used and the CC was hydrated 3 times in a 4 hour period.

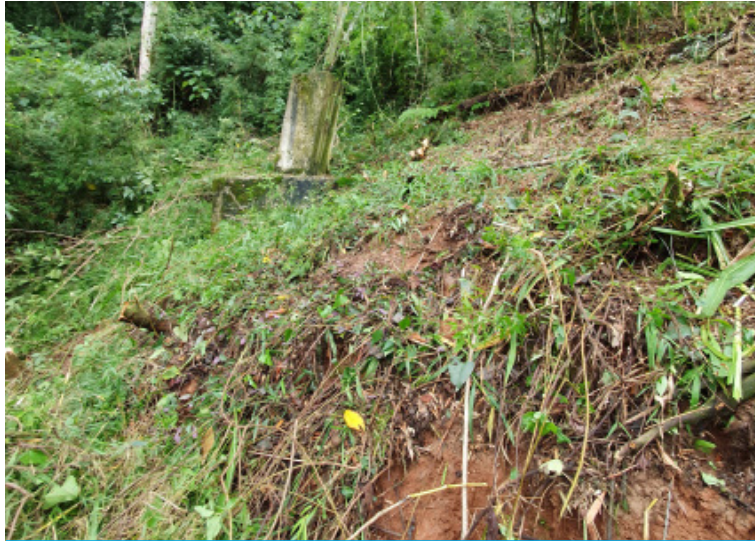
Vegetation was removed prior to installation of CC

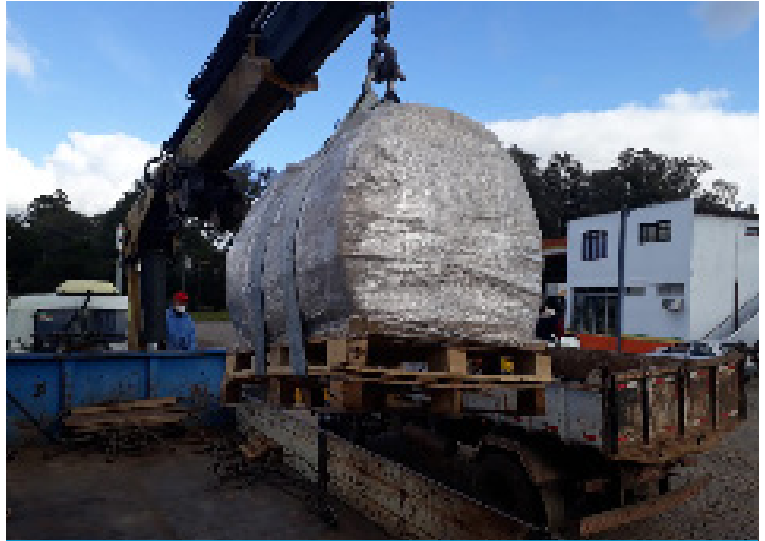
CC delivered to site in Bulk Rolls

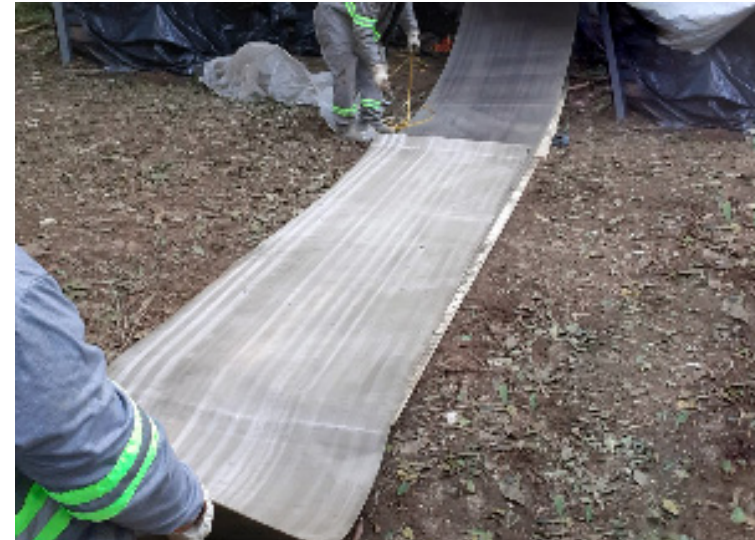
Bulk Rolls batched on site to suit handling limitations

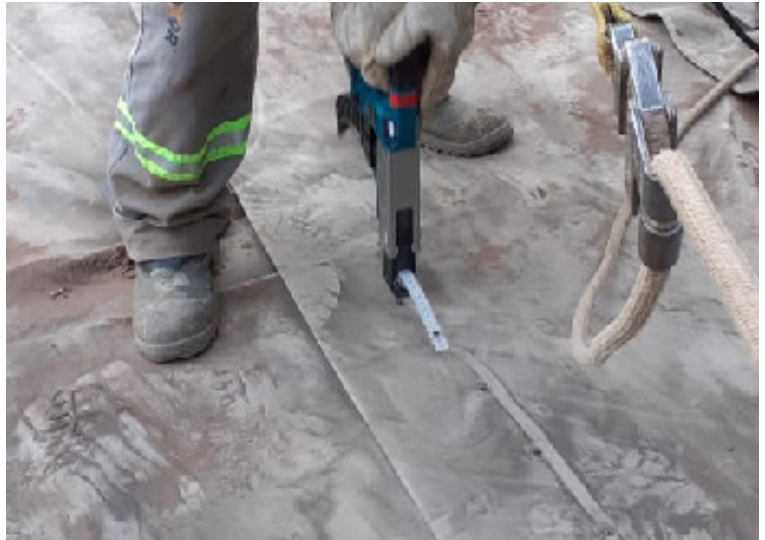
Overlapped edges were screwed together using an auto-fed screwdriver

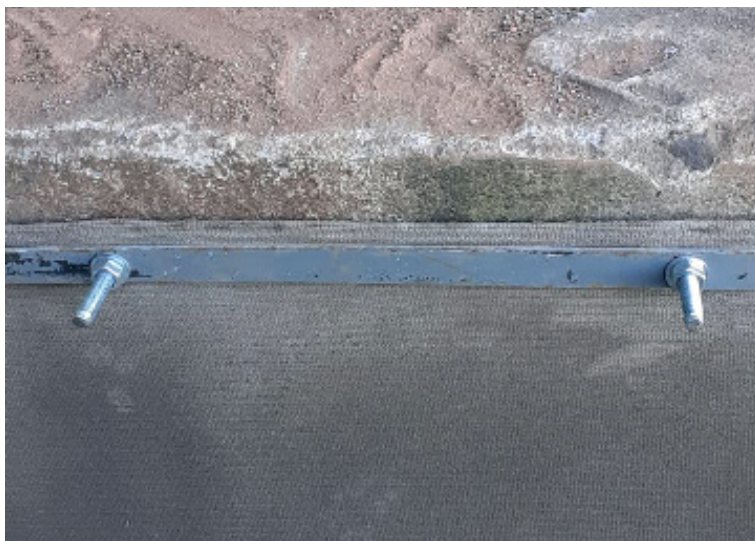
CC terminated around concrete plinths using clamping bar

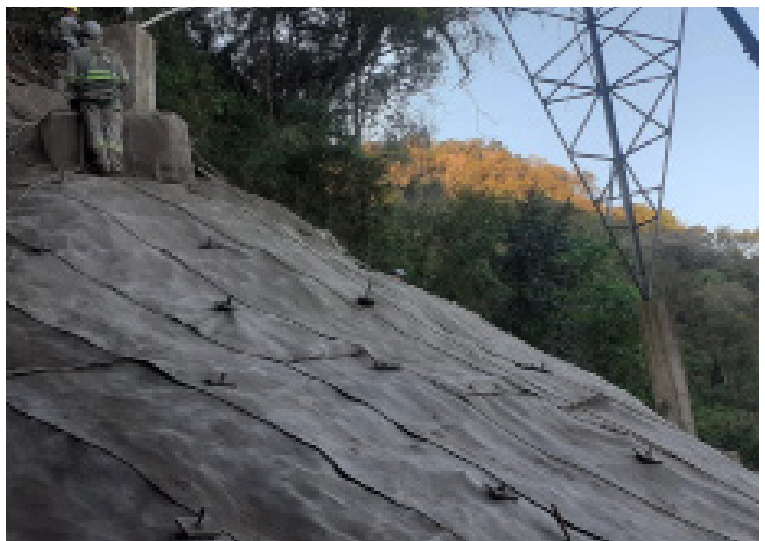
anchors and plates used to ensure CC conforms to the slope profile

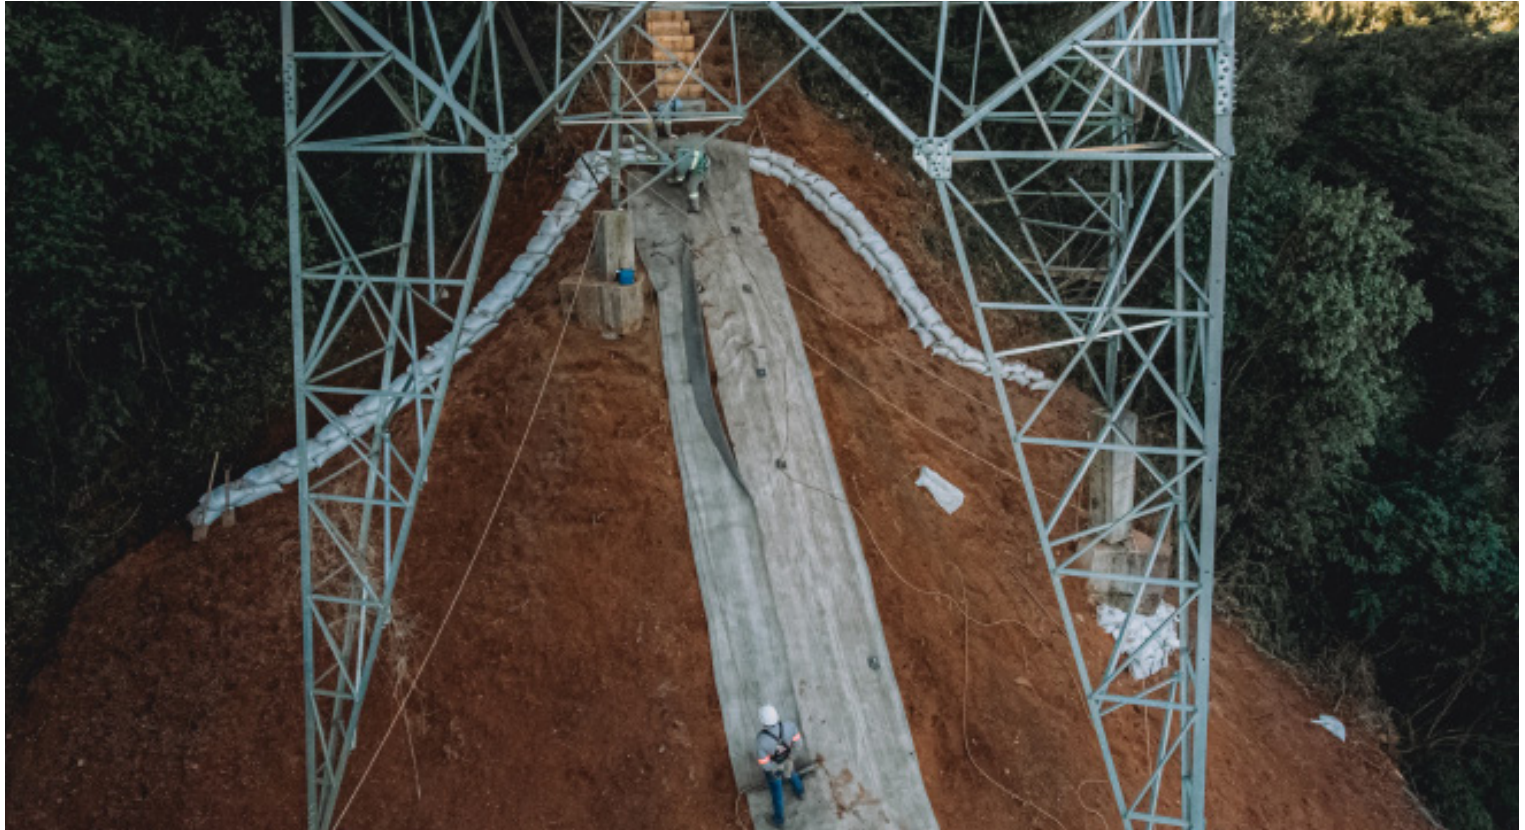
Installing CC

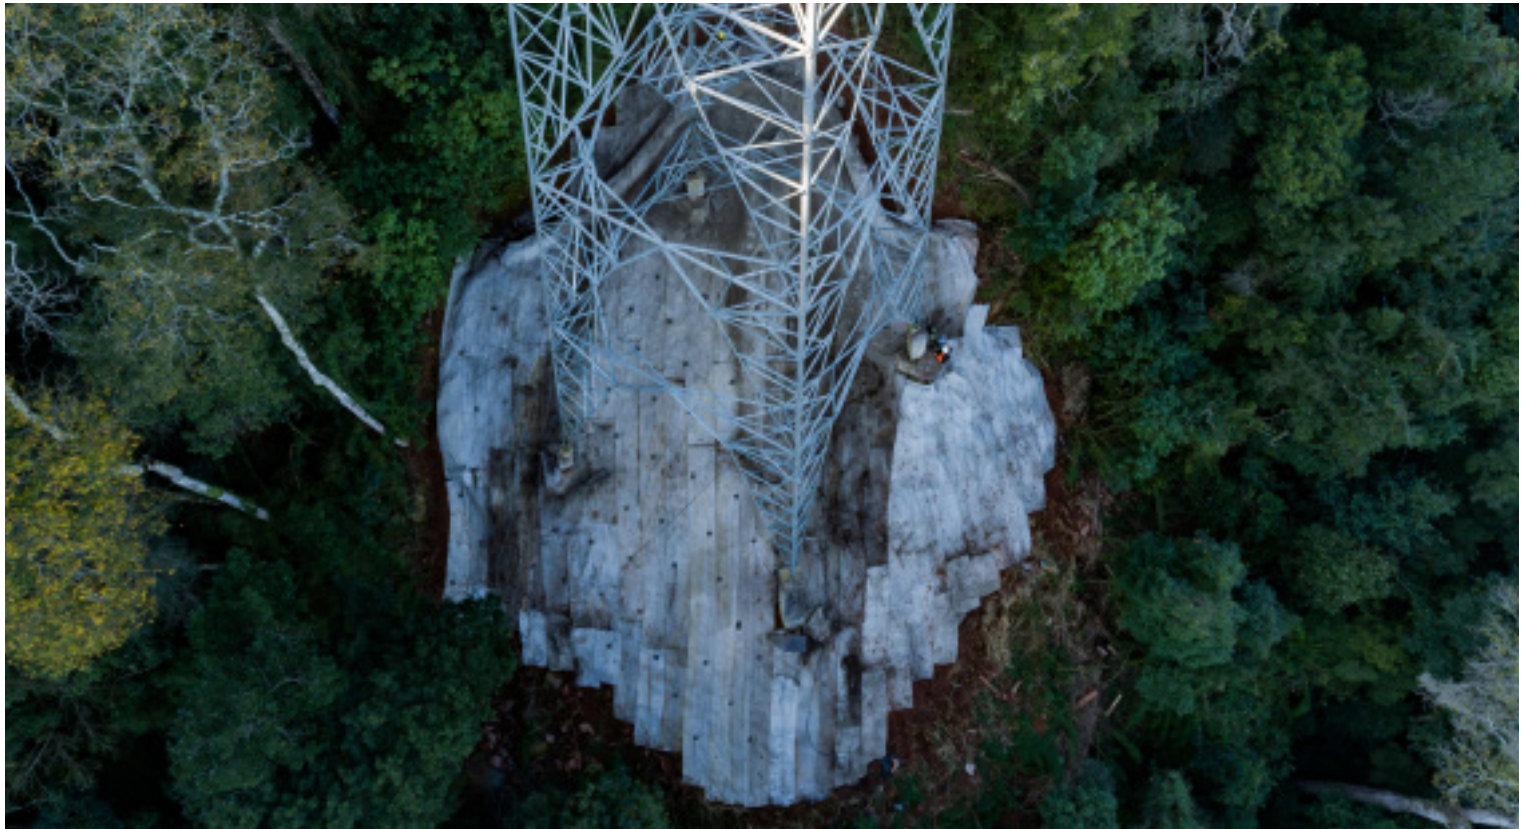
Completed Installation

The installation took about 10 days, working 8 hour shifts with rope access. The project was a success, the customer was extremely satisfied, and are considering using CC for other transmission tower erosion protection works.
