CC5™ Bulk Rolls

Caisan, Chiriqui, Panama

CC5™ was used to  
protect a slope affected  
by water erosion in  
Caisan, Panama.

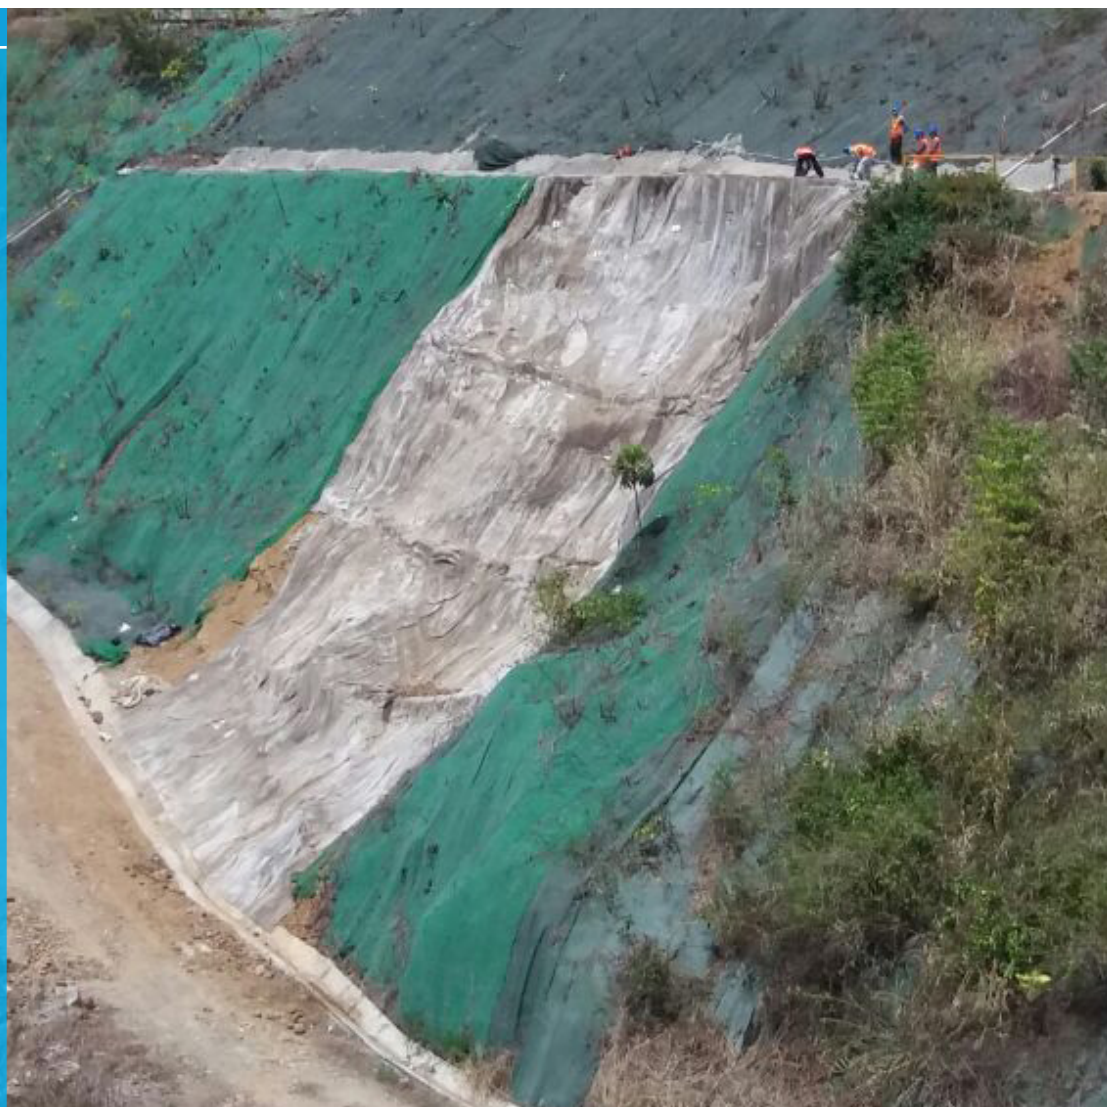
Completed installation in Caisan, Panama

In total, 600m<sup>2</sup> of CC5™ were installed in 20 days by 6 people, in inclement weather. The clients were pleased with the outcome of the installation and want to apply CC to the adjacent slopes on the remaining land. Installation of CC on this slope face will prevent rocks from the slope falling onto the sensitive infrastructure and road below. Since the installation, the client has noted that the slope has successfully withstood heavy rain without adverse effect.

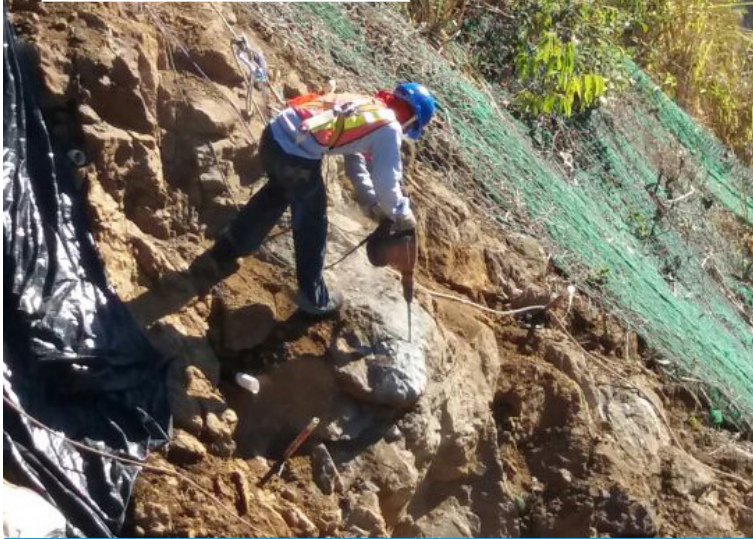
*Inserting anchor bolts into the slope before installation*

In preparation for the installation, the existing protective mesh and green mantle erosion control that had been installed on the site were removed, and all loose material, rocks and other debris was also removed from the slope. The ground was then cleaned with shovels and rakes and the loose material collected using a backhoe and transported from the site in a tipper. Soil nailing was then carried out, consisting of 24 anchor bolts, each 4 metres long, being driven into the slope at 10°.

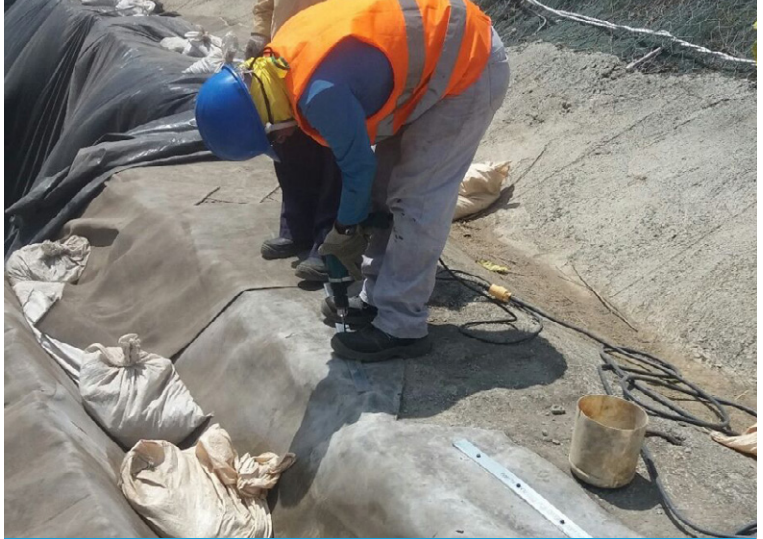
*Steel bars and screws were used to fix the CC at the crest*

The CC was then delivered to site in bulk rolls of CC5™, which was laid both vertically and horizontally on the slope according to the ground conditions, with overlaps of 100mm, which were then sealed with an epoxy sealant. The CC was fixed along the crest of the slope using a steel bar and screws at intervals of approximately 100mm; cement was later used to seal the edges of the CC at the crest of the slope to prevent water ingress. The CC was then fixed down the slope along the overlaps using further screws at similar intervals to ensure the CC lay flush against the substrate. To protect the CC material from the cold temperatures overnight, protective materials were placed over the CC. The CC was then hydrated using an AGU and hose every hour.

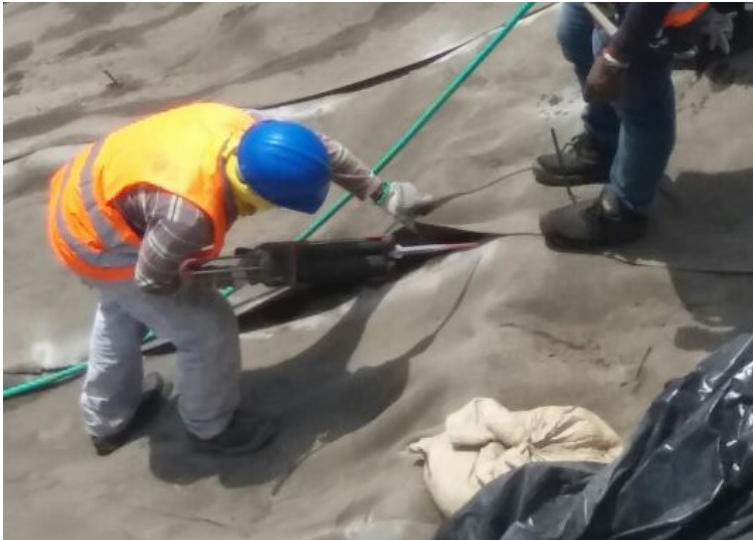
*Epoxy sealant was used to seal overlaps of the CC and prevent ingress*

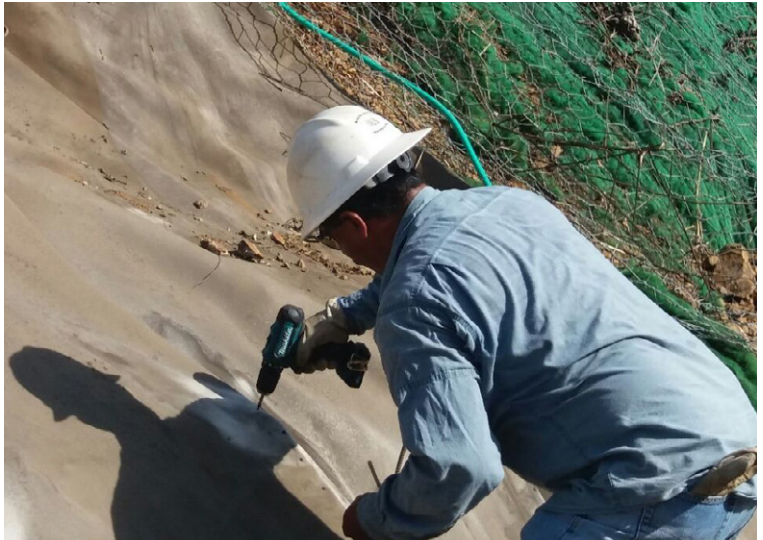
*Screws were inserted at the overlaps to fix the CC*

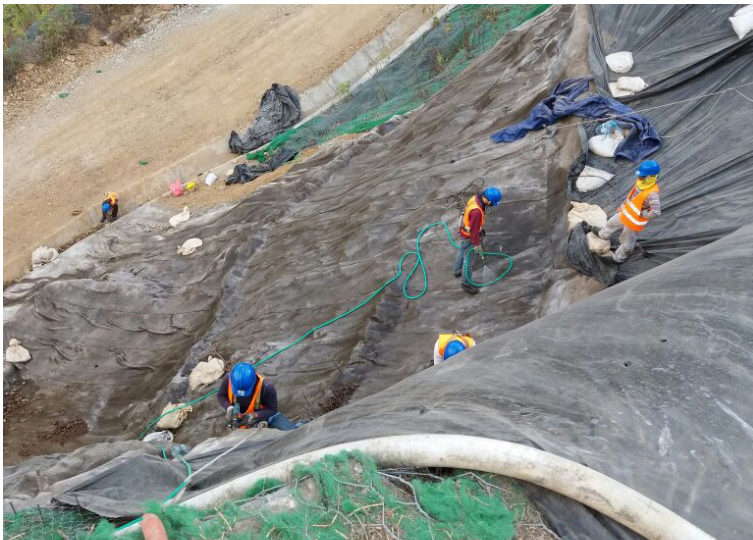
*Hydration was given via hose every hour*

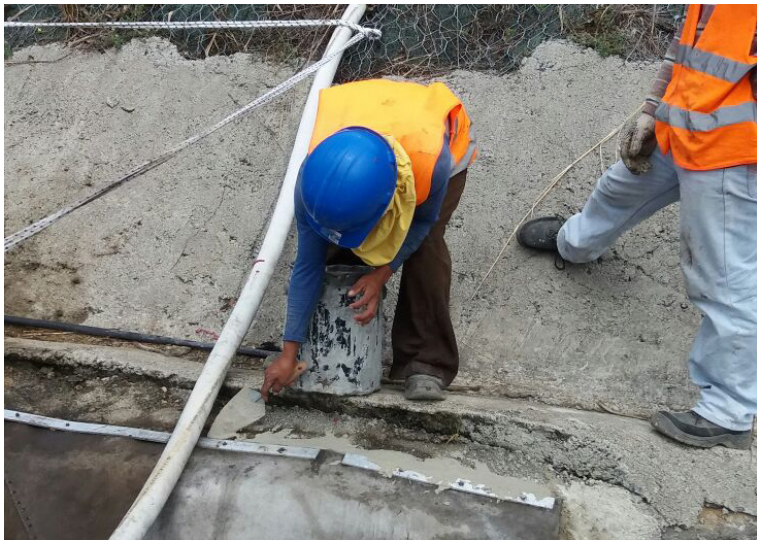
*Cement was used to cover and seal the edges of the CC at the crest*

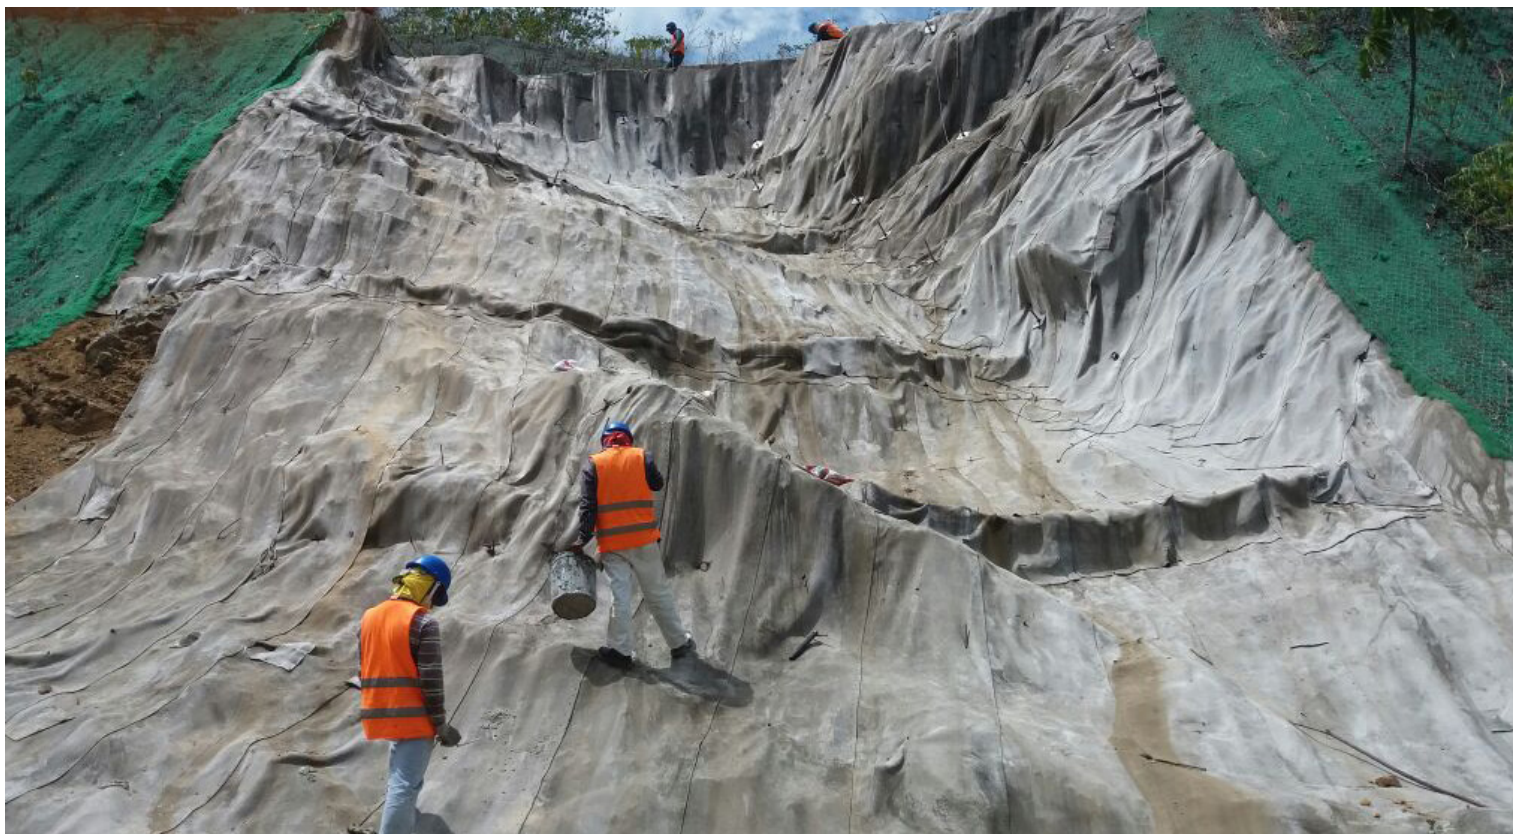
*The team had to use harnesses and climbing equipment to work on the steep slope*

The slope had been badly affected by water erosion and internal faults and required protection in order to prevent rockfall from the slope onto the road and micro-electric turbine below. Due to the steepness of the slope, access was difficult, meaning the works would have to be carried out using climbing equipment, and would also make the job more time consuming.
