## Project Info

CC5™ Bulk Rolls

Zipaquirá-Bogotá  
Highway, Colombia

CC5™ used as an erosion control measure in order to protect Zipaquirá-Bogotá highways from a washout of fines and other debris

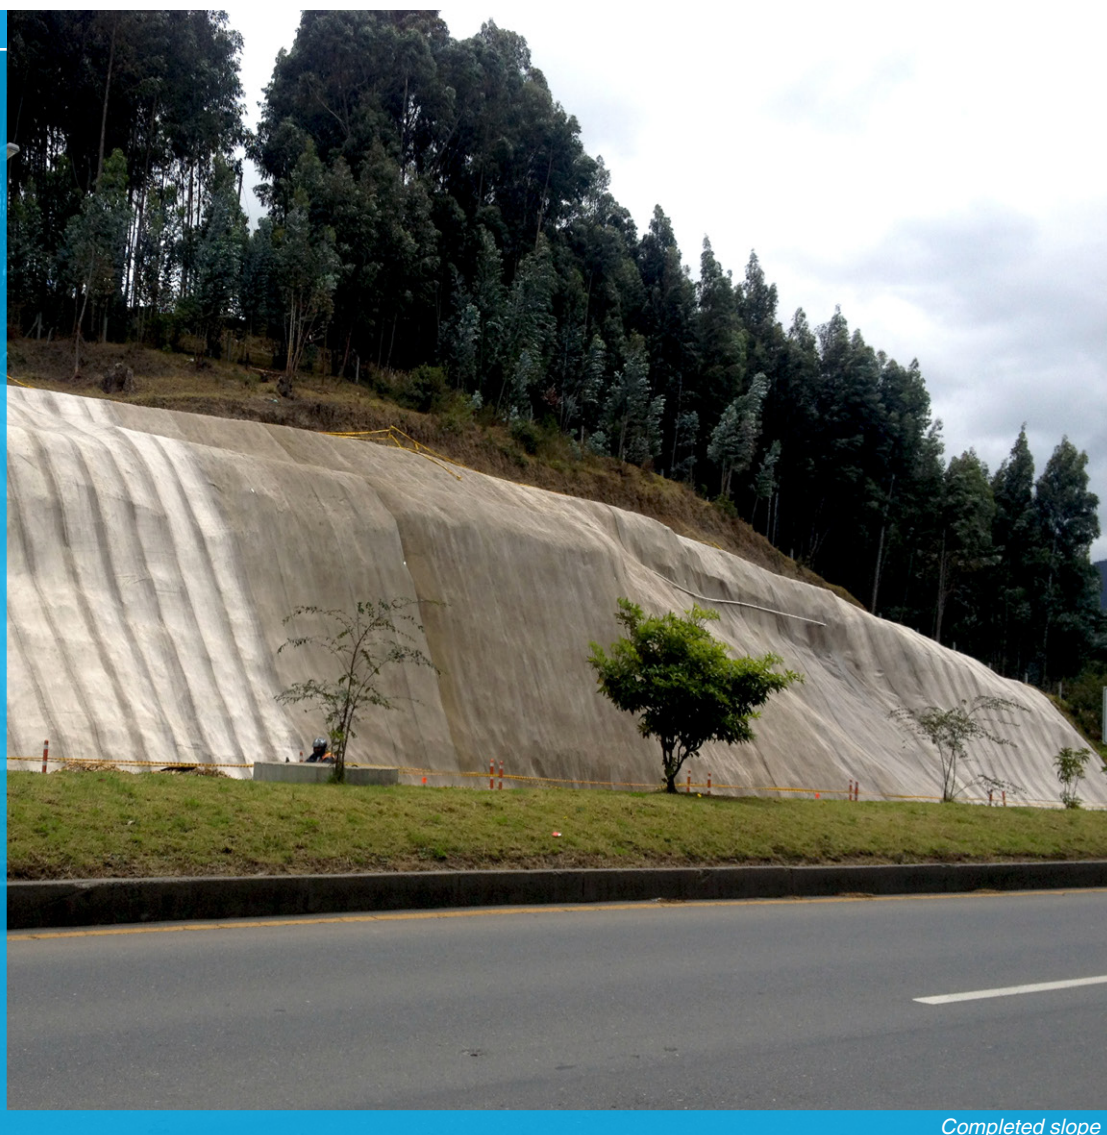
*Completed slope*

The 1000m<sup>2</sup> installation was completed in 13 days in inclement weather by an installation team of 6. The client and installation team were impressed with the ease and speed at which CC was installed, as well as the material's "consistency and functionality". Feedback provided by the project's head engineer in November 2013 stated that, after two weeks of very heavy rain, the CC was still stable and the slope had not shown any movement or further loss of fines.

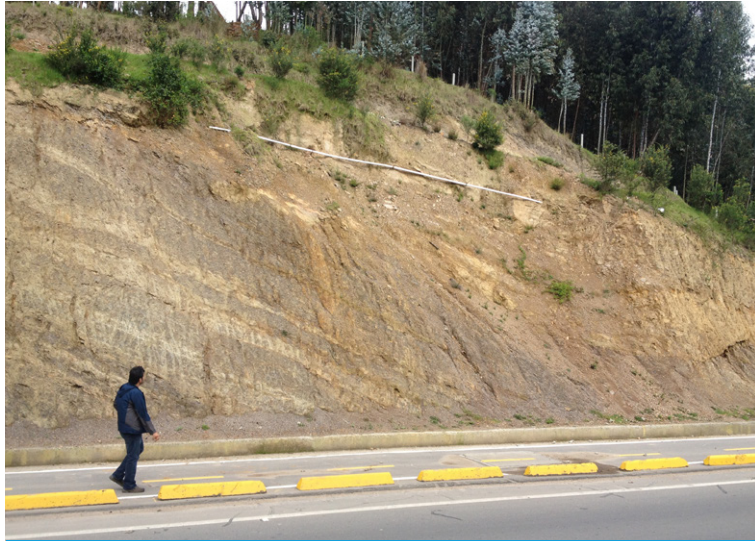
*The slope prior to installation of CC, displaying signs of slip and erosion*

In July 2013, Concrete Canvas® GCCM\* (CC) was used as an erosion control measure on a slope adjacent to a section of the Zipaquirá-Bogotá Highway in Chinchilla, Colombia. The slope had suffered from slip and the erosion of fines due to adverse weather in the region, worsened by leakage from a water pipe installed across the slope. There was potential for falling debris to cause an accident on the highway, or block the cycle path alongside it. Shotcrete had been considered, however, there was a concern that the associated rebound may cause damage to the highway and surrounding infrastructure.

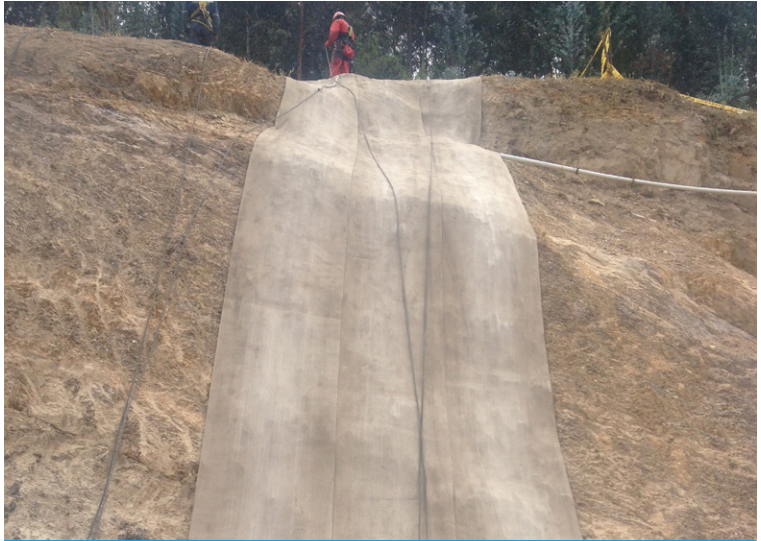
*Spreader beam and climbing equipment were used to install CC*

Prior to installation the area affected was cleared of vegetation, loose soil and rock and other debris. Bulk rolls of CC5™ were then delivered to site and cut to required length, eliminating material wastage. Each length was fixed to the top of the slope using 400mm steel ground pegs before being unrolled down the slope using a spreader beam and climbing equipment. Adjacent lengths were overlapped by 100mm and screwed together at 200mm intervals. Anchor bolts were used to fix the material to the foot of the slope and a drainage outlet at one end of the slope. The CC was then hydrated.

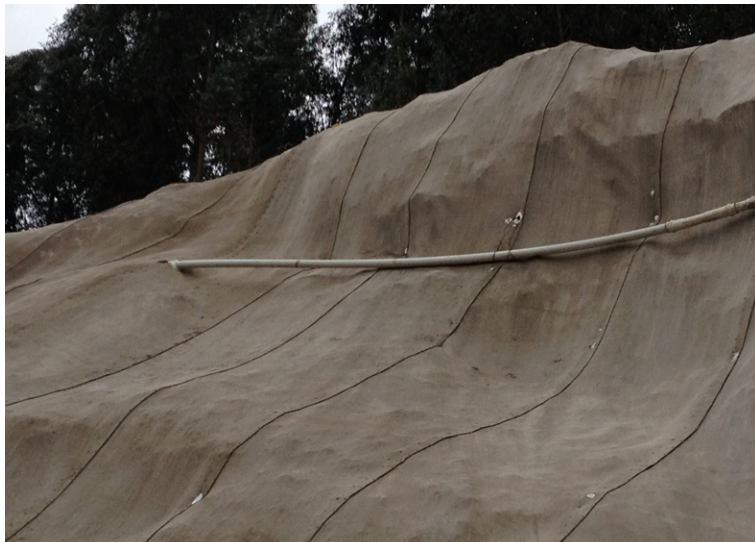
*CC's flexibility follows slope profile to prevent voids forming below material*

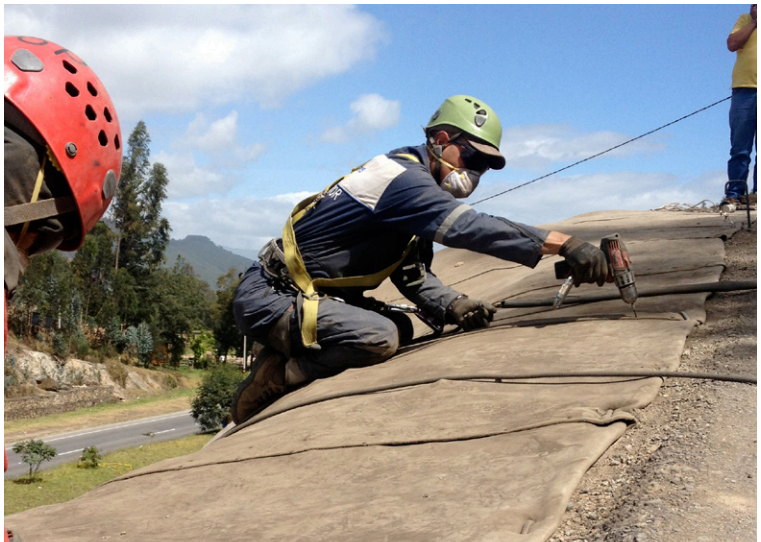
*Adjacent layers of CC were overlapped by 100mm and screwed together*

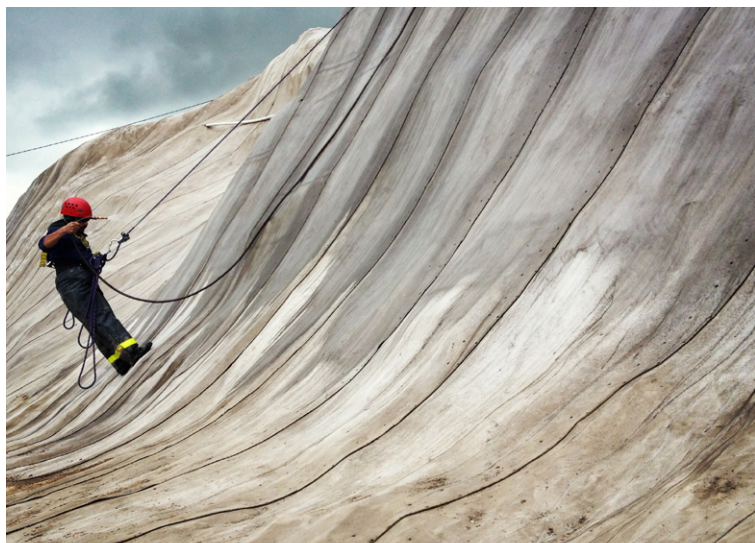
*CC hydrated using hose and climbing equipment*

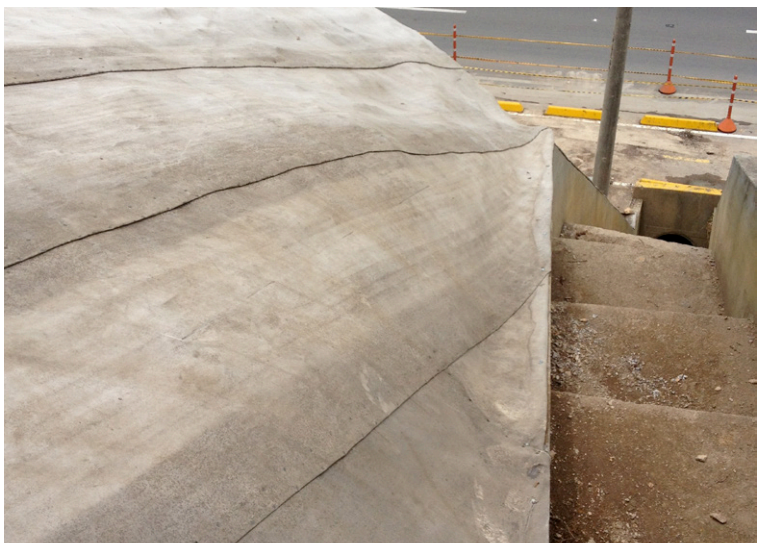
*Completed section showing CC tailored around existing infrastructure*
