SLOPE PROTECTION

In October 2012, Concrete Canvas® (CC) GCCM* was used to protect a roadside embankment in Cundinamarca, Colombia, and prevent further weathering erosion.

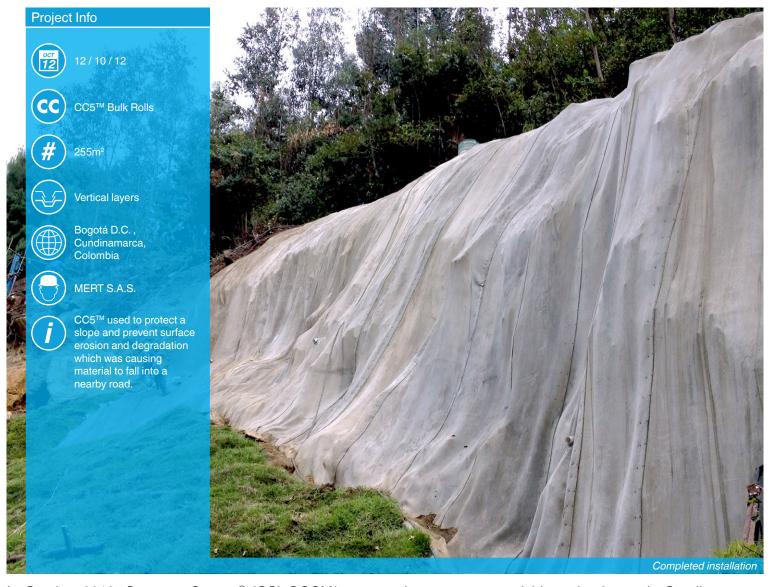
The slope had degraded to the point that traffic on the nearby road was at risk from falling rock and debris. Shotcrete or mortar slab had originally been considered for the project, but CC was chosen due to its speed and ease of installation, uniformity and consistency compared to shotcrete. It also allowed greater flexibility in terms of site access, as the installation team were unable to use heavy plant at the crest of the slope.

Bulk rolls of CC5™ were delivered on site which were then cut into 12 linear metre lengths to match the average height of the slope. The rolled lengths were mounted onto a spreader beam which was towed to the crest of the slope with ropes. The CC was then fixed securely to the crest with 250 x 12mm steel ground pegs into the soil substrate before unrolling down the embankment. Sikaflex 1A and CT1 adhesive were used to fix the CC to several PVC drainage tubes protruding from the slope, whilst 30mm screws were used to joint overlapping layers of CC. Hilti expansion anchors were used to fix the CC to the slope in overhanging sections to avoid voids between the material and the uneven profile. Following installation, hydration was given via a pump and bowser.

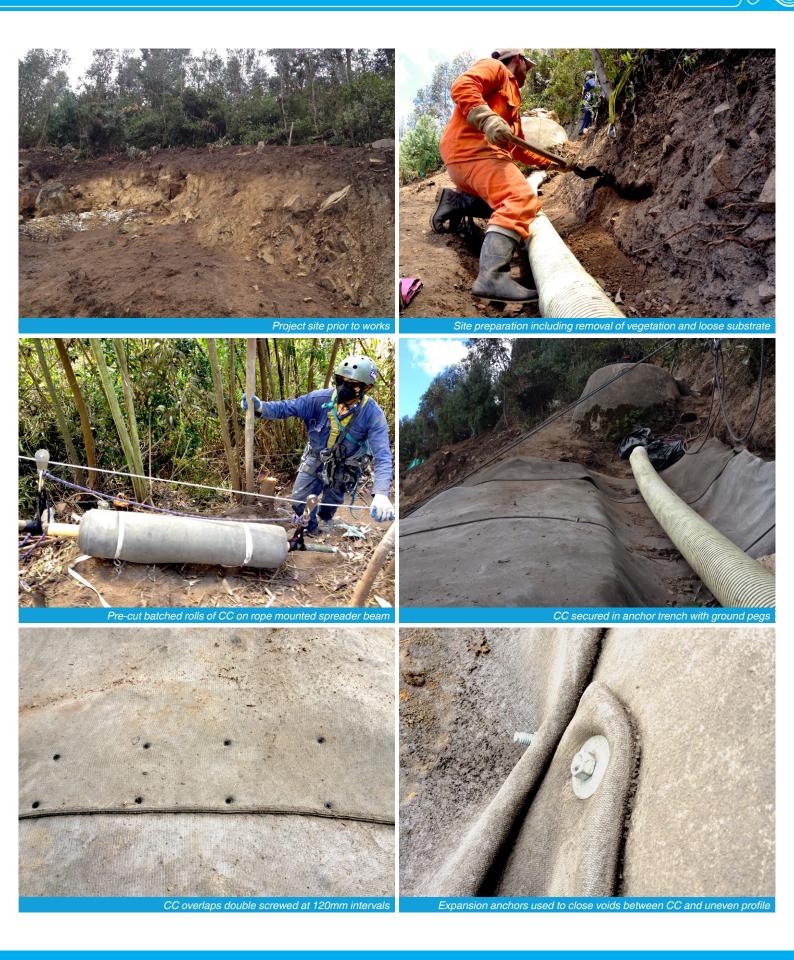
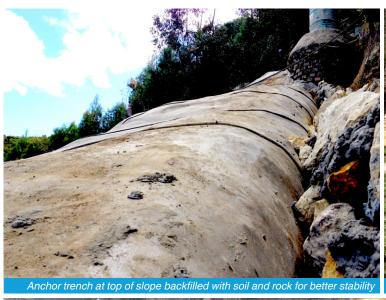
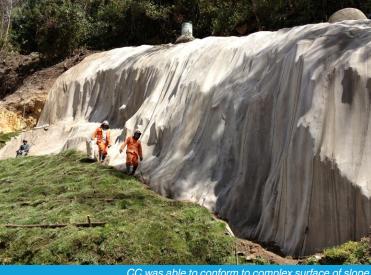
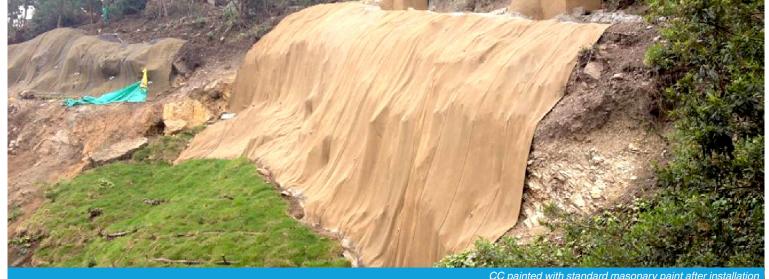
The installation team were impressed by the speed and ease of installation of CC on a site with heavily restricted access. The client was pleased with the aesthetic quality of the finished project and how the drape characteristics of CC5™ resulted in an organic, rock-like appearance. A 5-man installation team were able to complete the entire 255m² installation, including site preparation, in 8 days without specialist training or plant equipment.
