16 / 01 / 14

Cunningham's Gap,
Queensland, Australia

CC5 used to provide an
erosion-control solution
to a slope adjacent to the
Cunningham Highway in
Queensland, Australia

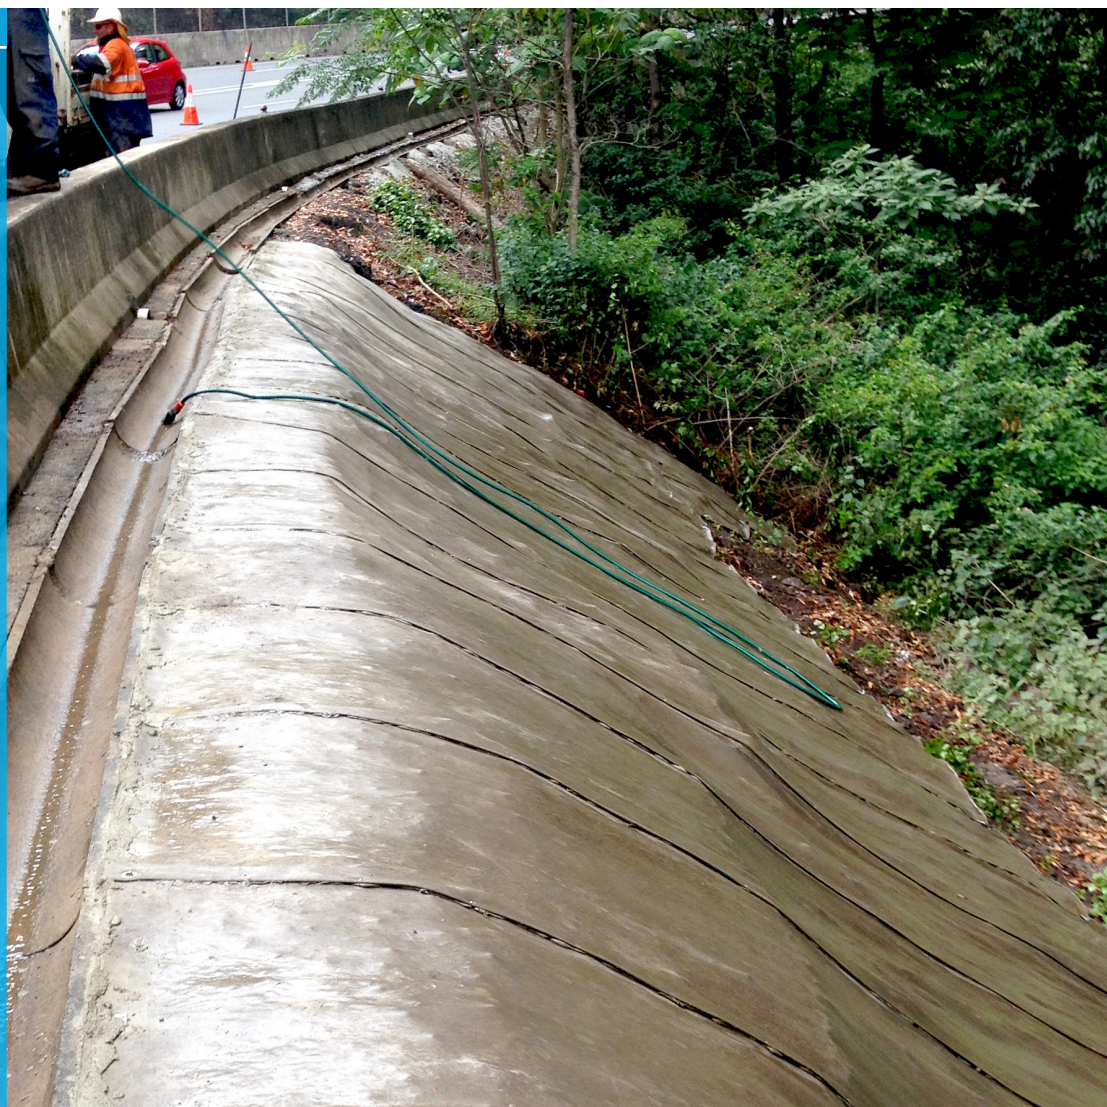
Section of slope immediately following hydration

In January 2014, Concrete Canvas® GCCM* (CC) was used to remediate a section of slope adjacent to Cunningham Highway in Aratula, Queensland. The slope had suffered erosion caused by insufficient drainage. A solution was needed to protect the slope from further damage, as it threatened to destabilise the adjacent road. Shotcrete had been considered to line the slope, but roadside barriers created issues with site access. The equipment and rebound associated with shotcrete could also cause delays and damage to the vehicular traffic using the road, as well as existing road infrastructure.

The 160m² installation was completed in a single day by an installation team of 5, much quicker than would have been the case with shotcrete or other traditional solutions. The installation was very successful, allowing a durable erosion prevention solution to be installed in average temperatures of 28°C, with very low impact on the vehicular traffic utilising the highway.

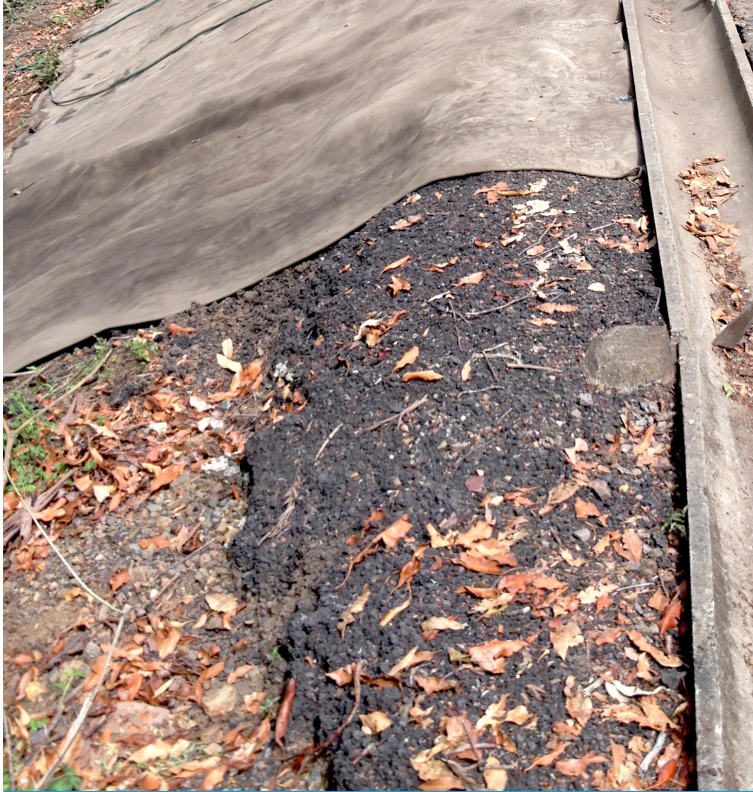
The site was cleared of vegetation and debris before installation

Prior to installation, the site was cleared of vegetation, before bulk rolls of CC5™ were delivered to site, deployed using a crane truck and spreader beam and cut to length. Each length of CC was then fixed to the substrate using ground anchors and concrete screws. Adjacent lengths of CC were jointed using stainless steel screws and Sika Pro adhesive. The interface between the CC and an existing spoon drain at the head of the slope was sealed with a non-ferrous, non-shrink grout, with the CC pinned in place. A water truck and hose equipment was then used to hydrate the CC after the grout had set.

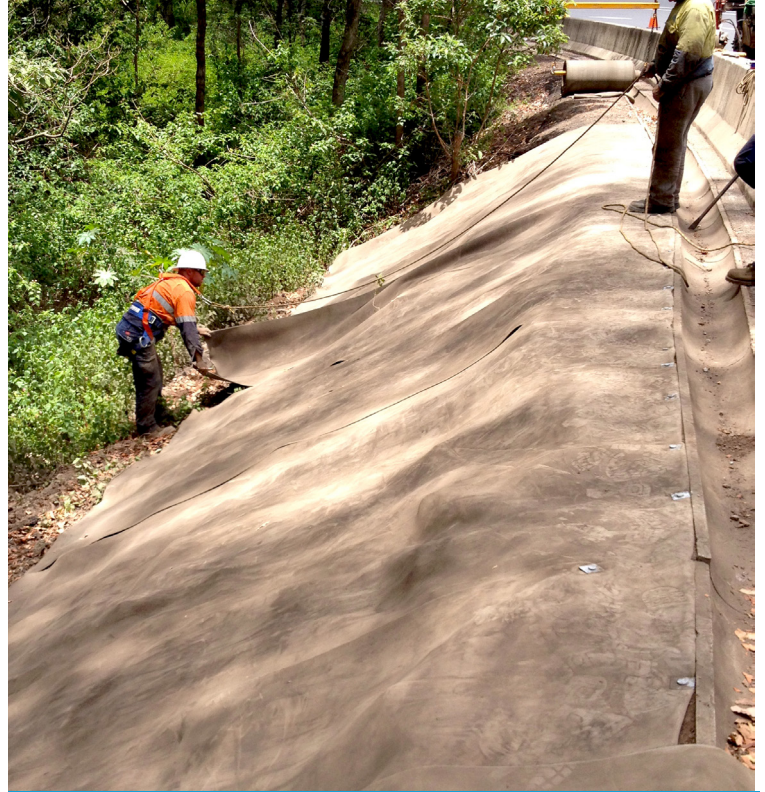
Bulk rolls of CC8 were dispensed using a spreader beam and crane truck

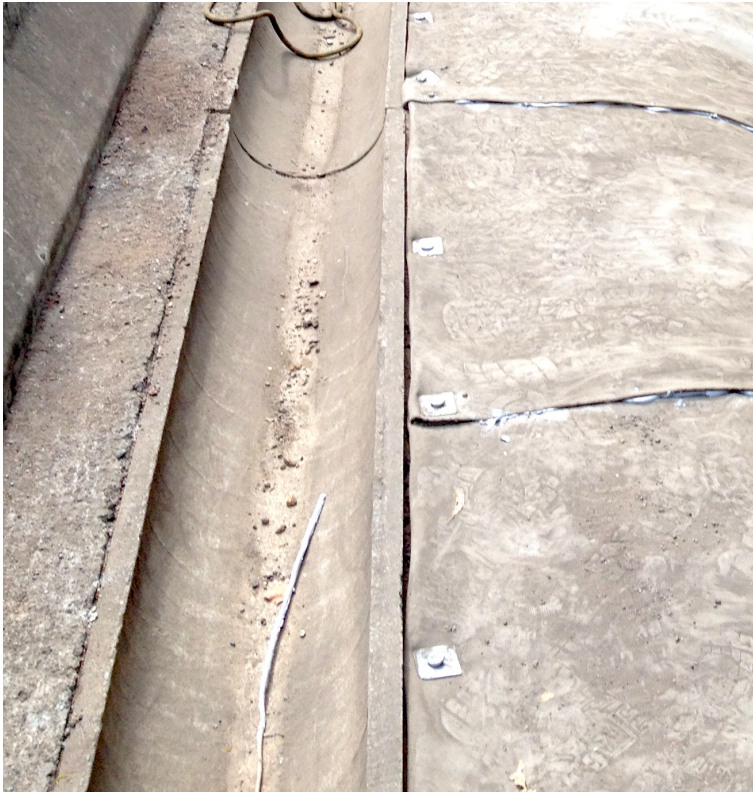
CC was fixed to the slope substrate using concrete anchors

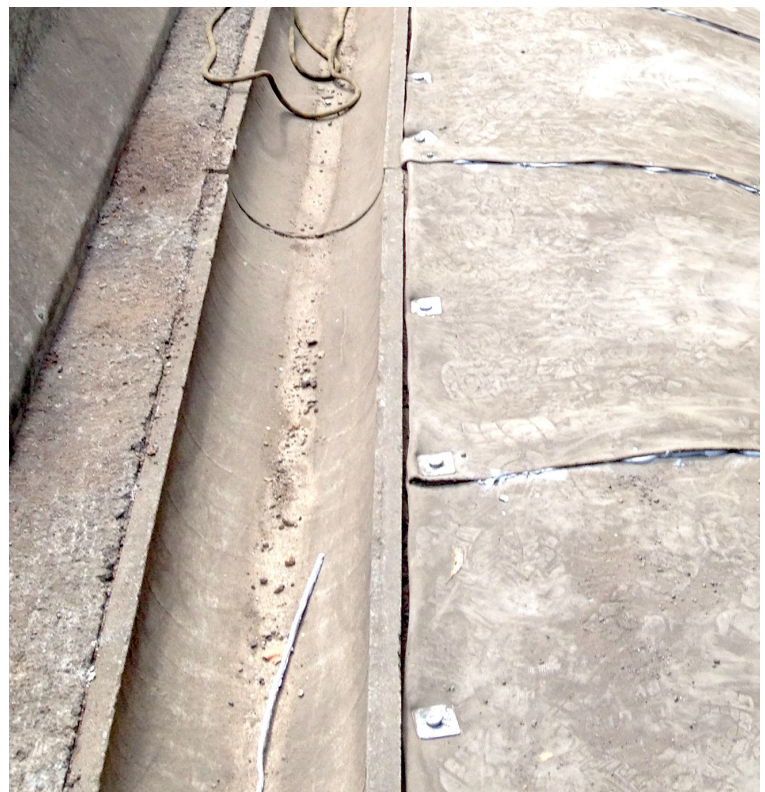
Bulk rolls of CC8 were dispensed using a spreader beam and crane truck
