CC5™ Bulk Rolls

El Barill,
Cundinamarca Region,
Colombia

CC5™ to prevent further
erosion and potential
land slip on a roadside
slope.

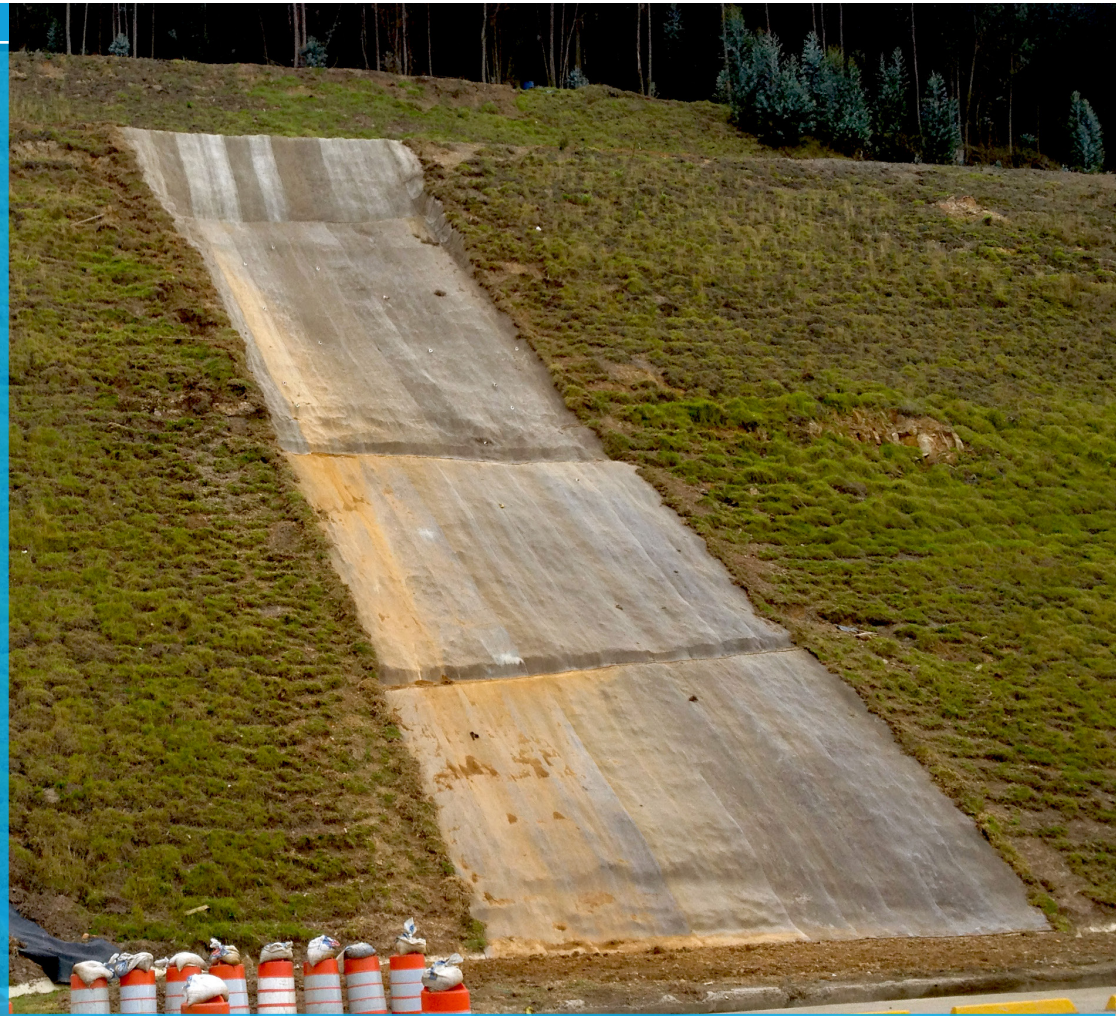
Completed project in El Barill, Colombia

CC met all expectations, and eliminated the difficulties that would have come with using more traditional solutions, particularly on a limited site and the weather conditions experienced. The project was completed in less than 5 days by 2 people.

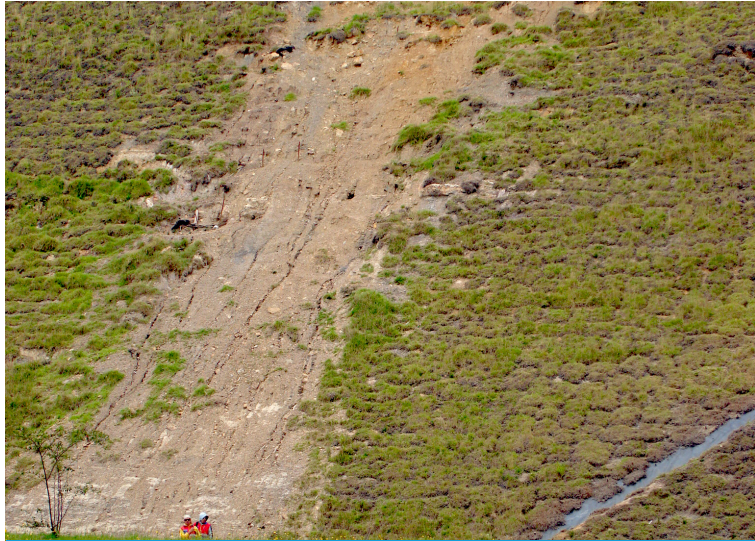
Slope prior to works

In April 2013, Concrete Canvas® (CC) GCCM* was used to provide slope protection in El Barill, Cundinamarca region, Colombia. The slope 40m long in total, and situated adjacent to a main road. Heavy rainfall had contributed to severe erosion, with a small section of the slope badly affected. The erosion had created a risk of land slip and debris endangering road users. There was also a risk to the integrity of the road's surface.

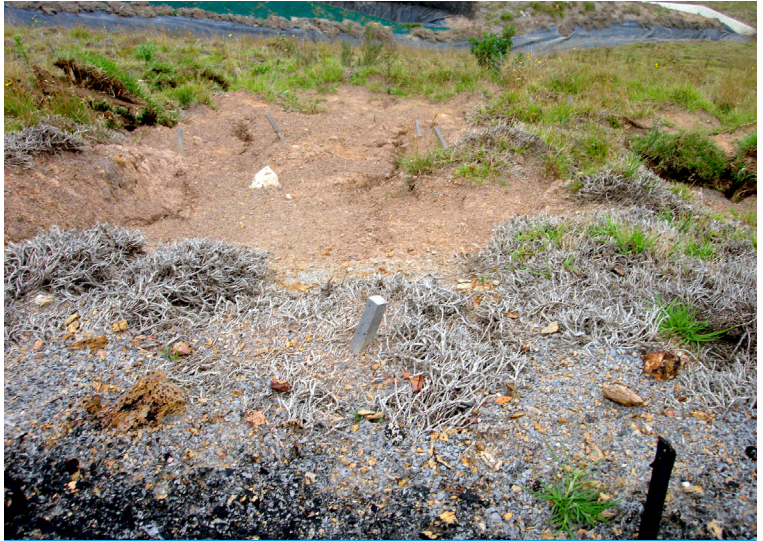
Bad weather and water runoff had caused severe erosion

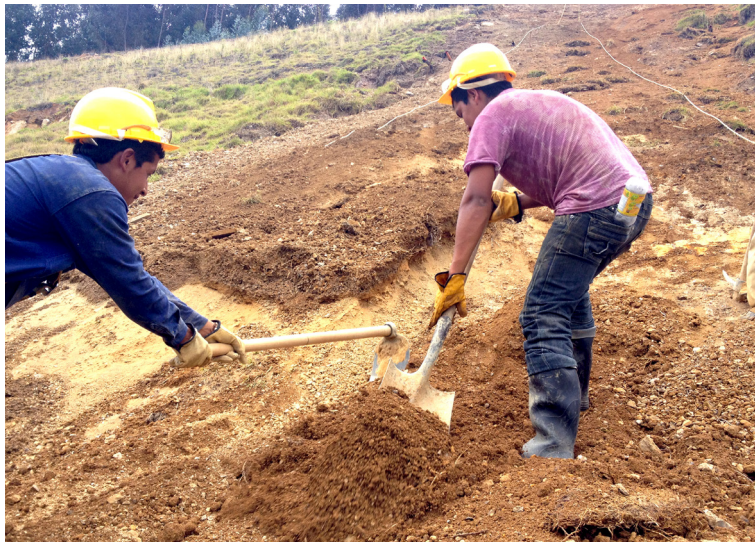
Ground preparation was carried out by hand

In preparation for the installation, vegetation and debris were removed from the slope before the substrate was regraded. A drainage channel was created at the crest of the slope, lined with a geomembrane and later capped with CC. Bulk rolls of CC5™ were then delivered to site and the material cut to length using hand tools. The CC was installed in vertical lengths, each fixed at the crest and toe using ground pegs. The team carried out the work in four sections, beginning at the toe of the slope, installing the CC across the width of the slope, before moving onto the next section. Layers were overlapped by 100mm and jointed using drywall screws before hydration.

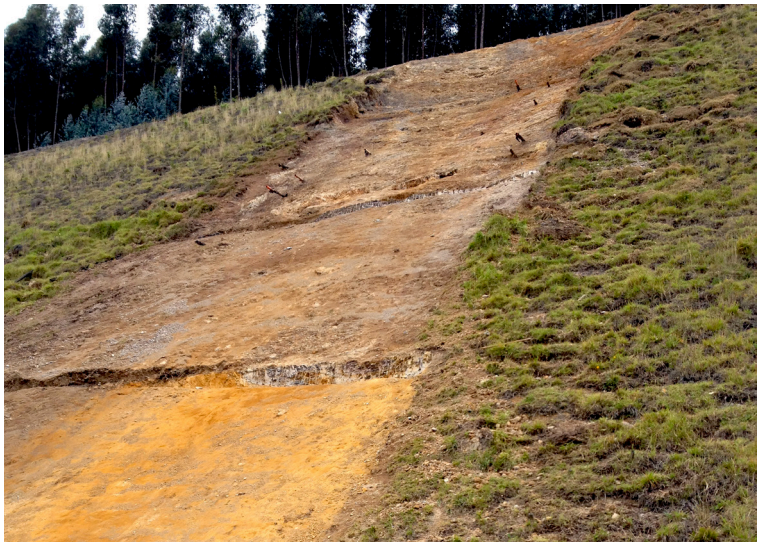
Ridges were created in the slope to dissipate water energy

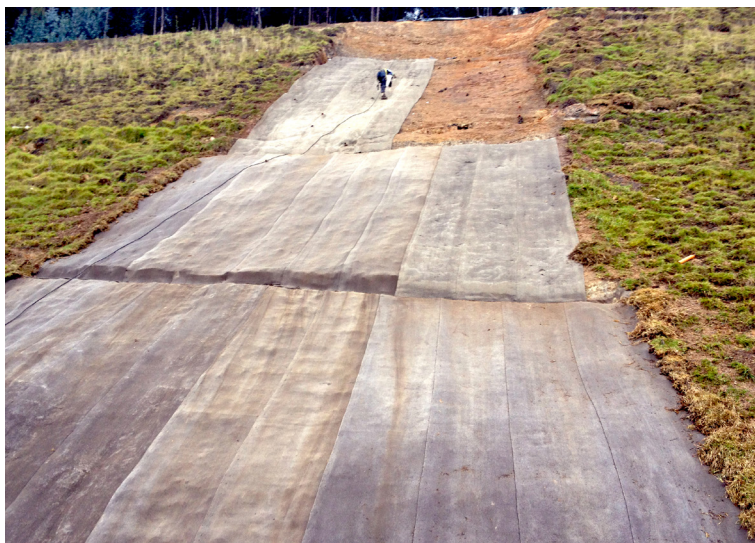
The CC was laid in vertical lengths, working from toe to crest

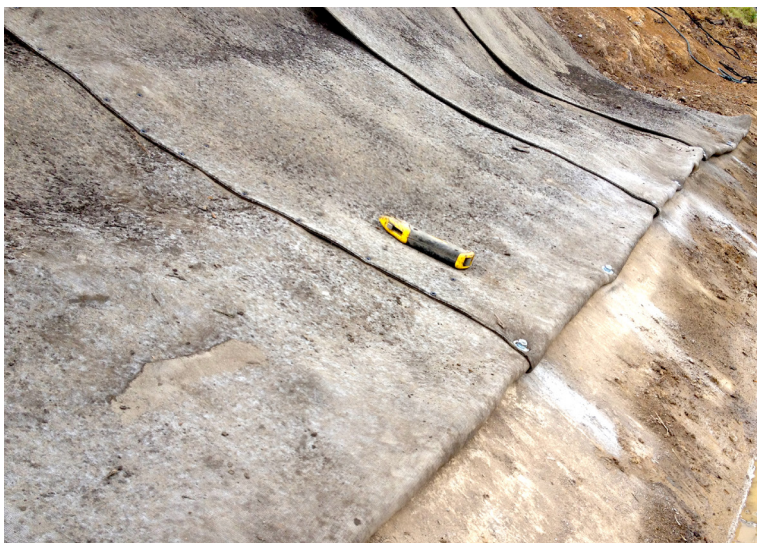
Hand tools were used to cut, fix and joint CC
