CC used to provide a slope protection solution to an earth cutting to prevent erosion and damage to surrounding buildings

Project Introduction

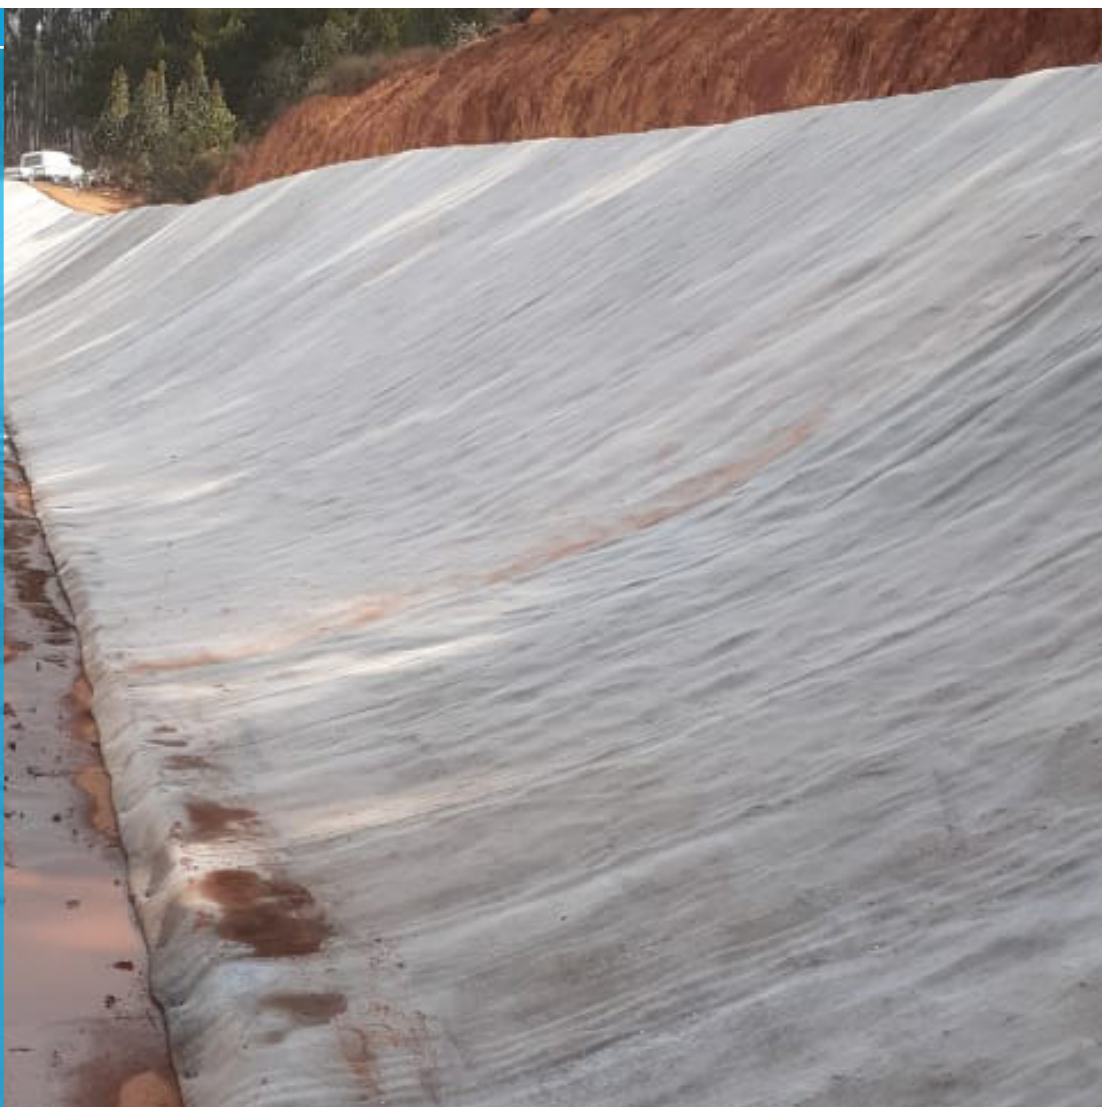
Completed slope protection installation in Hilton, South Africa

A total of 900m² of CC5™ were installed by a team of six over the course of a week. An average of 200m² were installed per day. The project has been deemed a great success and CC has met all the client's requirements.

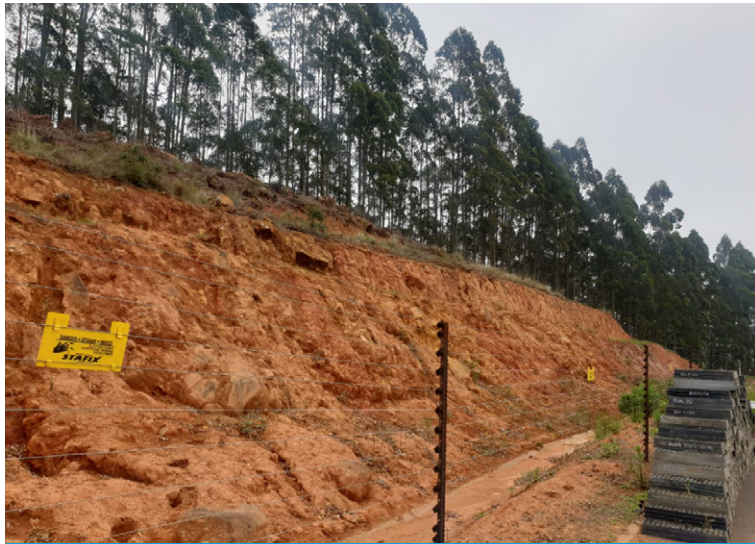
Slope before works

The cutting, situated behind client Mondi PLC's tree nursery, was prone significant erosion caused by run-off. As a result, there was continuous disruption to the nursery operations as well as damage caused to the facilities from time to time as boulders were dislodged from the slope face. Hilton is subject to a very wet rainy season that continuously poses a risk of these boulders coming loose and causing damage to Mondi's assets. Mondi therefore required a slope protection solution which would prevent future disruption and damage.

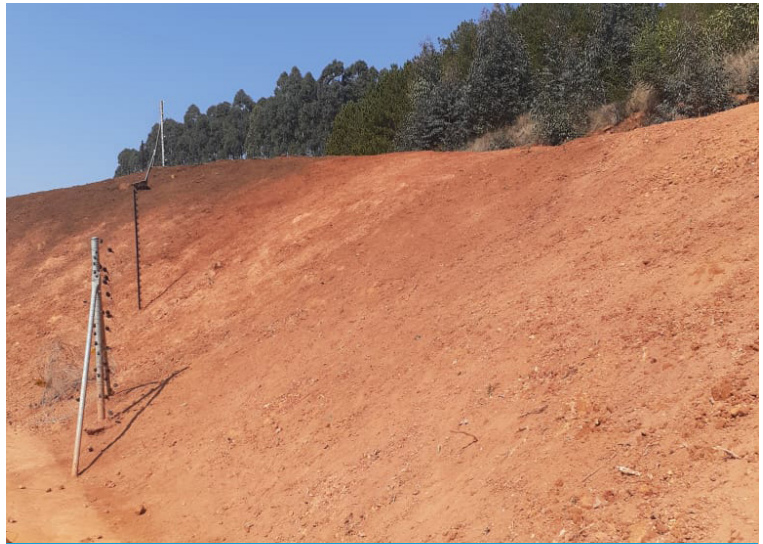
Rocks and boulders removed and slope face trimmed

Prior to the installation of CC, large rocks, loose stones and all vegetation was carefully removed from the slope face, which was then trimmed to provide a more uniform profile on which to install the CC.

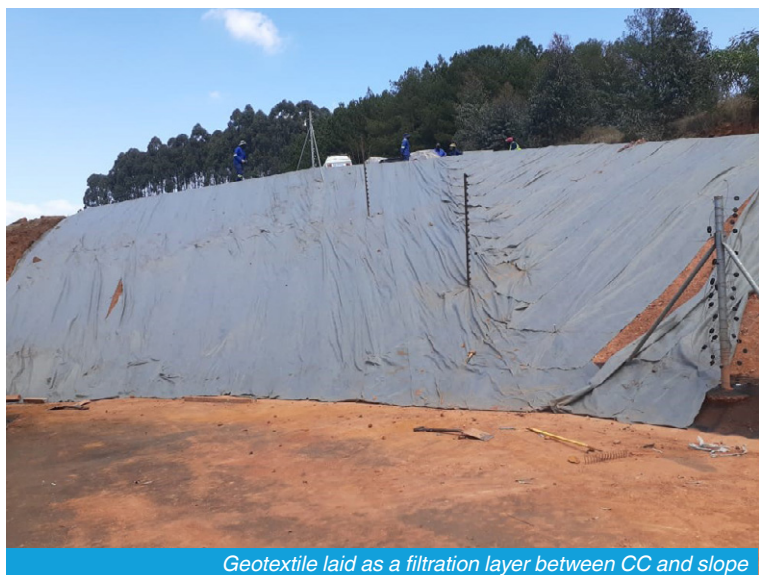
Geotextile laid as a filtration layer between CC and slope

As per the design specifications, a geotextile was laid on the slope face to act as a filtration and separation layer below the CC. The CC bulk rolls were mounted on a spreader beam, dispensed from a stand positioned at the crest of the slope and cut to required lengths. These lengths of CC were then deployed vertically down the slope face with the material ends at the crest secured within a 300mm deep anchor trench. CC at the toe was terminated onto the existing concrete drain with masonry fixings at 200mm spacings. Lengths of CC were laid so as to overlap the last by 100mm, with stainless steel screws inserted along the overlaps at 100mm centres, positioned 30mm from the edge of the overlapping layer. No sealant or other jointing methods were used on this project so as to allow for the dissipation of any subsoil water permeating through the substrate. The geotextile layer below the CC allows the water to flow between the layers, without risk of further erosion to the slope below.

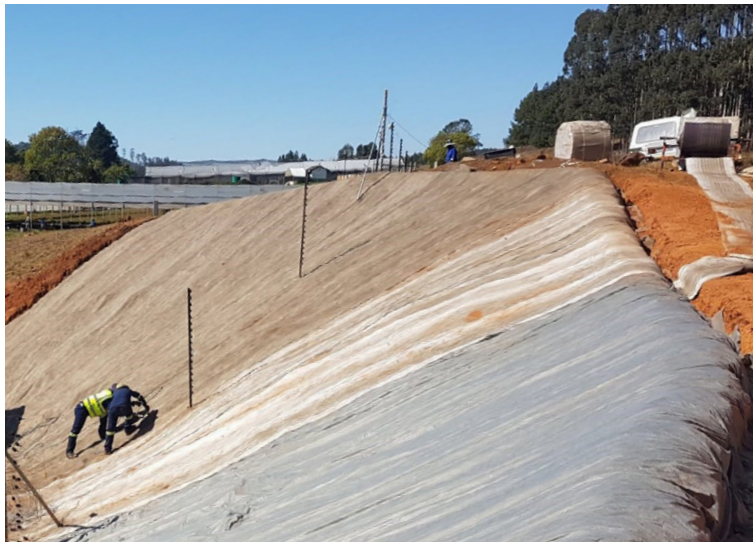
Bulk rolls dispensed at crest of slope and deployed vertically down slope face

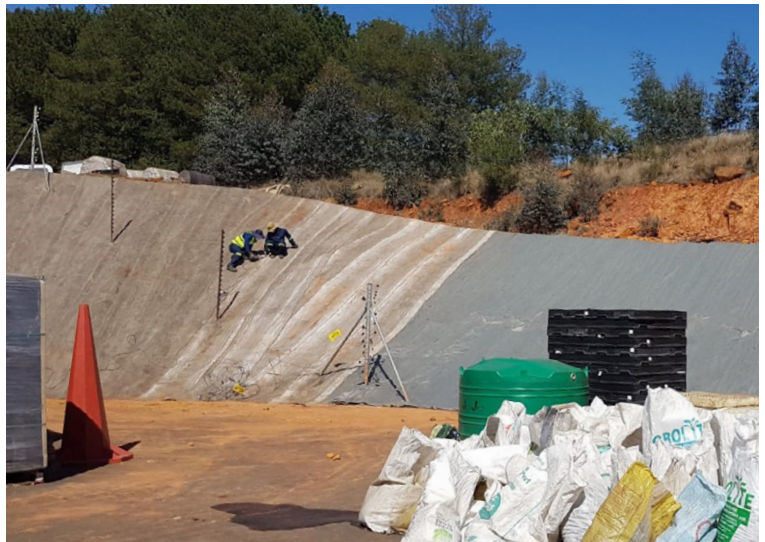
CC installed over geotextile barrier layer

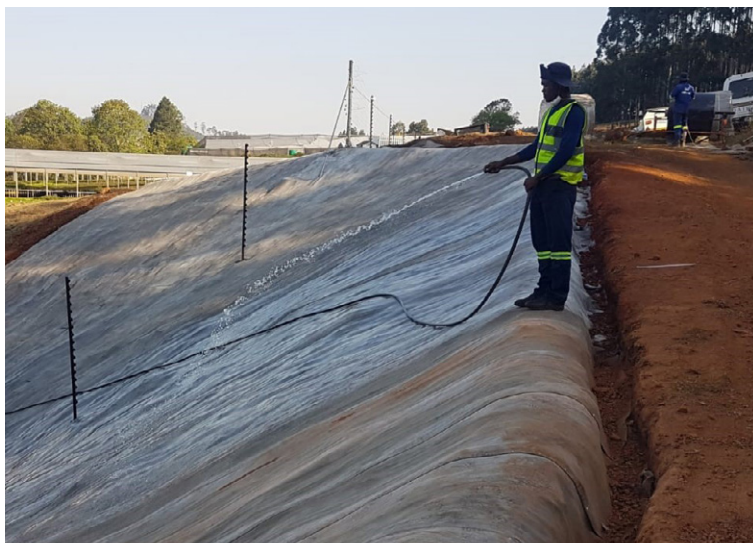
Hydration of CC

Once the installation was completed, the CC was hydrated twice at 60-minute intervals to saturation and then a final hydration was given at the end of each day's installation. Following hydration, the anchor trenches were backfilled with a cement stabilised non-erodible gravel and compacted with a mechanical rammer.

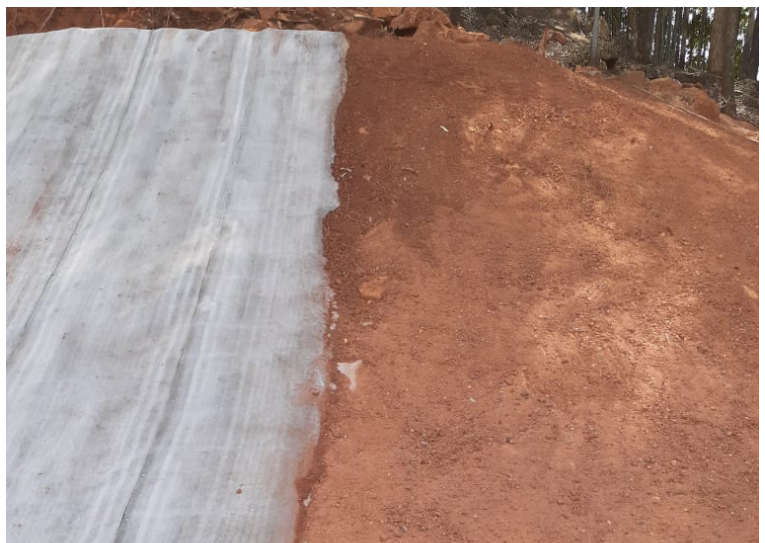
Open side edge buried in anchor trench

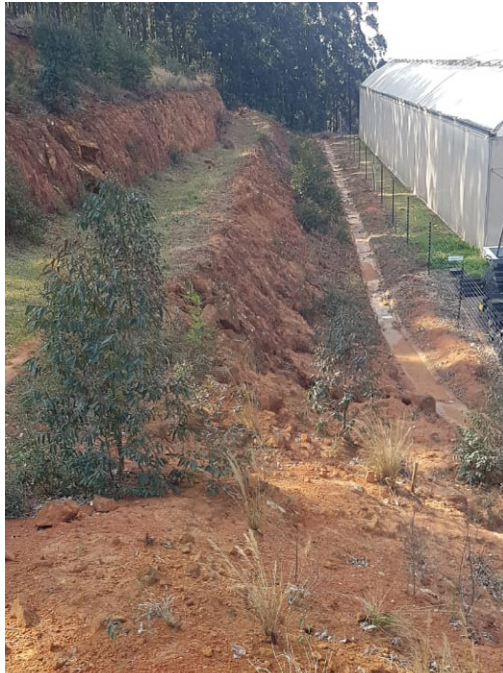
Site before works

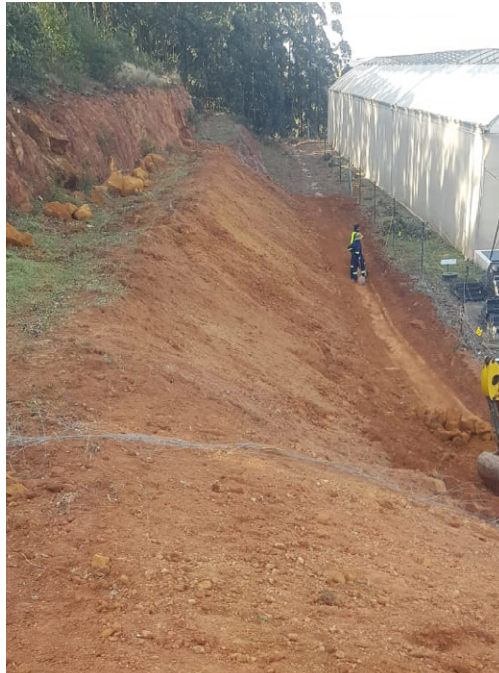
Site after ground preparation

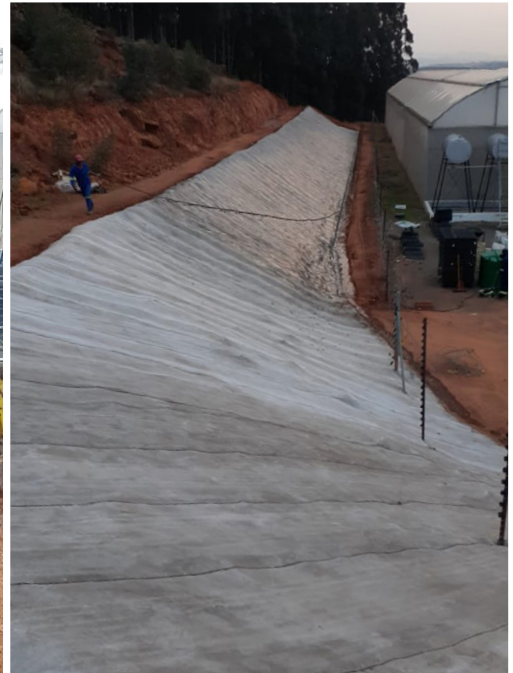
Site after completion of works
