CC5™ Bulk Rolls

Enna Province, Sicily

CC5™ was used to  
cover a slope 281m  
in length, and 14m  
in height in Piazza  
Armerina, Sicily

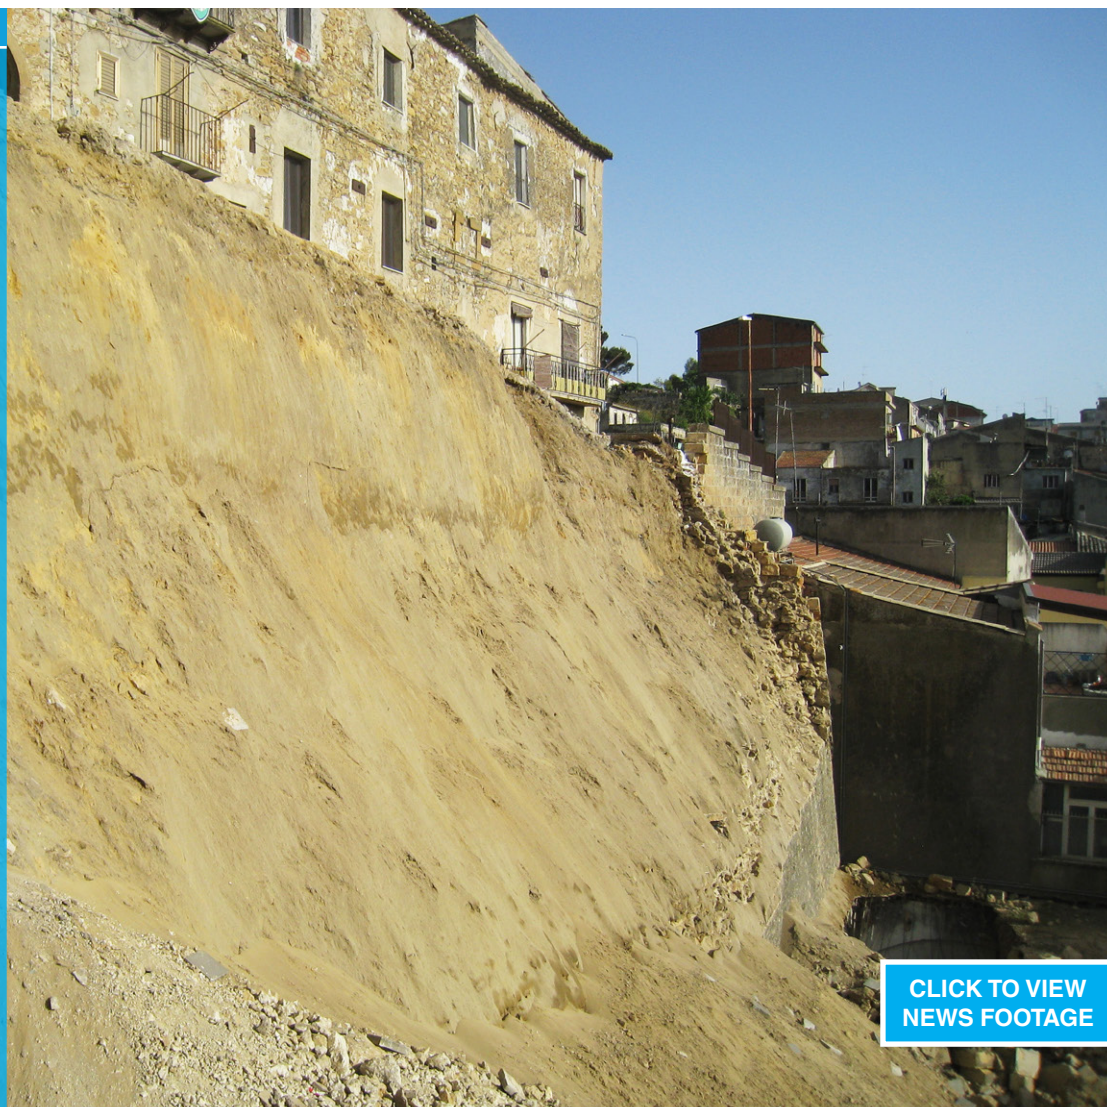
*The slope prior to installation*

In August 2015, Concrete Canvas® GCCM\* (CC) was used to protect a steep slope in the Piazza Armerina in the Enna Province, Sicily. The slope was 281 metres in length, and 14 metres high, and had been exposed after a historical wall (built in the 1900s) collapsed, and dragged the parking areas above down with it. The slope was in need of temporary protection to prevent further collapse on the site.

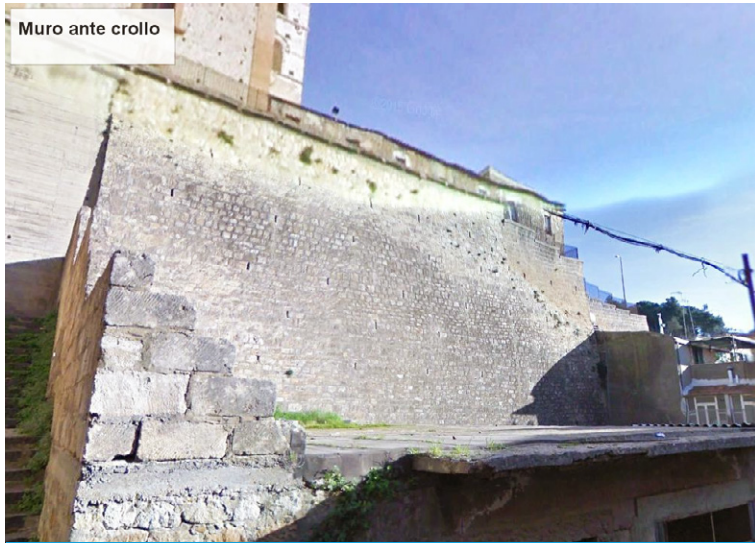
Muro ante crollo

The historical wall which previously occupied the site

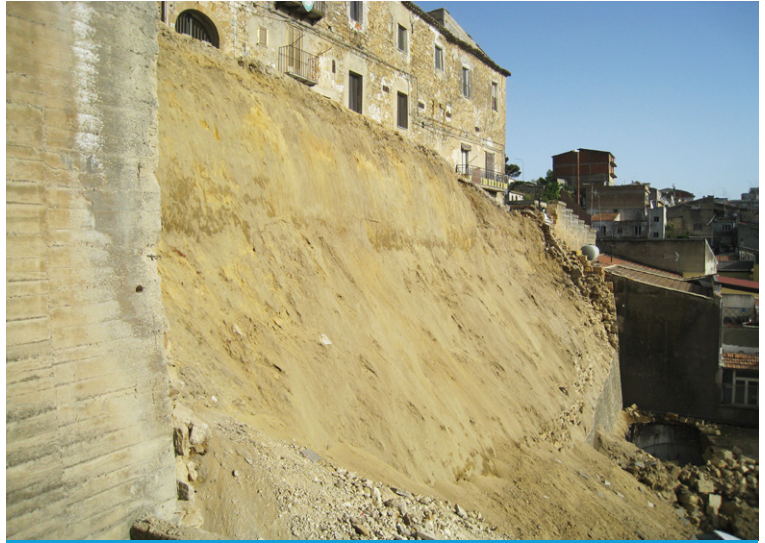
The site following the wall's collapse

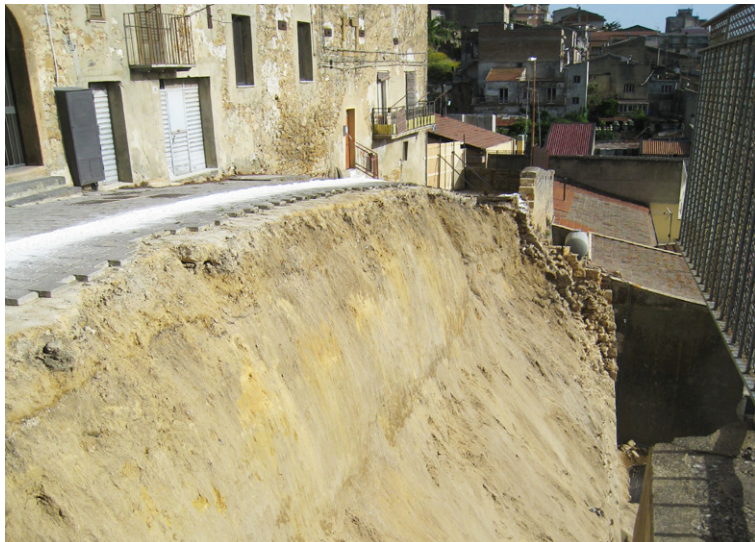
The wall's collapse also took down some of the carpark above

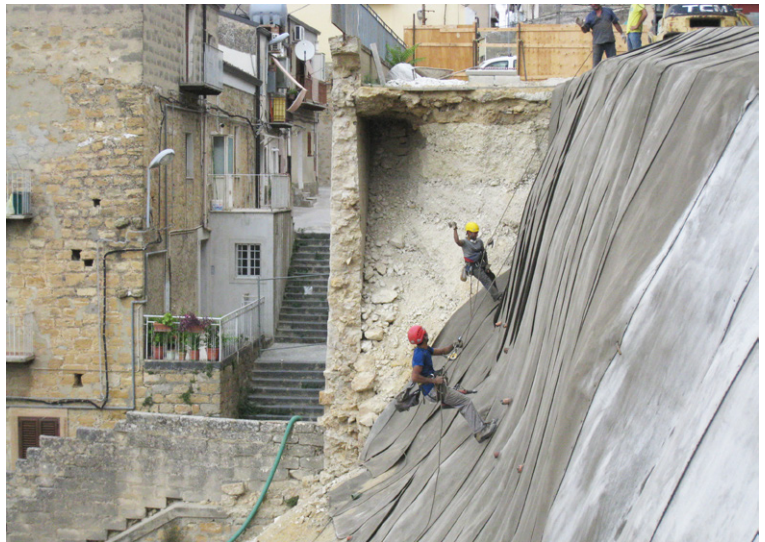
Two rock climbers assisted on the installation

400m<sup>2</sup> of CC5™ were installed over a period of four days by a team of three people, including two rock climbers, in temperatures upwards of 35°C. The client was very happy with the ease of installation of the CC and how well it met their needs.

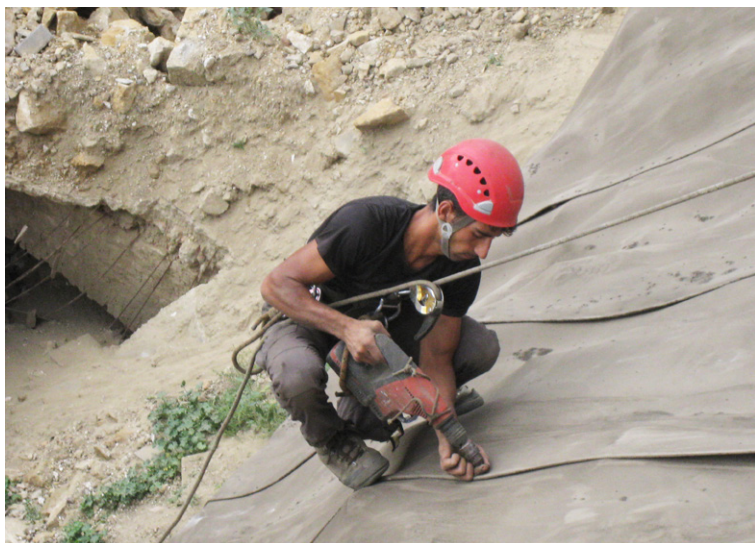
The CC was fixed with screws every 200mm

Work began with ground preparation, which consisted of the removal of any stones, rocks and moving soil parts which could disturb the CC or make its fixings less effective. The CC was then fixed with screws at intervals of 200mm, along with top anchor trenches and ground pegs every 1 metre along the top of the slope, before being hydrated with a hose.

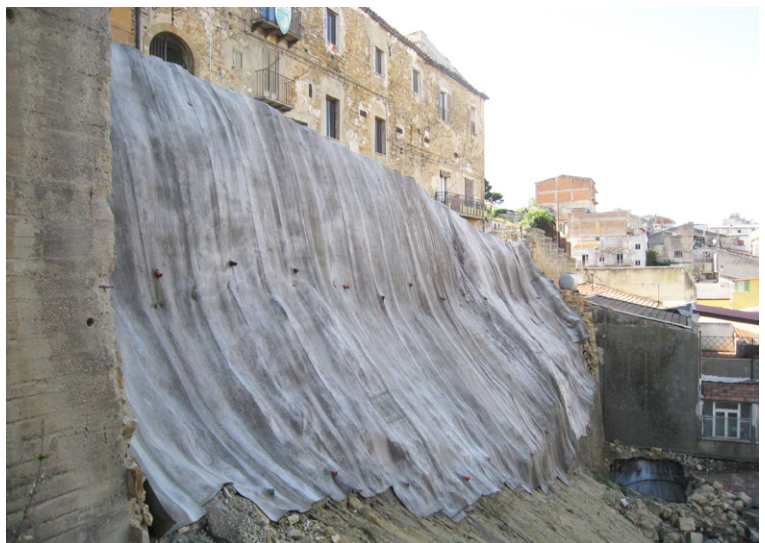
Completed installation

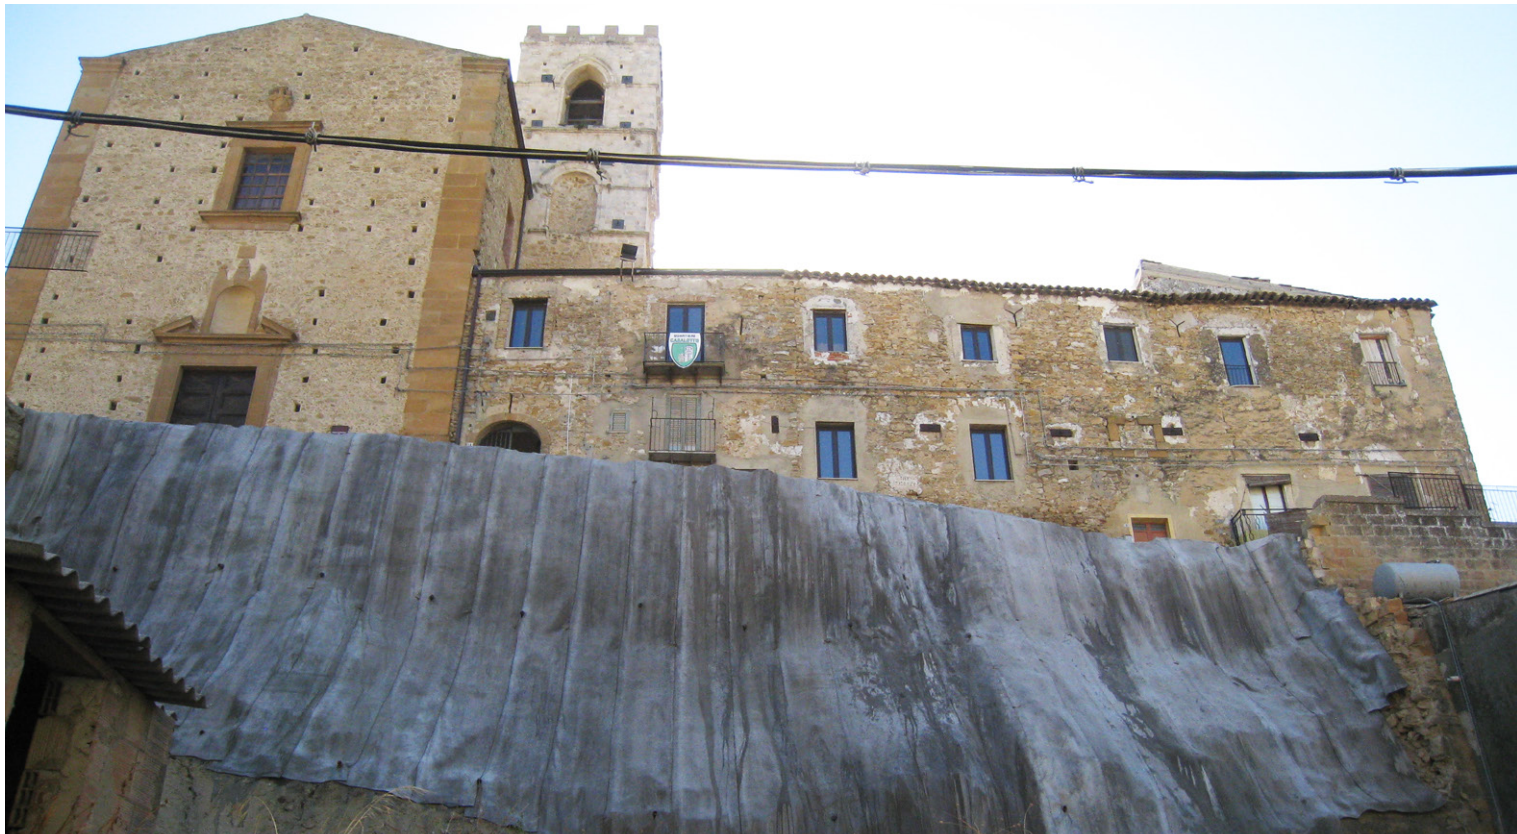
Completed installation
