**i** CC5™ used to provide erosion protection on bund slopes surrounding an electrical pylon

In August 2018, a slope protection project was carried out in order to provide a quick and permanent erosion protection solution on a bund embankment surrounding an electrical pylon.

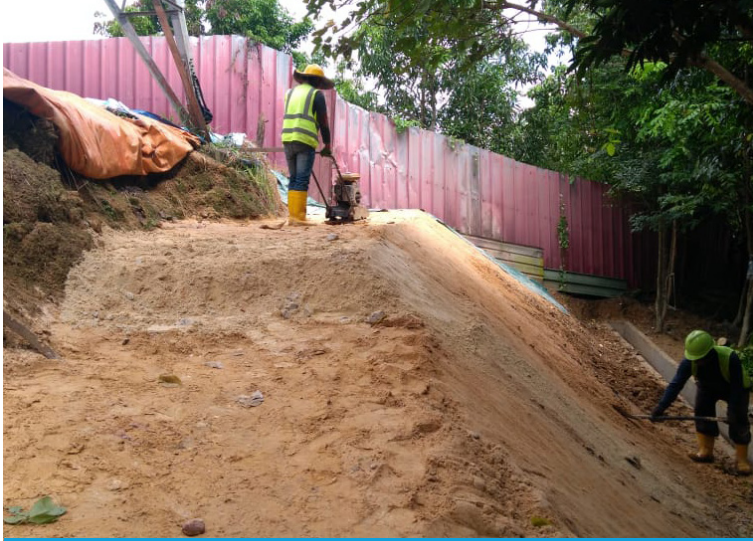
*Compaction of slope following devegetation and grading*

Prior to installation, the slope was profiled and vegetation removed, before the substrate was levelled and smoothed to prevent voids forming below the material and ensure intimate contact between the CC and substrate. Anchor trenches were then dug by hand at the crest of the slope.

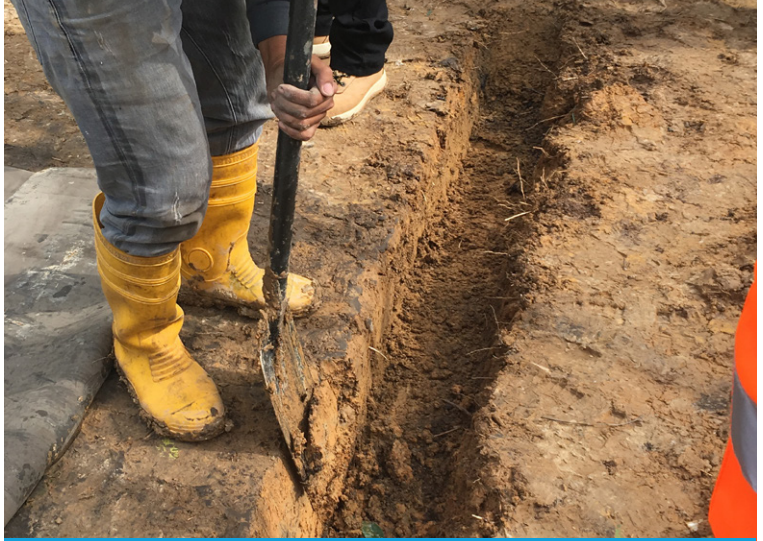
*Creation of anchor trenches*

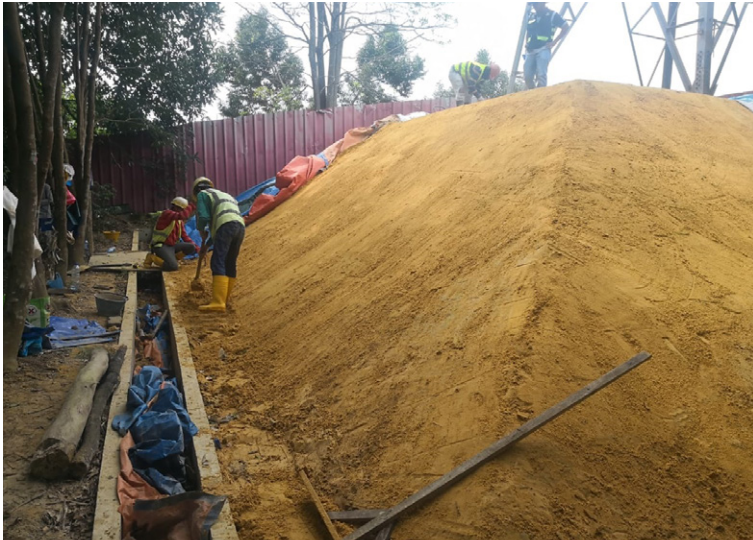
*Slopes following preparatory works*

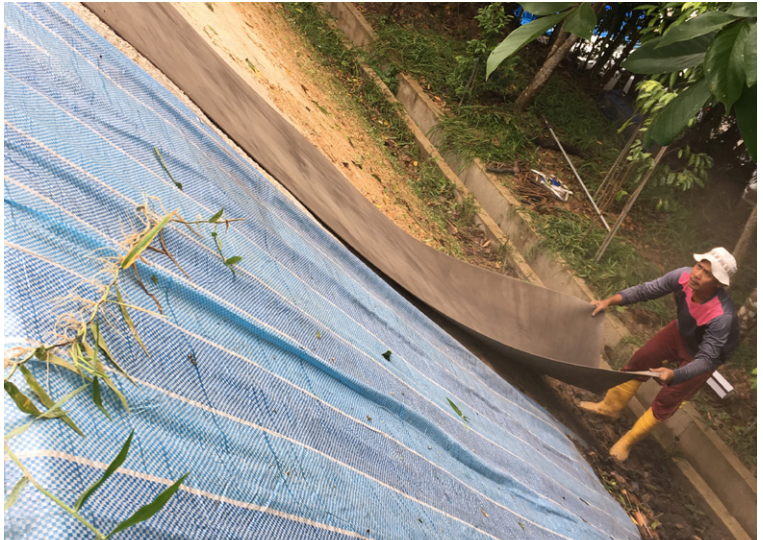
*CC layers installed vertically*

The CC material was laid vertically, with the leading edge captured within the crest anchor trench and secured using ground pegs before the material length was unrolled down the slope face. Subsequent layers were laid so as to overlap the last by 100mm and jointed using screws and sealant following the hydration of the overlapped section of the lower layer. At the toe of the slope is a concrete slab, on the other side of which is an existing concrete drain. A small anchor trench was created on the inside of the slab in which the CC was buried and sealed using grout to prevent water ingress. An additional, small drain was constructed along the side of the embankment where the CC terminated against an existing corrugated metal boundary fence. This additional drain was designed to lead surface and rain water to the toe drain. Following installation, the CC was hydrated using a portable water tank. Hydration was given twice, with a one-hour interval to ensure sufficient saturation in the high temperatures.

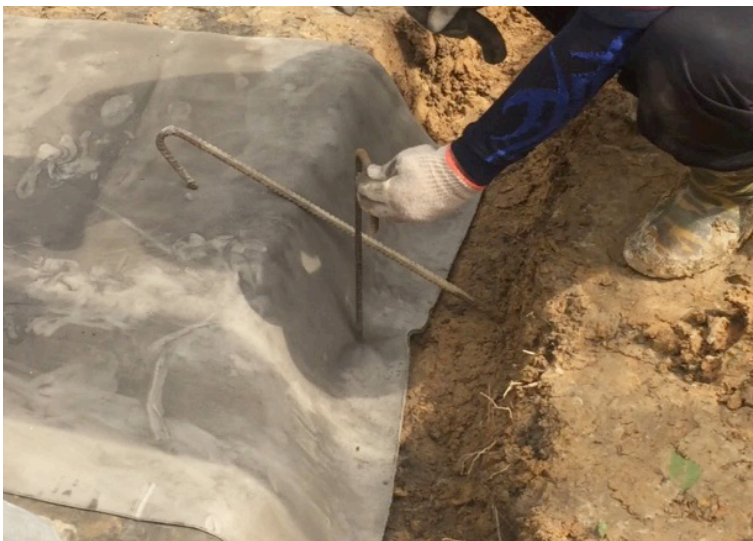
*CC edges pinned within anchor trenches using ground pegs*

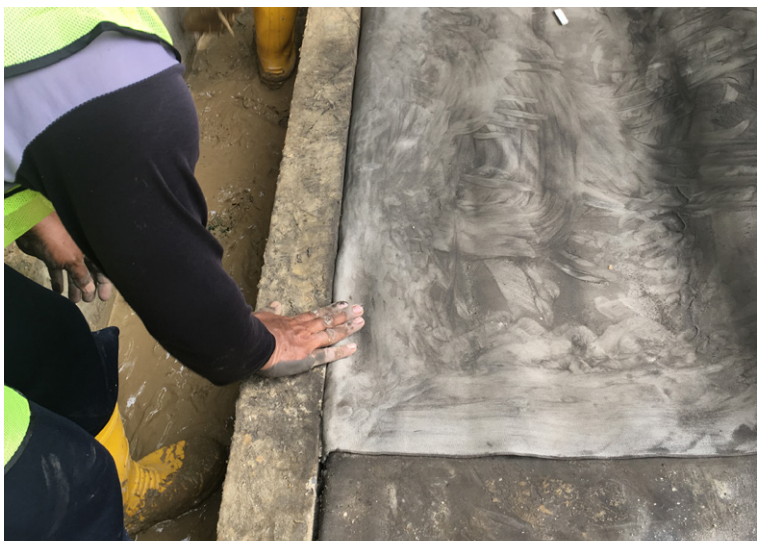
*CC termination at toe*

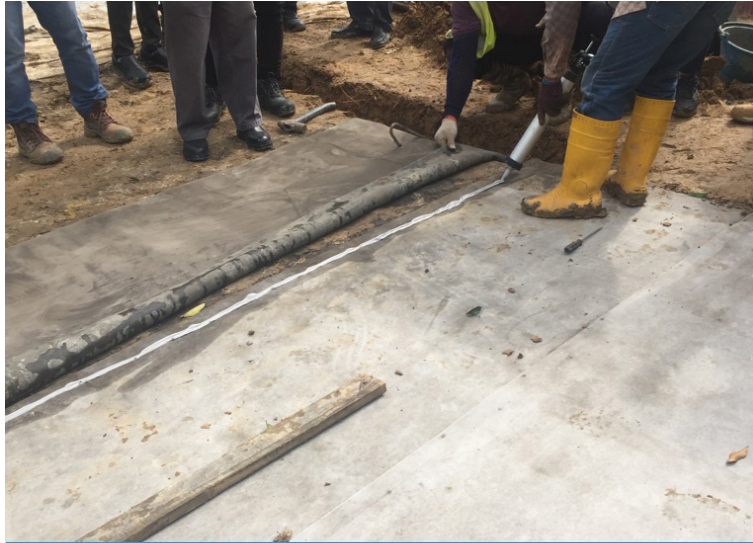
Sealant used to joint CC layers following hydration under overlap

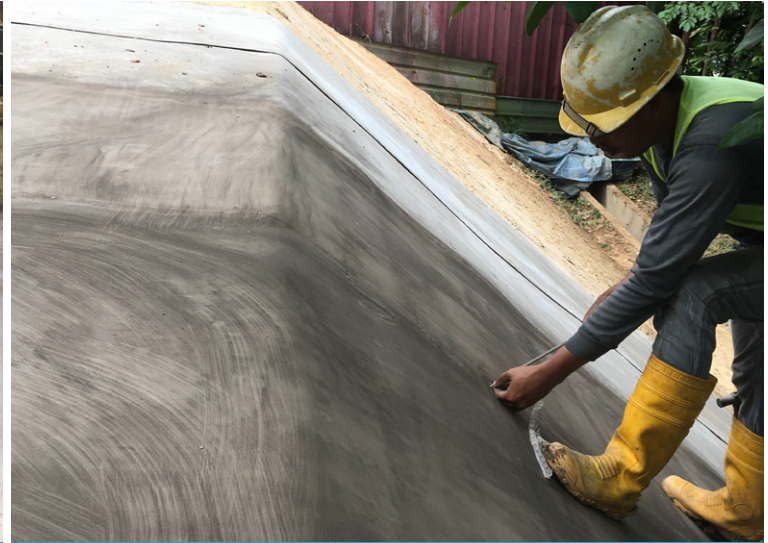
Stainless steel screws used to joint overlaps

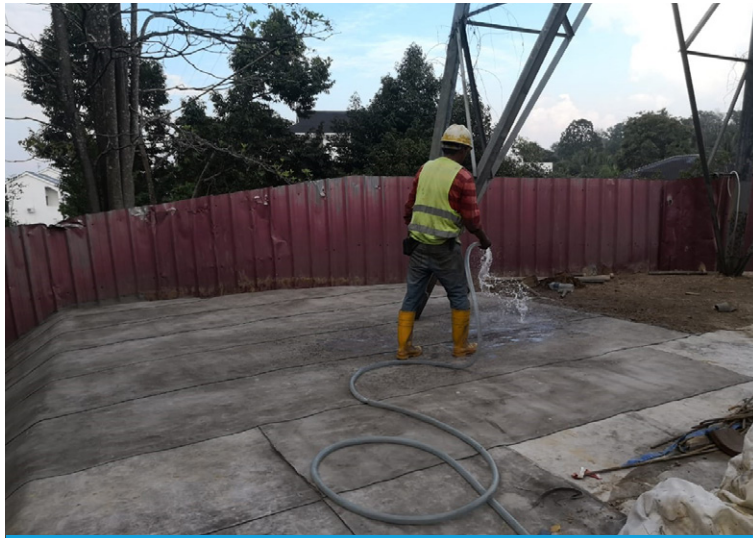
Hydrating CC

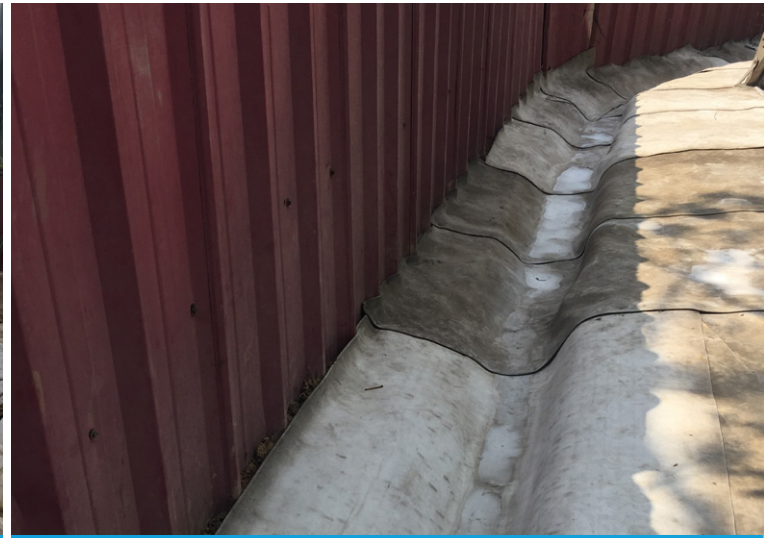
Additional drain at slope side
