CC5™ Batched Rolls

Jalan Kasawari 11,  
Puchong, Selangor,  
Malaysia

CC5™ used to prevent  
erosion of a slope  
located between a road,  
primary school and  
houses.

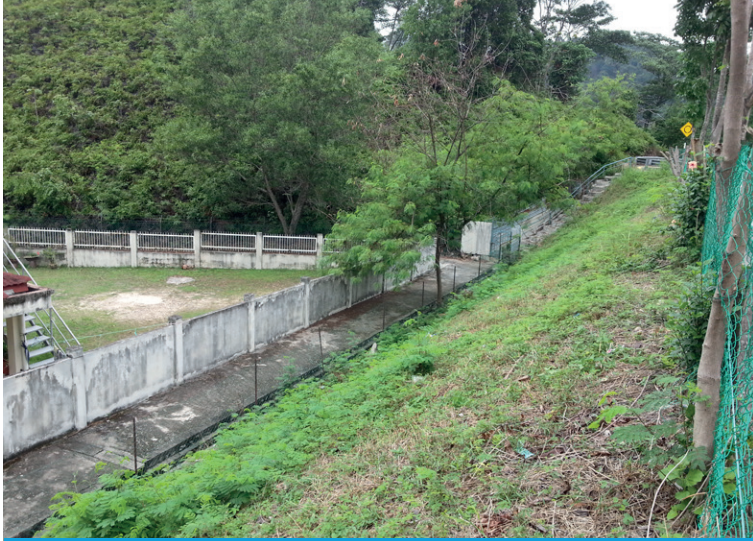
*Site before works began*

In October 2014, Concrete Canvas® GCCM\* (CC) was used to prevent erosion of a slope in Jalan Kasawari 11, Puchong, Selangor, Malaysia. The slope is located between a road and primary school at the top and residential dwellings in close proximity at the toe. Due to the high levels of rainfall and runoff flowing over the slope there was concern that the slope would eventually fail, putting lives at risk. Shotcrete was considered for the installation, however the large amount of plant required would have posed a risk to the students and teachers at the primary school, as well as requiring closure of the road - the only vehicular access route to the school.

Vegetation and loose rocks were removed from the slope before batched rolls of 5mm thick CC (CC5™) were delivered to site. The CC was pegged at the crest through the overlap before being unrolled down the slope by hand, with the installation team ensuring there was a 100mm overlap between subsequent layers. Pegs were also used where necessary down the face of the slope, to ensure intimate contact with the substrate. The overlaps were jointed with screws before hydration.

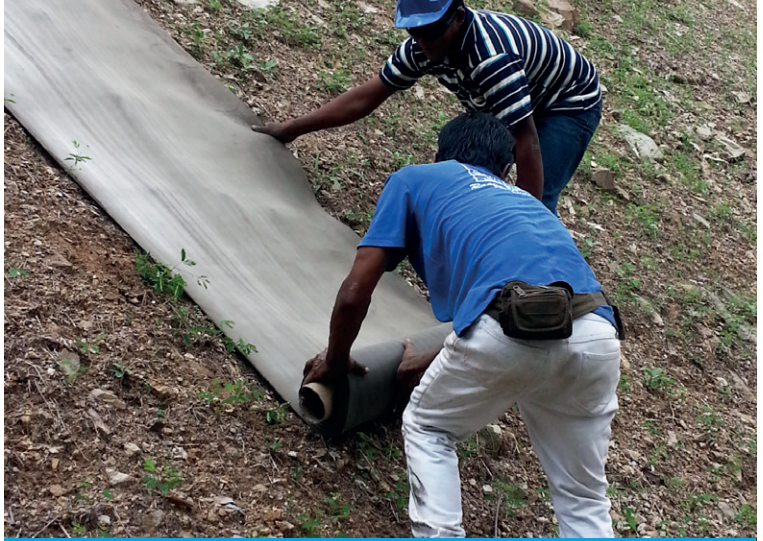
*Unrolling CC*

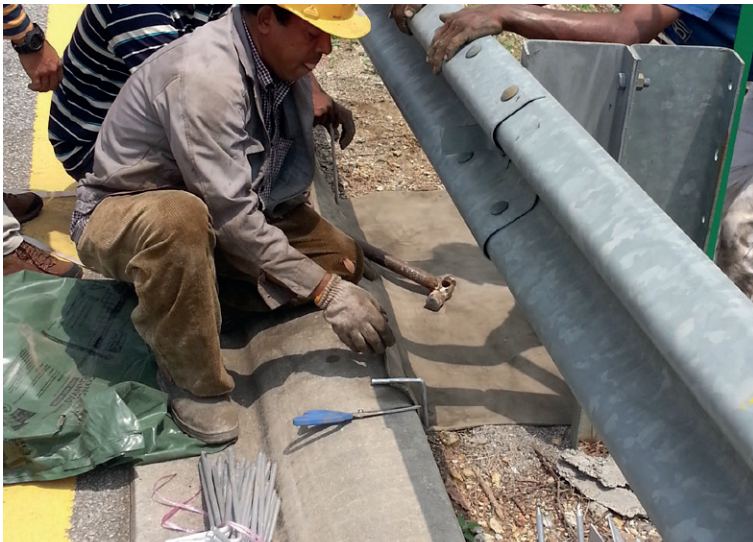
*Fixing at crest with ground pegs*

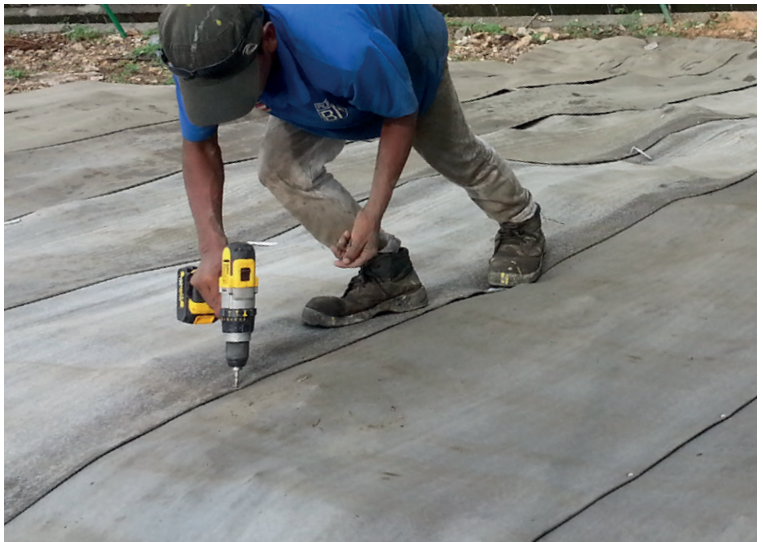
*Screwing overlaps*

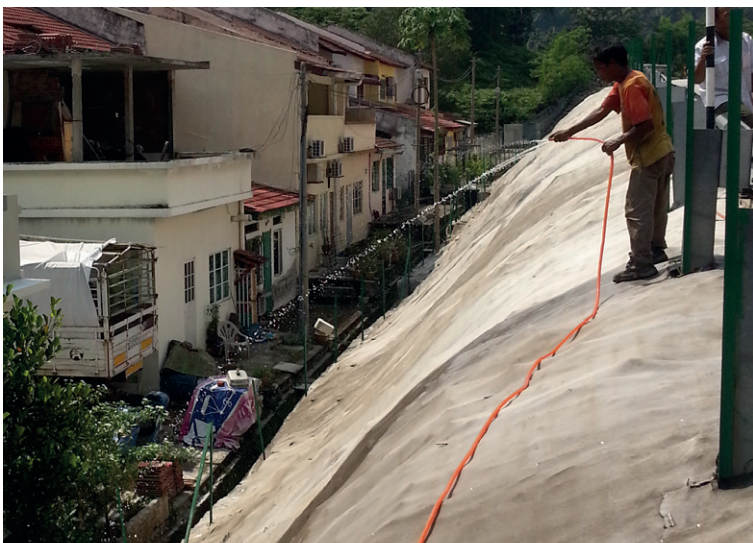
*Hydration*

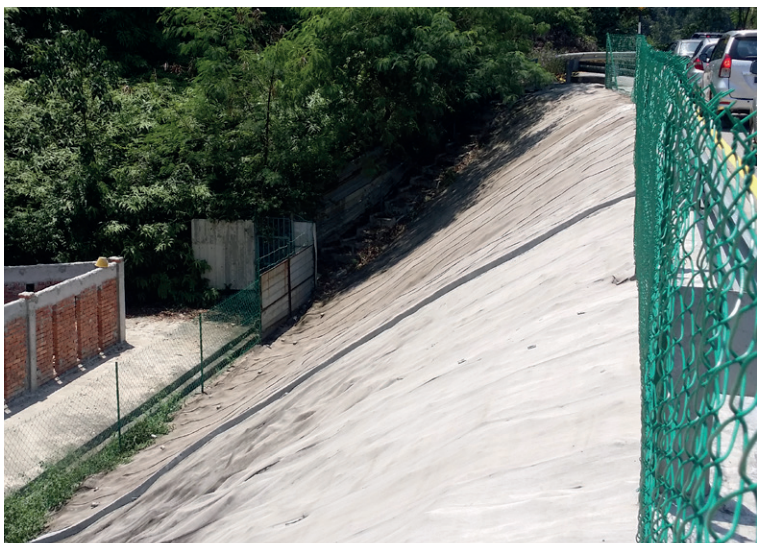
*The completed project 18 months after installation*

In total, 1230m<sup>2</sup> for CC5™ were installed in just 4 days, on a difficult to access site with no disruption to the local residents and no lane possession. The local council was pleased with the installation and have since ordered more material for other similar projects, with neighbouring councils now following their lead.
