SLOPE PROTECTION

In October 2017, Concrete Canvas® GCCM* (CC) was used to line a slope along a mountain road in New Caledonia. Surface runoff had caused erosion on a section of the slope which leads down to a drainage pipe outfall area. The erosion had caused large areas of the slope to subside, affecting drainage, putting the slope at risk of slip and in turn, endangering road users.

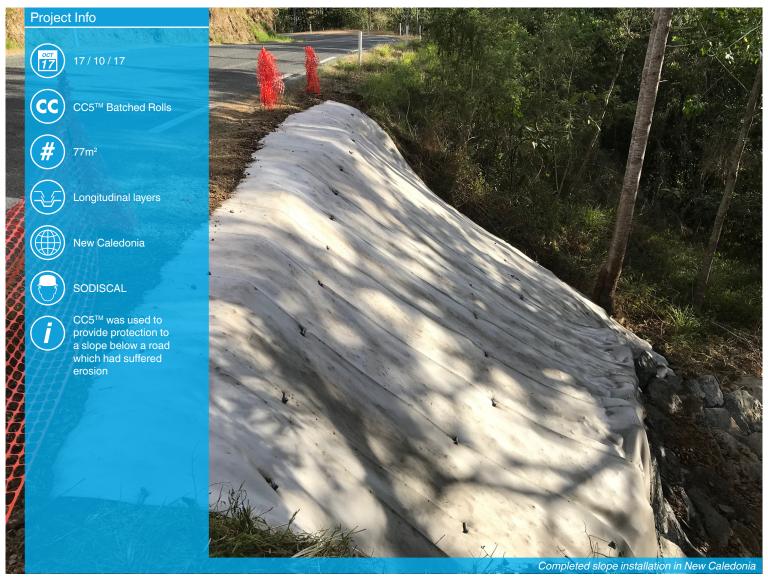
In preparation for installation, vegetation was removed from the slope and the substrate reprofiled. Batched rolls of CC5™ were delivered to the site, and unrolled down the length of the slope, from crest to toe. The CC was fixed using ground pegs and masonry rocks, where required. Overlaps of the material were then jointed using a sealant and screw combination. This was repeated along the width of the slope which required lining, and hydration giving once installation was complete.

A total of 77m² of CC5™ were installed in just 4 hours by a team of four people and in good but warm conditions of 25-30°C. The client was satisfied with the outcome of the installation and is considering specifying CC for future projects.
