CC used to protect waterfall slopes to prevent erosion caused by water flow

In December 2016, Concrete Canvas® (CC) GCCM* was used to protect a slope in order to prevent erosion as a result of water flow in Oman.

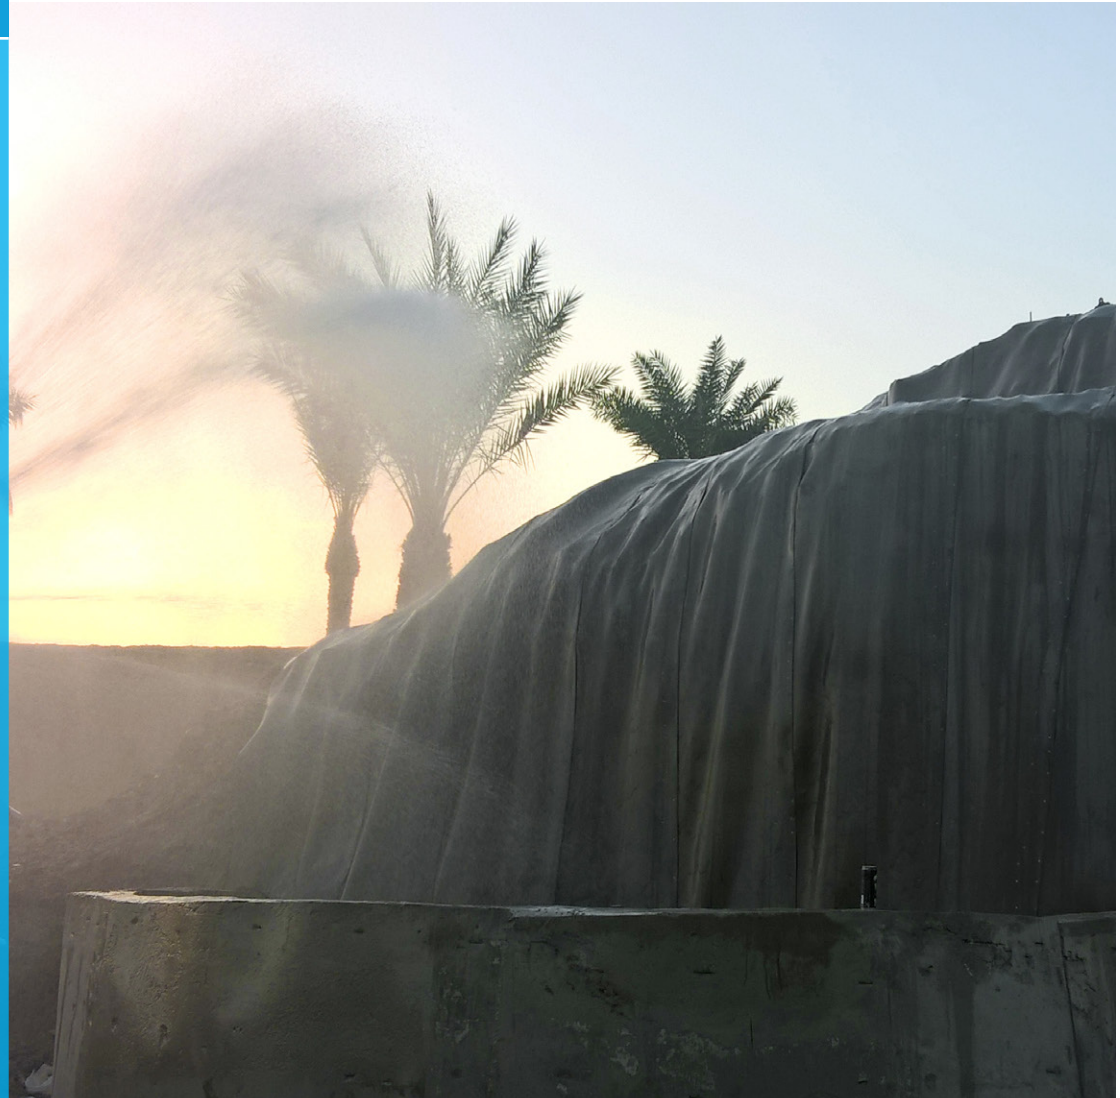
CC lined waterfall slope and water collection pool being hydrated

Once installation was completed, the team hydrated the CC using a hose and 4500-gallon truck. The team positioned the hose pipe at the toe of slope, aiming the hose pipe at the crest to allow the water to run down its face in order to hydrate it fully. The material was left for 30 minutes before a second hydration. The CC was hydrated for the third and final time the following morning, ensuring a successful installation and full hydration despite the temperatures in the region, which could otherwise accelerate the process and result in the CC not setting fully. The process was then repeated for a second water fall.

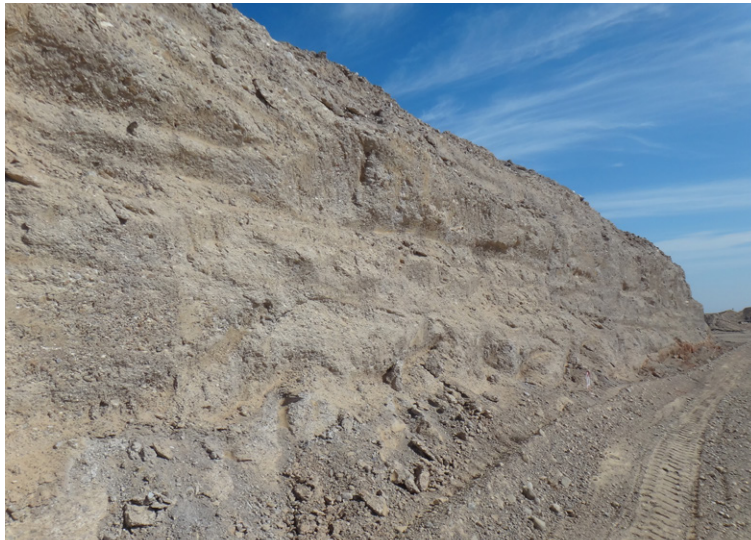
Slope prior to works

The slope is made up of a sand-based substrate due to the location of the site. Artificial waterfalls had been created, which had resulted in significant surface erosion due to the varying flow rates.

In preparation for the installation, the slopes were graded in order to create the right fall for the water. A small pool was also created at the toe of the slope to collect the water, allowing it to be recycled in order to reduce water usage.

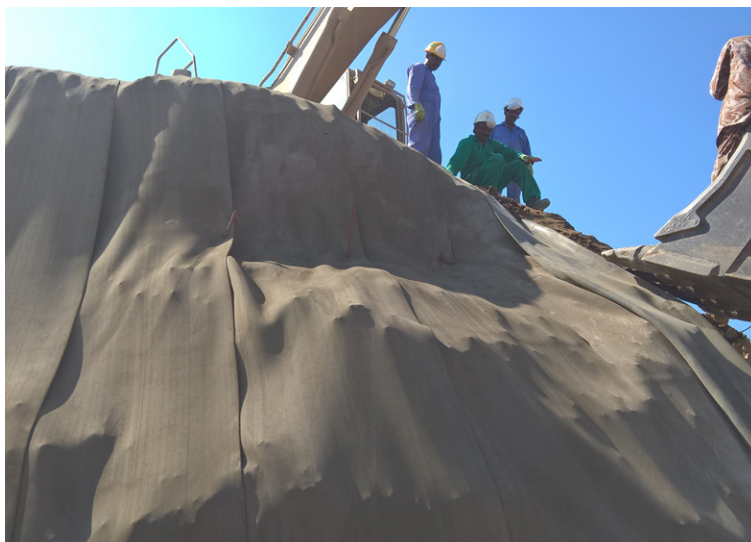
CC easily accomodated the slope profile

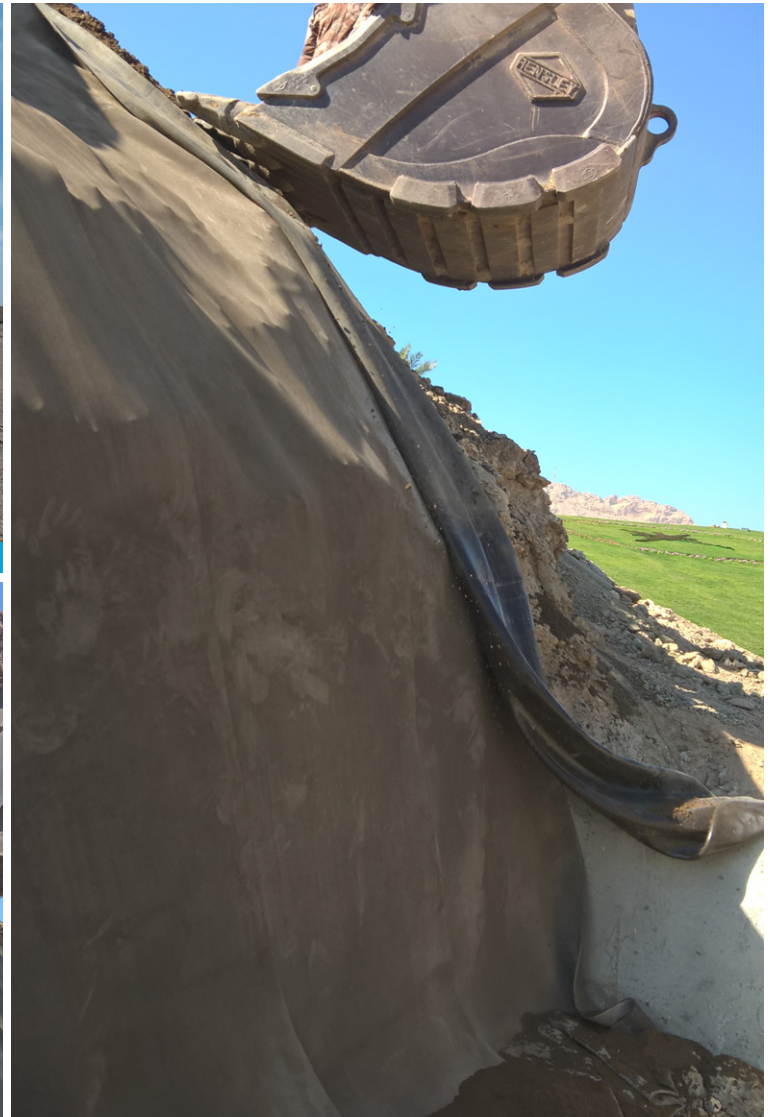
CC deployed using excavator

The CC was delivered to the site in bulk rolls and suspended from a spreader beam and PC400 excavator. The material was pegged within an anchor trench at the crest of the slope and deployed vertically down its face. Subsequent layers of the material were positioned so as to overlap the last by 100mm.

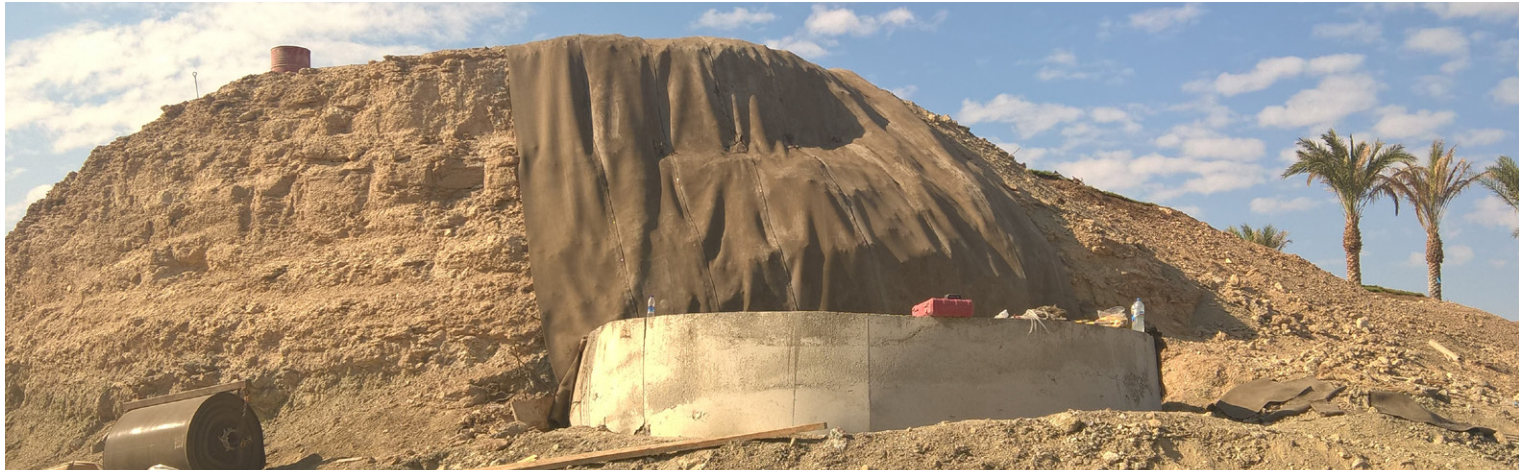
Completed installation of waterfall 1 and introduction of formworks for pool

The overlapping layers were then jointed using Clearfix adhesive sealant and screws positioned in two rows at 50mm intervals. The first row of screws was positioned around 10mm from the edge of the material, and the second approximately 100mm. The material edges at the toe of the slope are secured using ground pegs and mortar. Stainless steel ground pegs were also used to pull the CC into the base of the rocks, creating the waterfall effect. The edges were then banked into a mound to ensure the water stayed within the confines of the waterfall. Any leftover material was used to line the collection pool below.

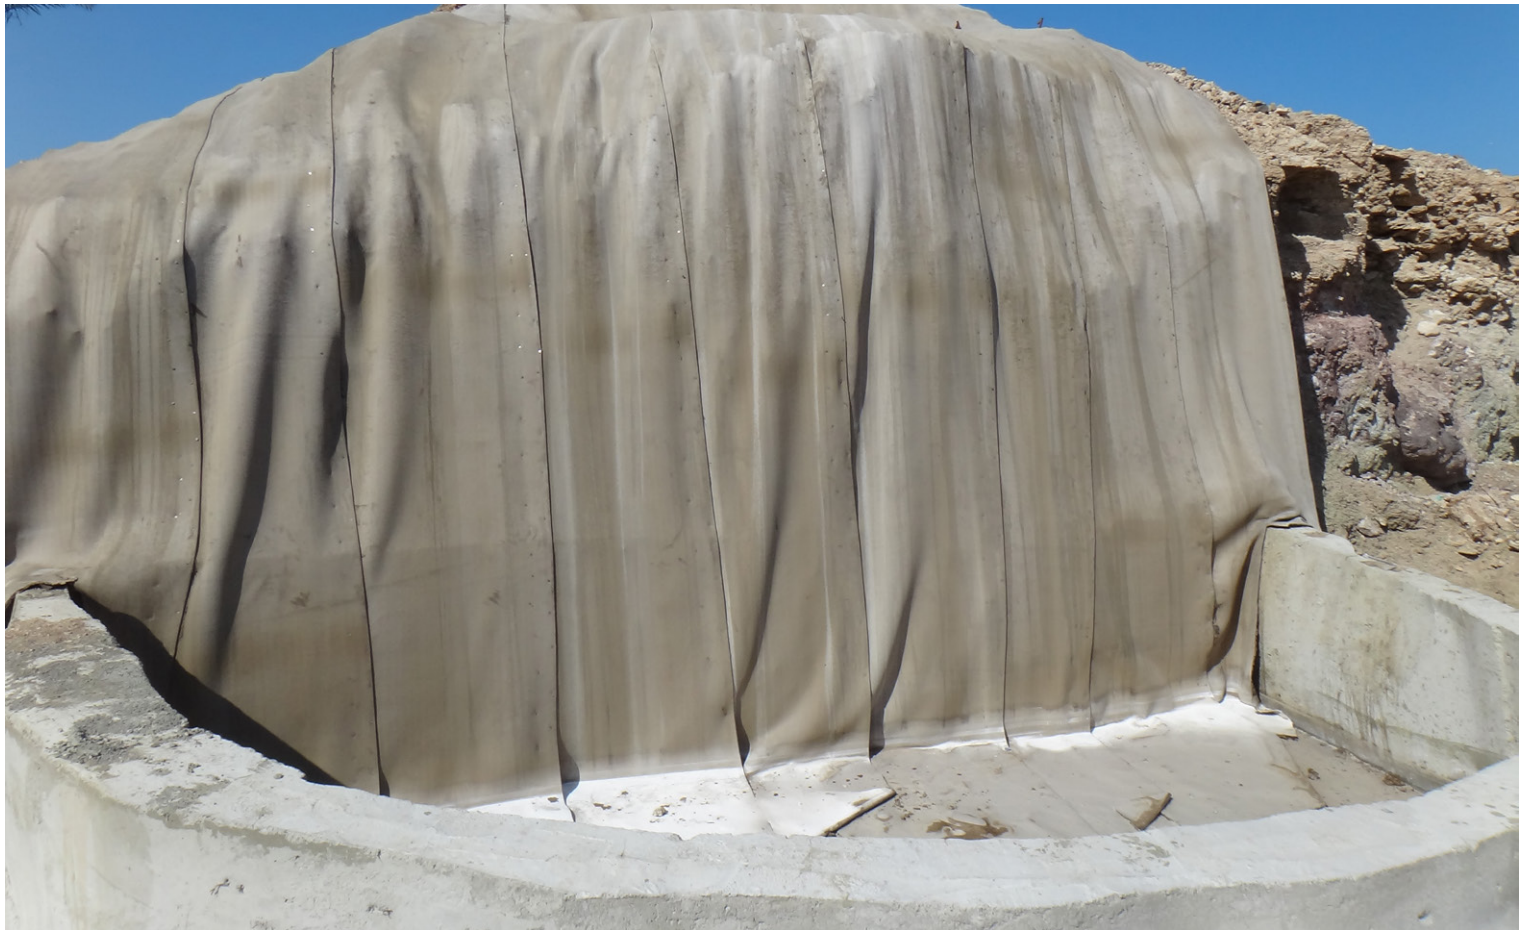
CC laid across pool floor of waterfall 2

Both waterfalls were lined within two days, with the installation team working between 8am – 6pm each day. The works were completed within the time scale given by the client, despite the volume of civil works required in preparing the site, and working around obstructions. On the second waterfall in particular, a significant amount of cutting and preparation had to be carried out to ensure the CC would sit flush against the substrate.
