CC8™ Bulk Rolls

Undisclosed Tank Farm,  
Oman

CC8™ was used to prevent the weathering of a roadside slope which was leading to rockfall onto the road.

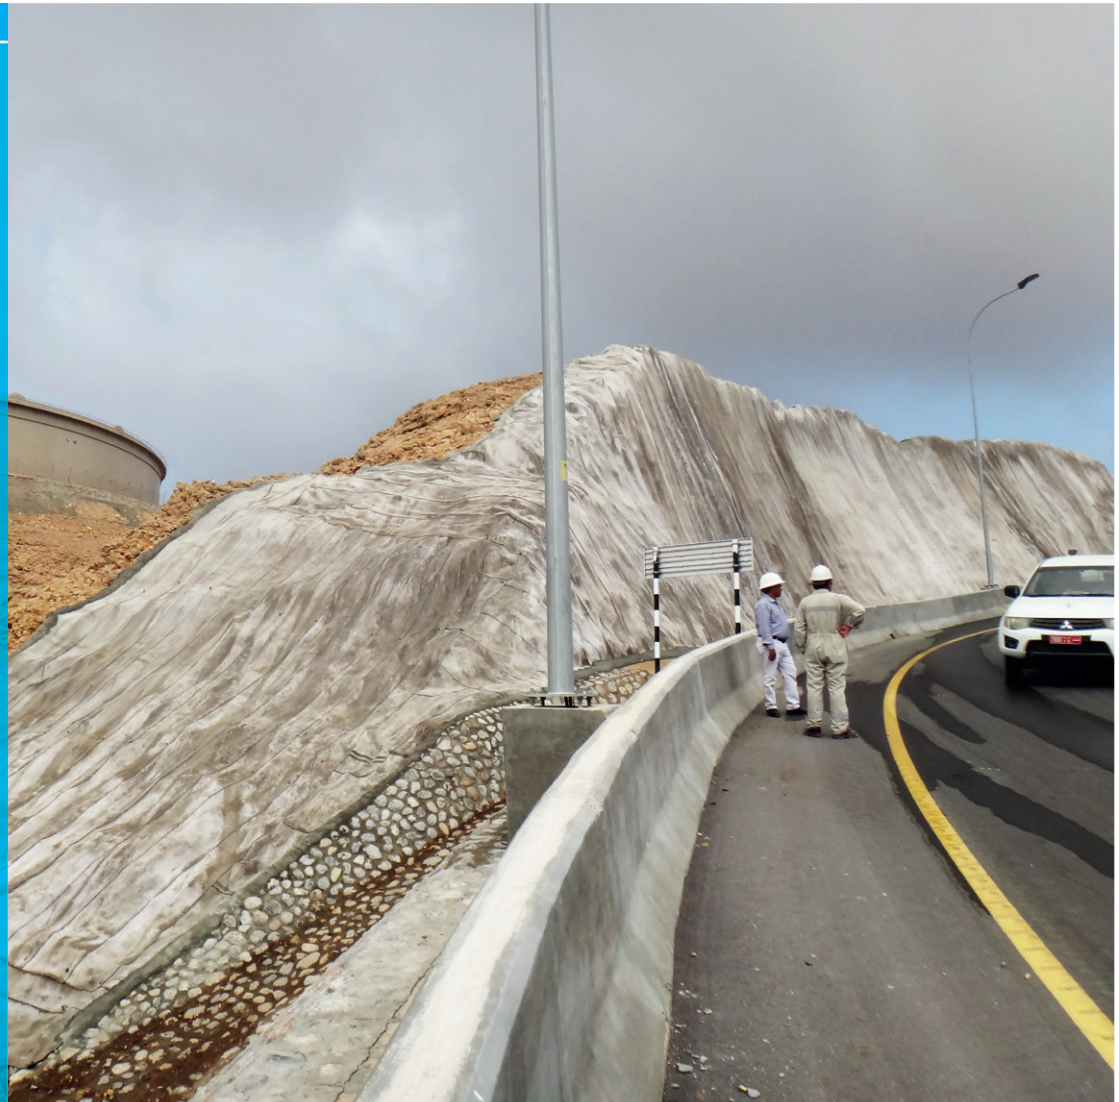
Completed installation

A total of 3,550m<sup>2</sup> of CC8™ was installed over a period of five days, compared to the 12 days installation time for the shotcrete. The CC also resulted in cost savings and allowed the road to remain open for the duration of the installation. Unlike the shotcrete, there have been no signs of cracking or failure, and CC is being considered by this client for further projects.

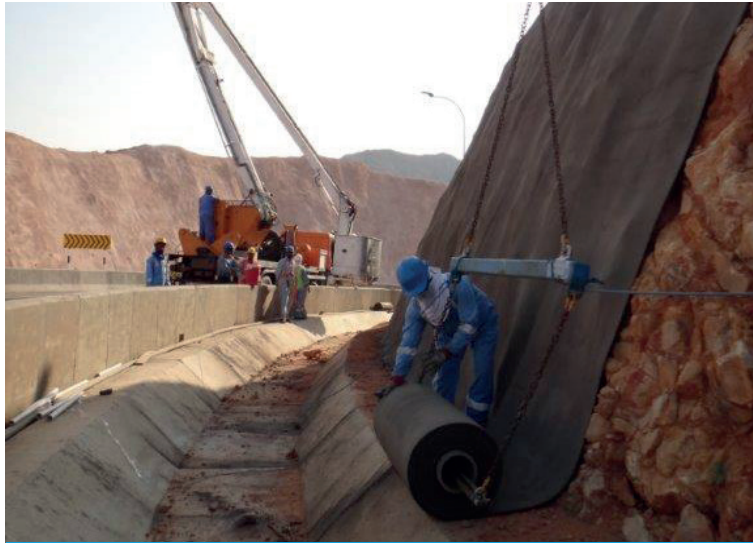
*The CC was delivered to site in bulk rolls*

Loose rock was removed from the slope face to ensure intimate contact with the CC. Bulk rolls of CC8™ were delivered to site and mounted onto a spreader beam and hung from a crane. The rolls were lifted to the top of the slope and the leading edge placed in an anchor trench and pegged in place. The CC was then unrolled down the slope and cut to length, to avoid wastage. Layers were overlapped by 100mm and then sealed with an adhesive sealant and screwed at 100mm intervals. Pegs were also inserted where needed, and mortar used to seal the CC to the concrete substrate and to the pipes installed to allow the egress of water. Hydration was achieved using a 200-gallon tanker at the crest of the slope and a bowser at the base. Due to high temperatures, a second hydration was given an hour later.

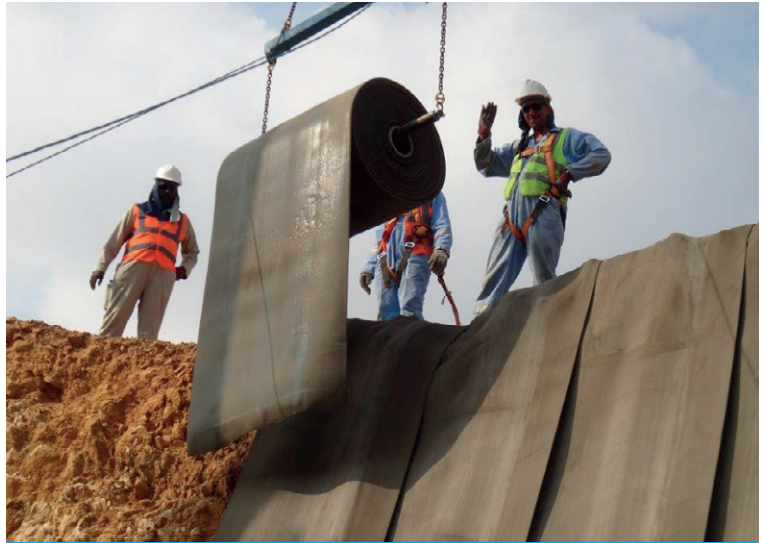
*The CC was suspended from a spreader beam and excavator for unrolling*

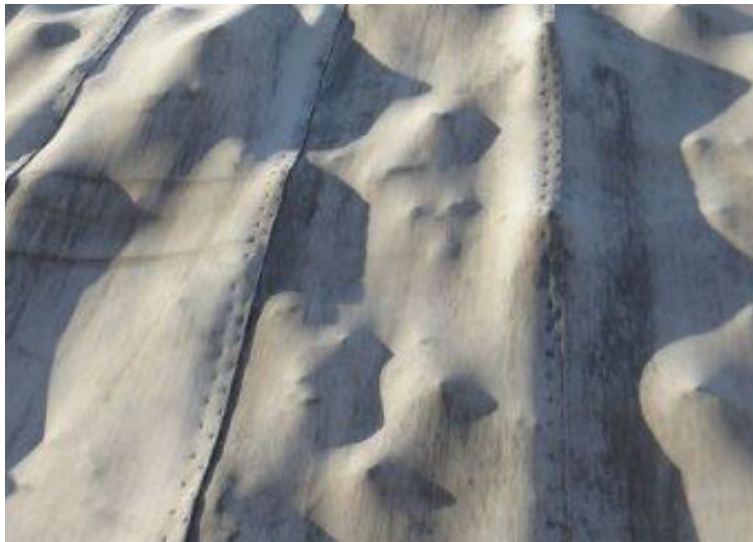
*Overlapping layers of CC were secured with adhesive sealant and screws*

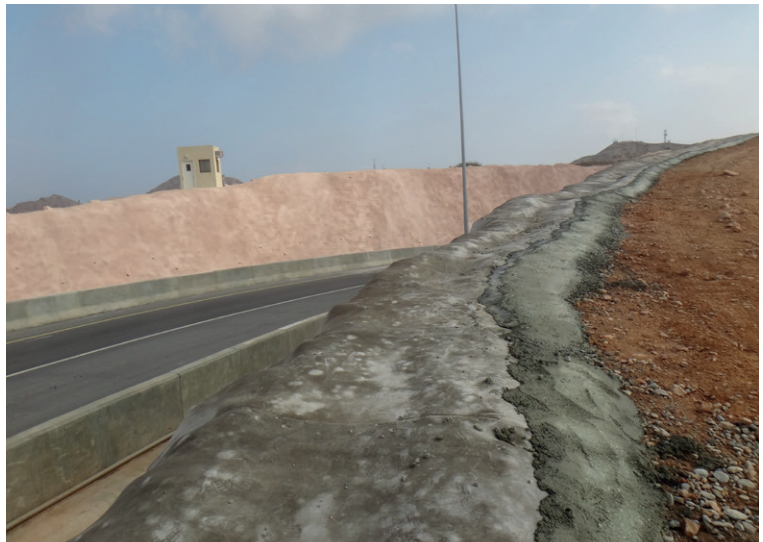
*Edges of the CC were backfilled using concrete at the crest of the slope*

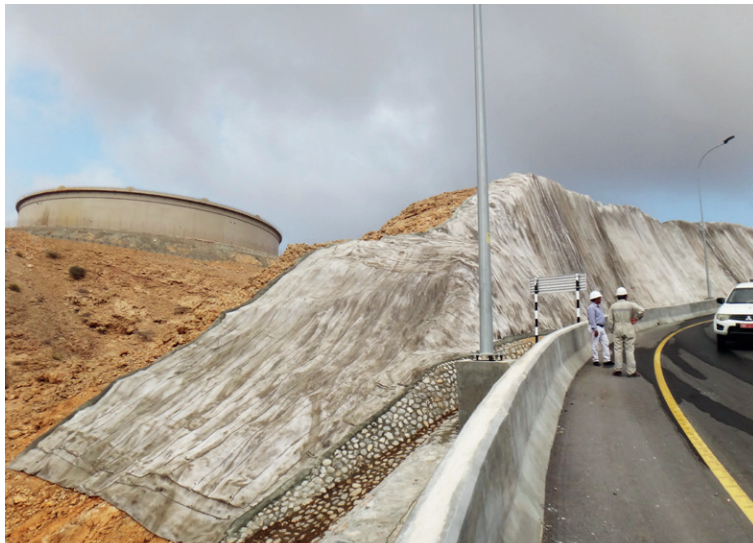
*The end of the slope was covered using longitudinal and transverse layers*

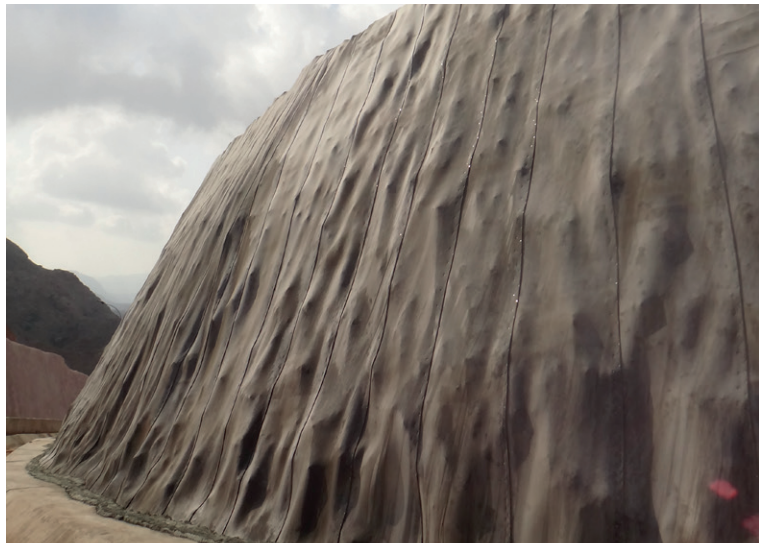
*Completed installation*
