CC5™ used to provide bank erosion protection to an RSA pond required for Bauxite liquor storage.

In April 2021, Concrete Canvas® GCCM for the second phase of the embankment side wall erosion protection works in Ras Al Khair, Saudi Arabia.

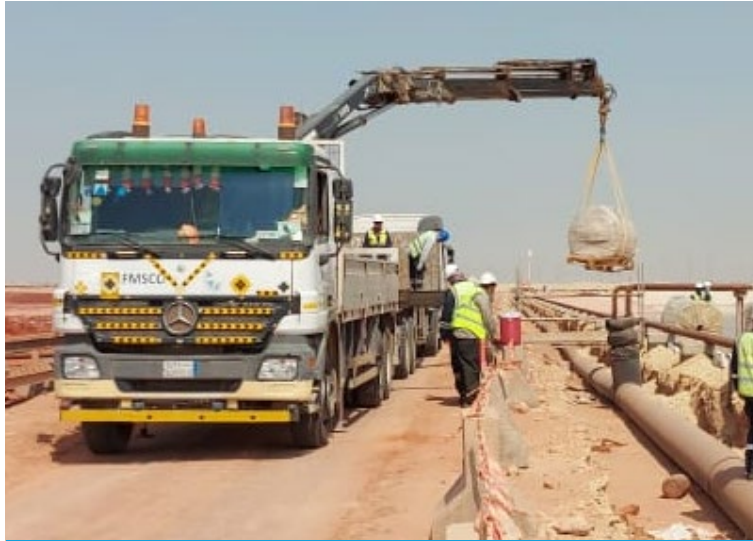
*CC5™ Deployed using boom truck*

Once the slope was prepared, Bulk Rolls of CC5™ were brought onto site and mounted onto a spreader beam. With the Bulk Rolls of CC being suspended from a boom truck at the crest of the slope for easy and rapid deployment. The Bulk Rolls were unrolled manually and laid vertically down the length of the slope. Each layer was then cut to the desired length to reduce wastage with the subsequent layers overlapping by 100mm. Each overlapped layer was then jointed using stainless steel screws applied in a zig-zag pattern at a distance of 50mm from each other.

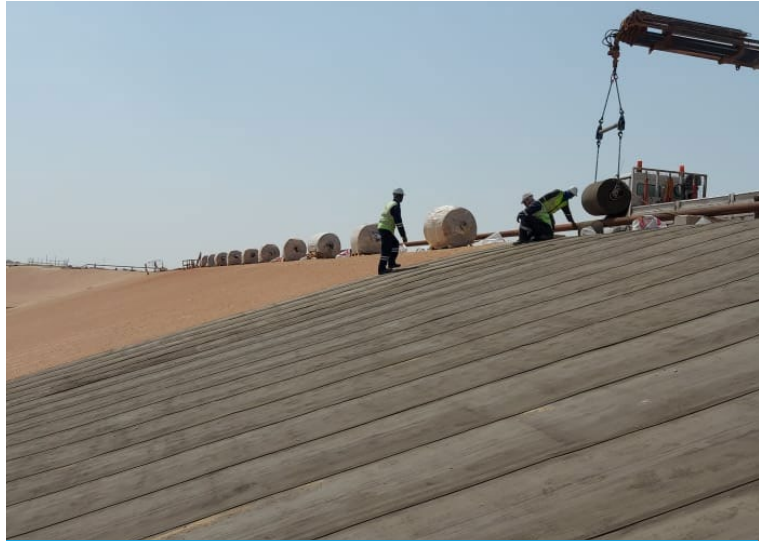
*CC5™ Material suspended using spreader beam*

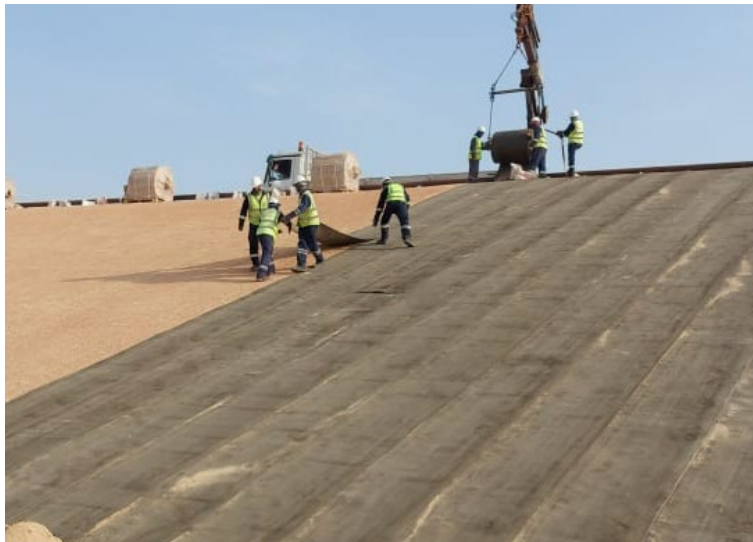
*CC5™ Material laid vertically down the slope*

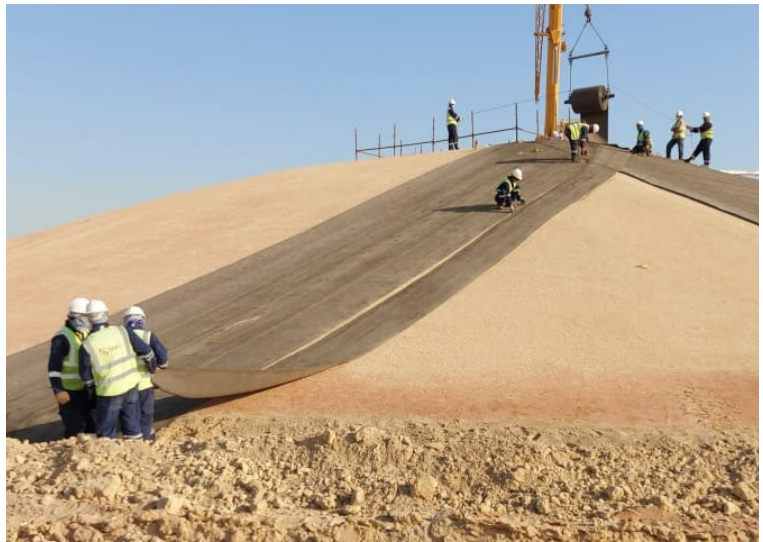
*CC5™ Material laid vertically down the slope*

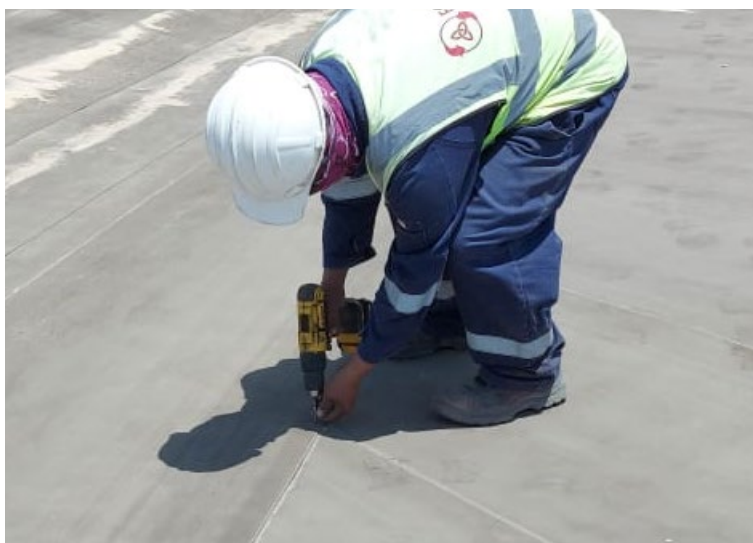
*Overlapped layers secured using stainless steel screws*

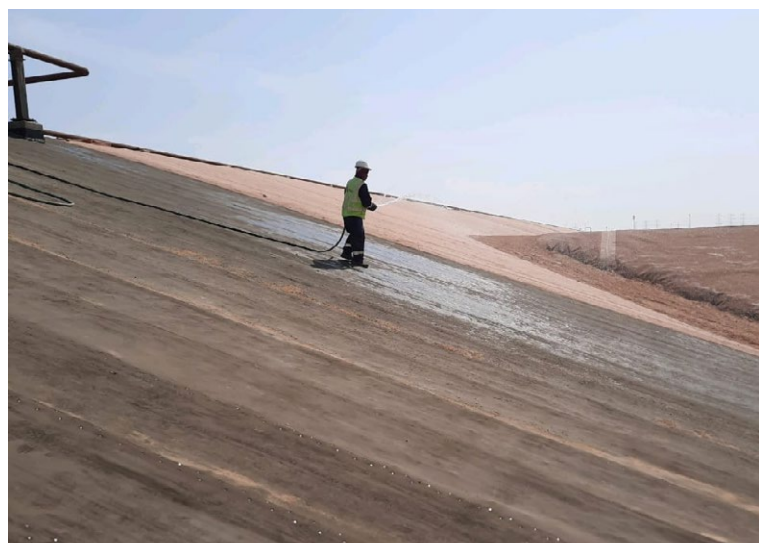
*CC5™ being hydrated with hose*

At the crest of the slope the leading edge of the CC5™ material was terminated inside anchor trenches and pegged using stainless steel pegs at a distance of 500mm from each other. The anchor trenches were then backfilled with marl. When terminating to concrete sleepers, the CC5™ material was terminated using stainless steel batten strips and bolts. At the toe of the slope CC was laid over a HDPE lining and covered with sand. The material was then hydrated at the end of every shift using a water tanker and hose.

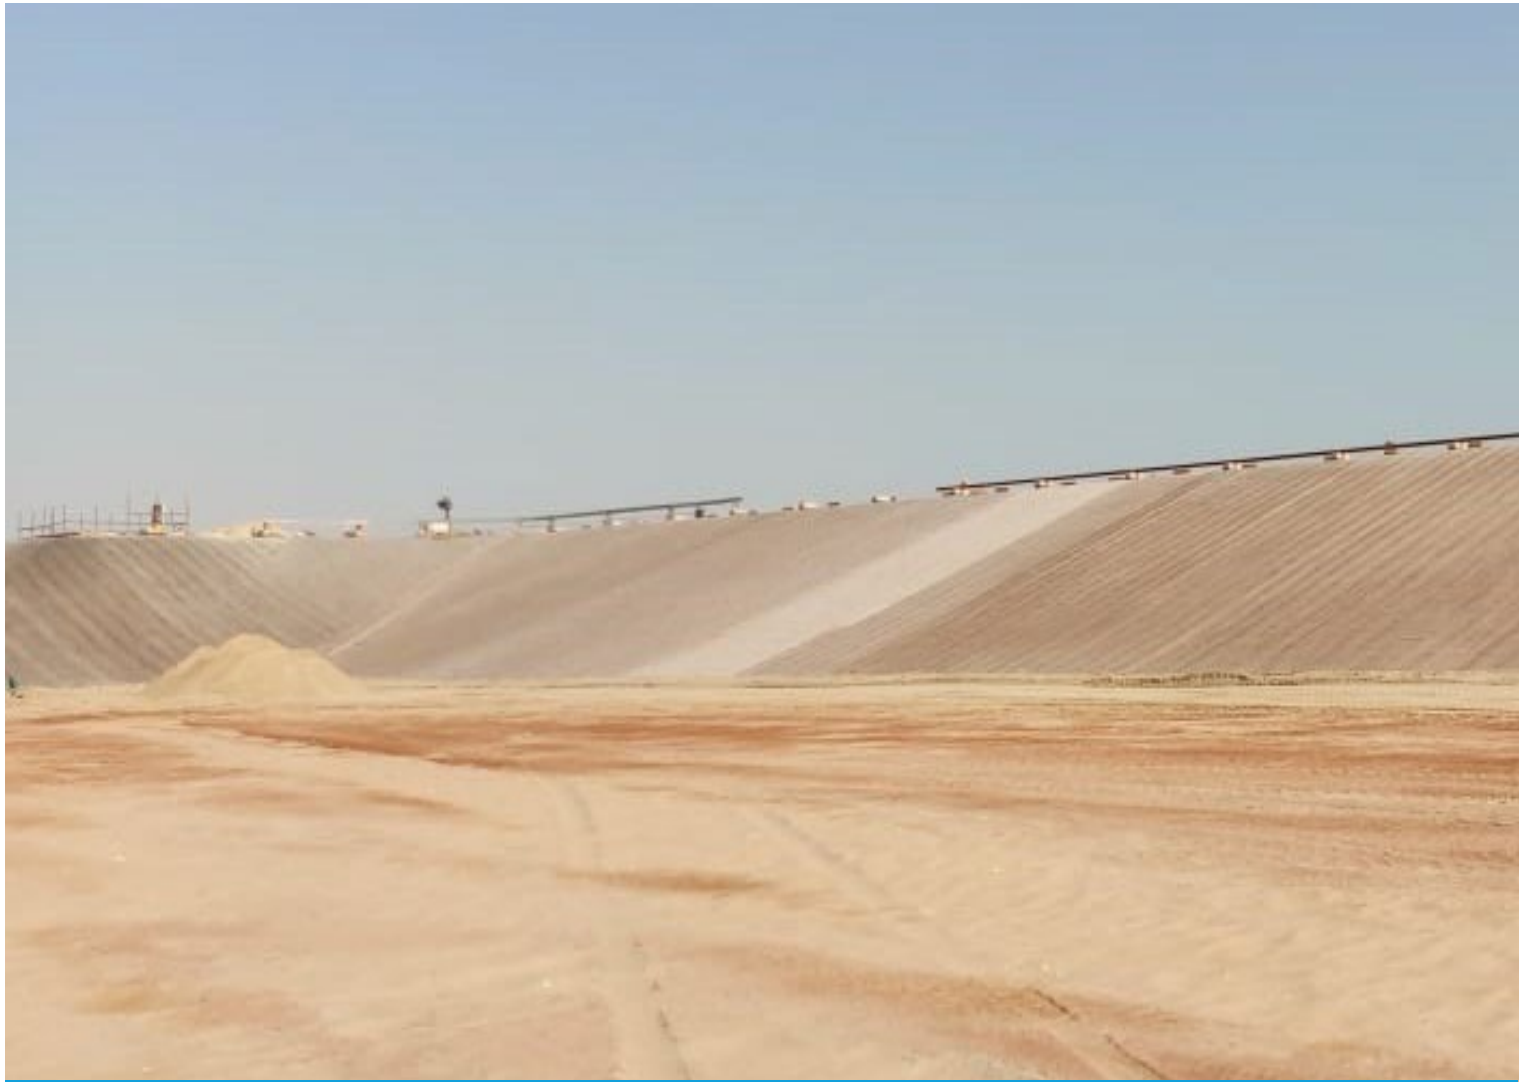
*Completed slope protection works*

A total of 18,922m<sup>2</sup> of CC5™ was installed in 21 days with an average of 10 hours of work was carried out each day. The installation was a success and the client pleased with the overall process and timescale to complete.
