Project Info

CC8™ Bulk Rolls

Wadi Laban, Riyadh,
Saudi Arabia

Prevent rain water run-
off infiltrating a gulley
and causing a land slip

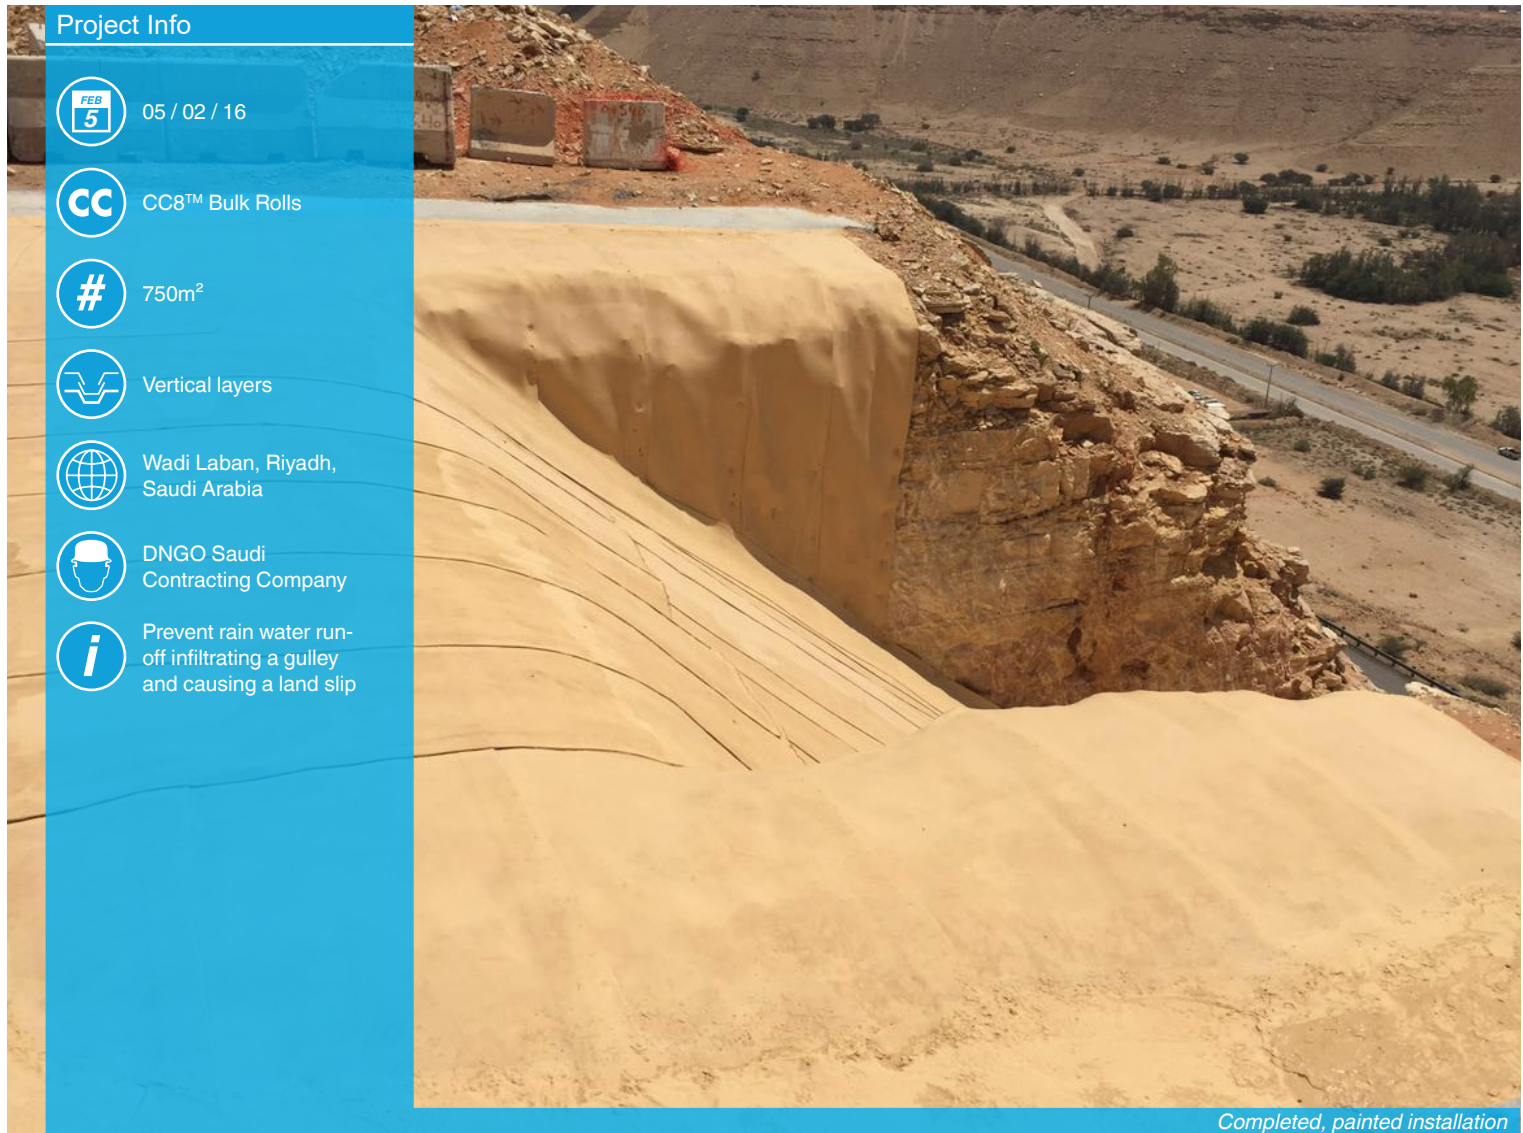
Completed, painted installation

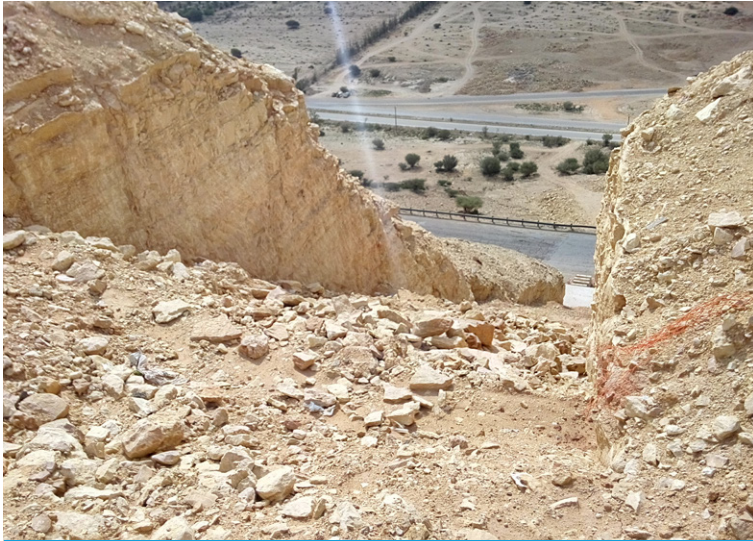
The slope before work

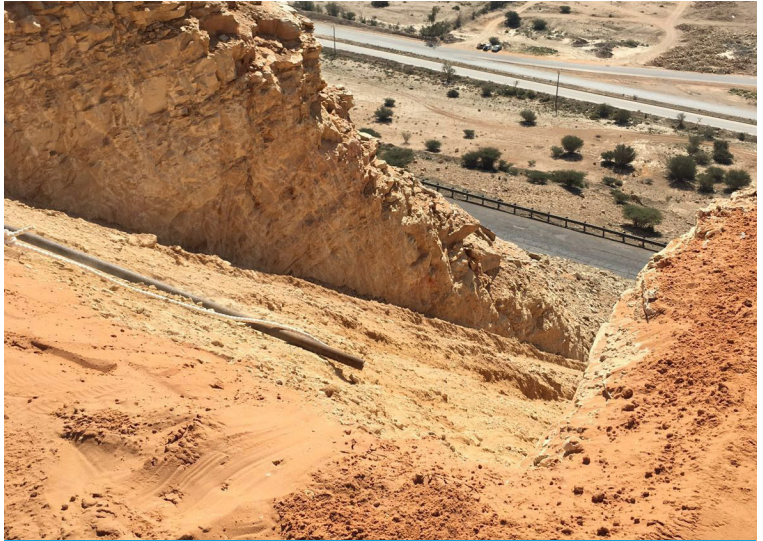
The slope prior to CC install

The weather was mainly dry with intense sunshine and the temperature moderate as this installation was carried out during the winter months. Pre-installation preparation included removing loose gravel and sharp rocks from the surface, levelling of uneven areas and a single layer of geotextile being laid.

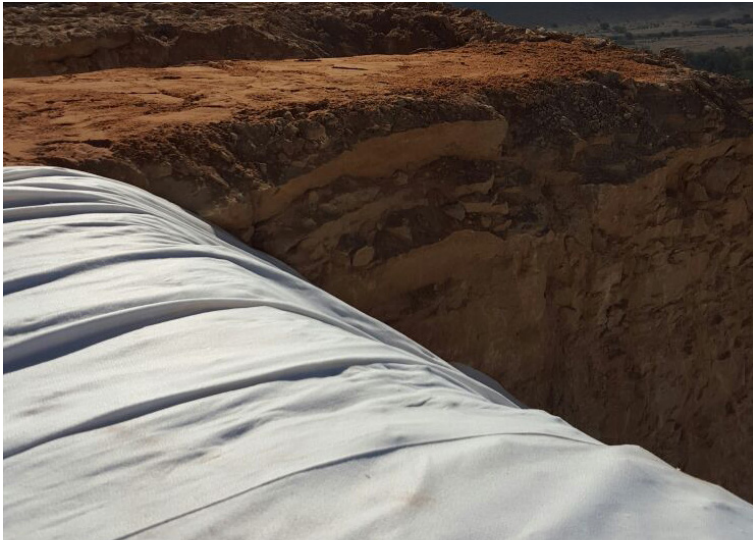
A geotextile was laid prior to installation of the CC

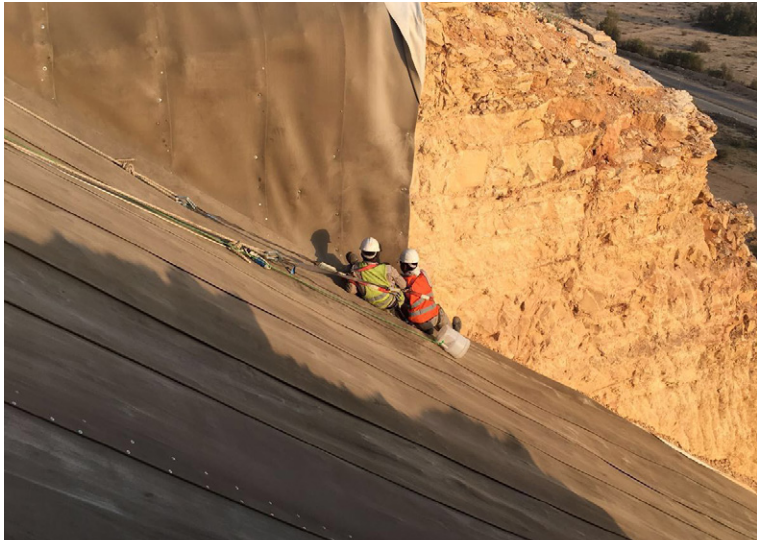
Contractors fixing the CC with bolts & pegs to the slope at 50mm centers

The CC was then laid longitudinally using a spreader beam and crane then cut to required lengths. Once laid, holes were drilled on the sides, and the CC was fixed using 200mm rock bolts. Multiple layers were jointed at 50mm intervals using 19mm stainless steel screws. The CC was anchor trenched at the top and backfilled with concrete before hydration was tanker with hose attachment.

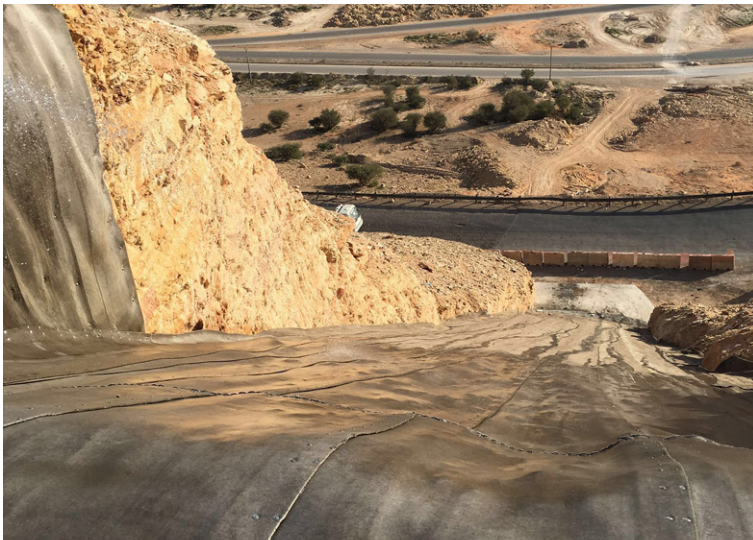
Hydration taking place

Hydration was carried out in three 2-hour periods over two days due to the dry conditions and steep nature of the slope. Once set, the CC was painted with a client specified colour to blend in with the natural landscape of the surrounding area.

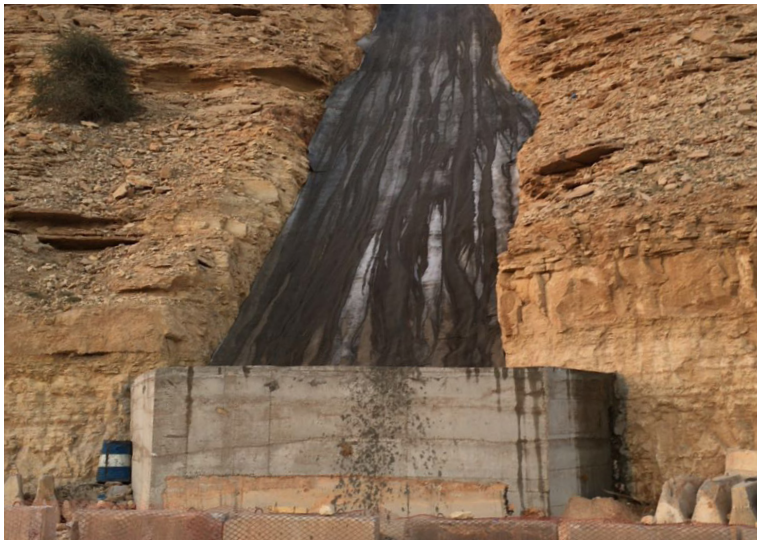
A 5,000 gallon water tank was used for hydration

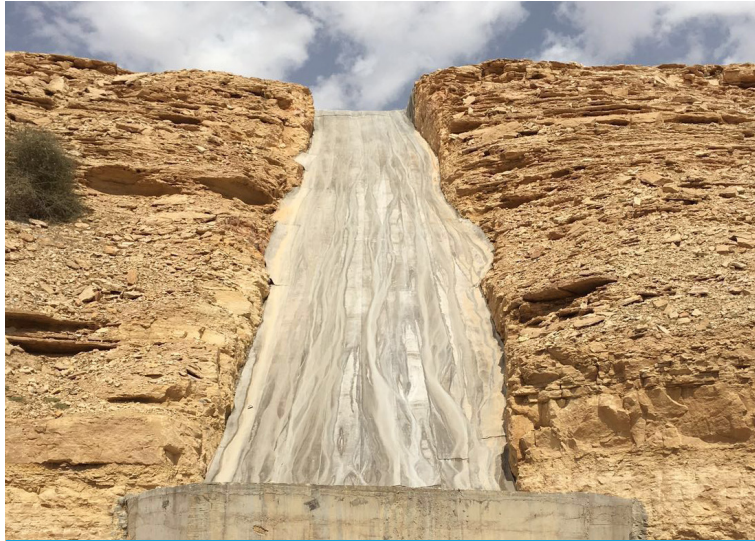
The set CC8™

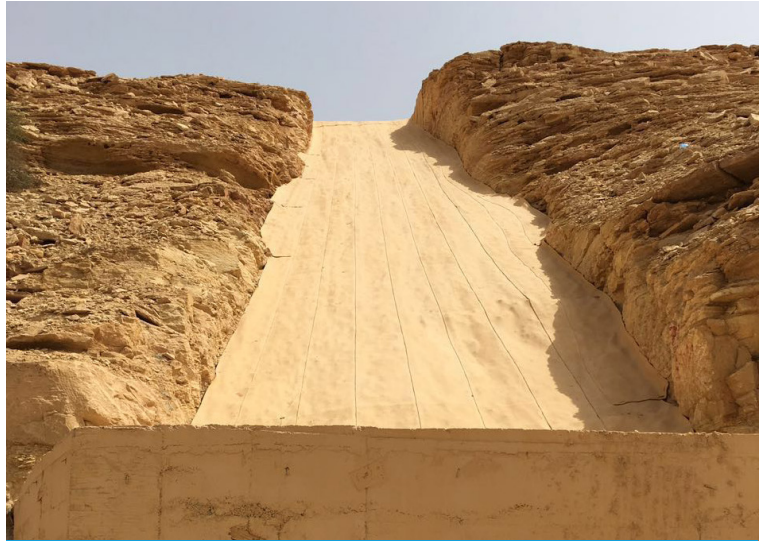
The slope after being painted for Aesthetics
