CC8™ Bulk Rolls

Dasmarinas, Cavite,  
Philippines

To replace the damaged  
existing concrete lining

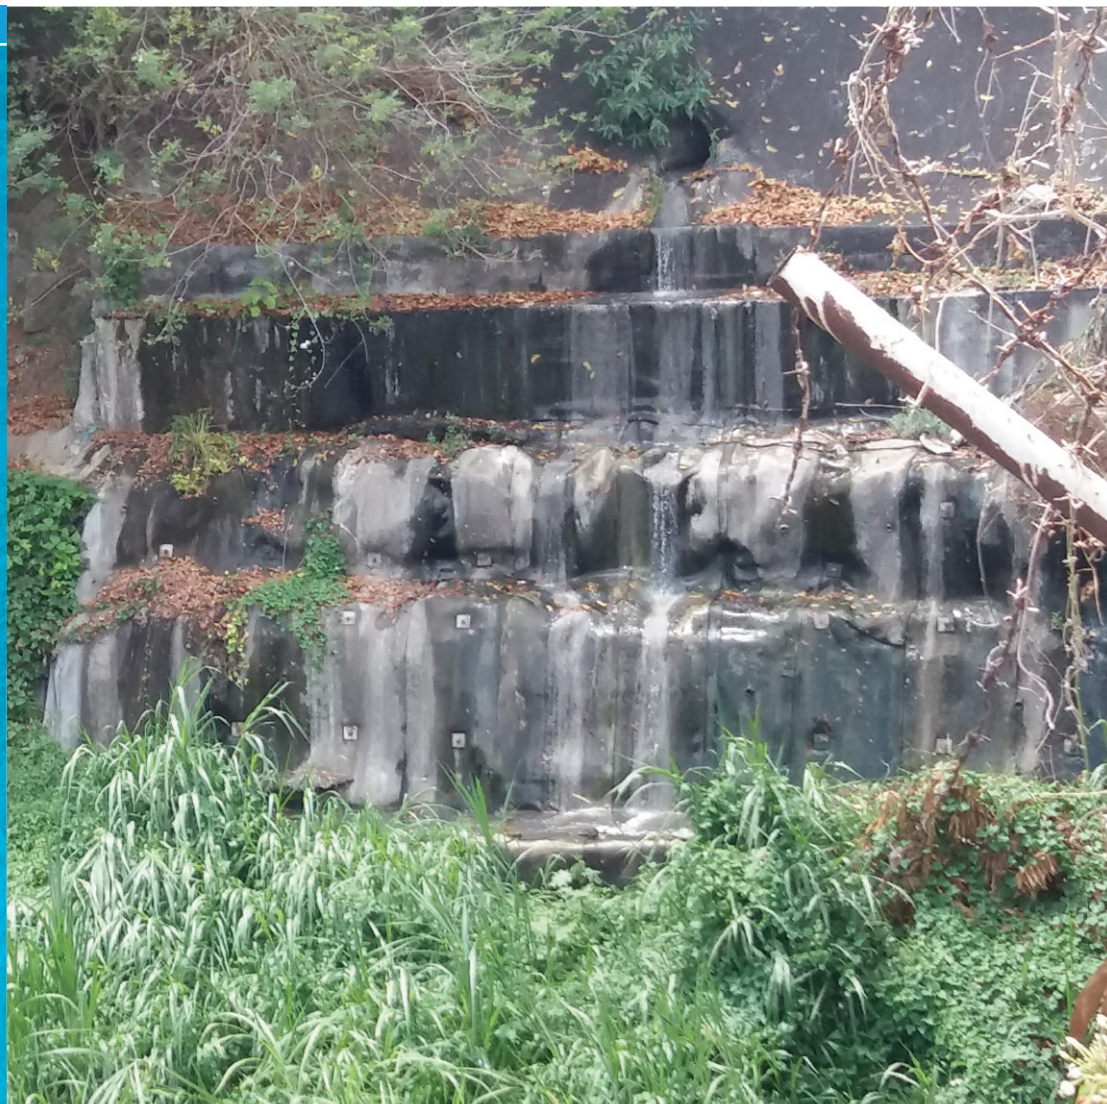
The completed installation

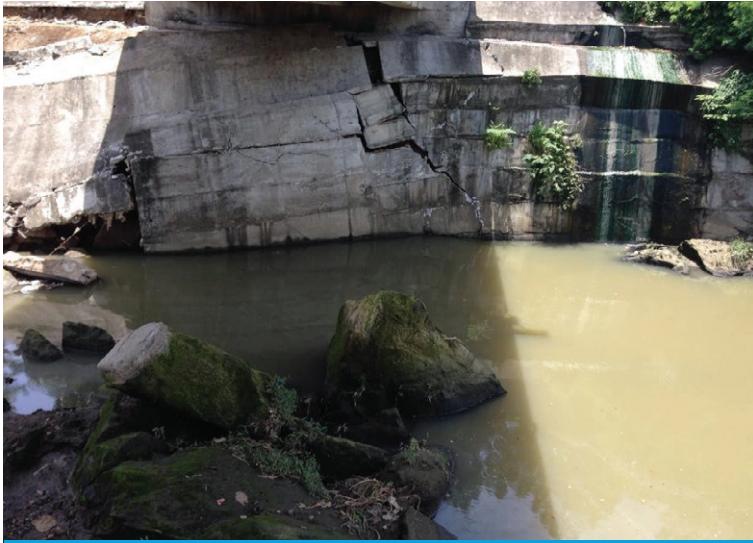
Existing damaged concrete lining

The works were carried out by PGA - Earth Structure Solutions, Inc. towards the end of the Summer season, approaching the rainy season. The whole area measured from 4m to 7m at its highest point by 52.5m wide. Prior to installation, the existing damaged concrete lining was removed along with the manual removal of any vegetation at the upper section of the slope.

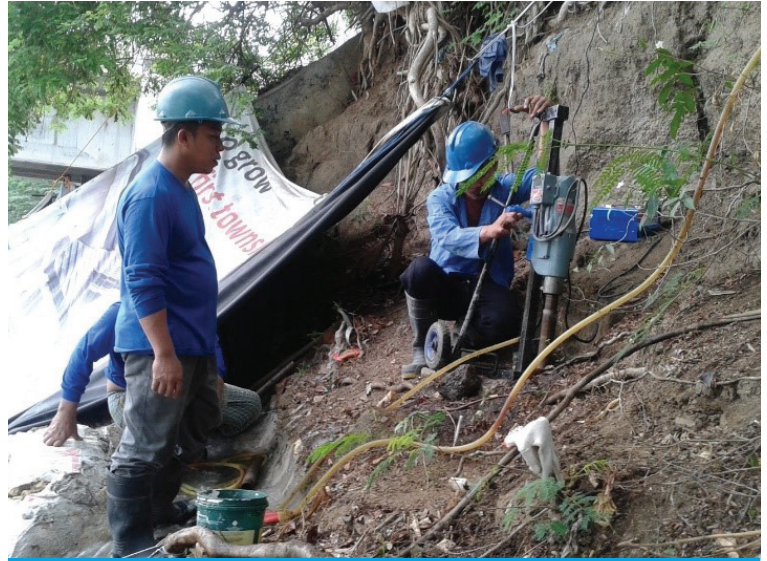
Holes were pre-drilled for the grouted anchors

The was CC was laid vertically with 100mm overlaps. Grouted anchors were installed (1.5m x 16mm Ø) for additional stability on the slope. Clear-Fix sealant was used at each overlap with stainless screws at 200mm centres to joint the material. Steel pegs were used to fix the Concrete Canvas® into the anchor trench, this was then backfilled. Hydration was achieved via an ordinary garden hose pipe and nozzle combination.

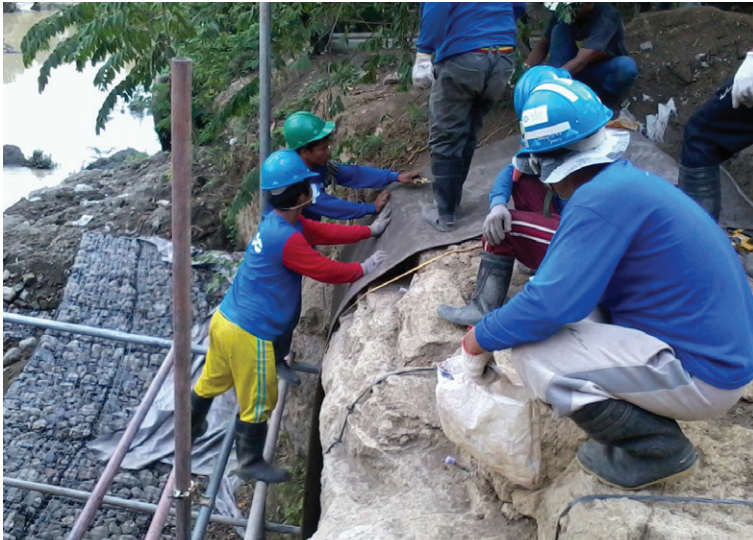
The CC was pegged into the anchor trenches

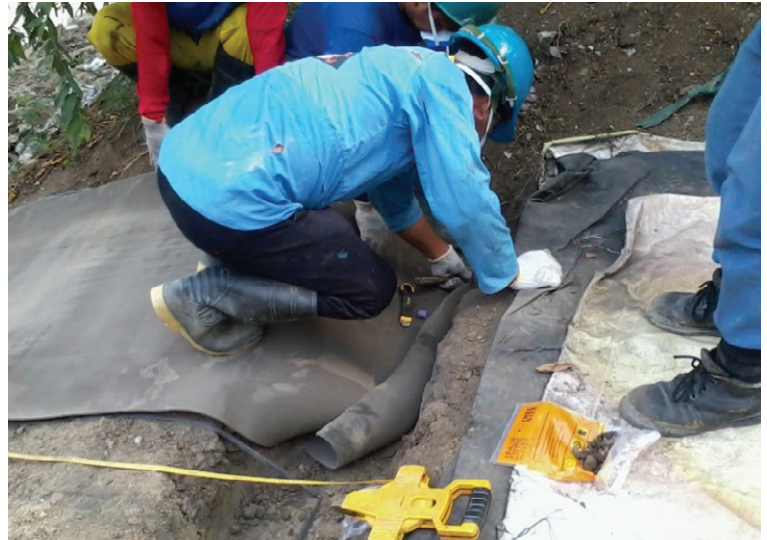
CC will accommodate any variations in profile

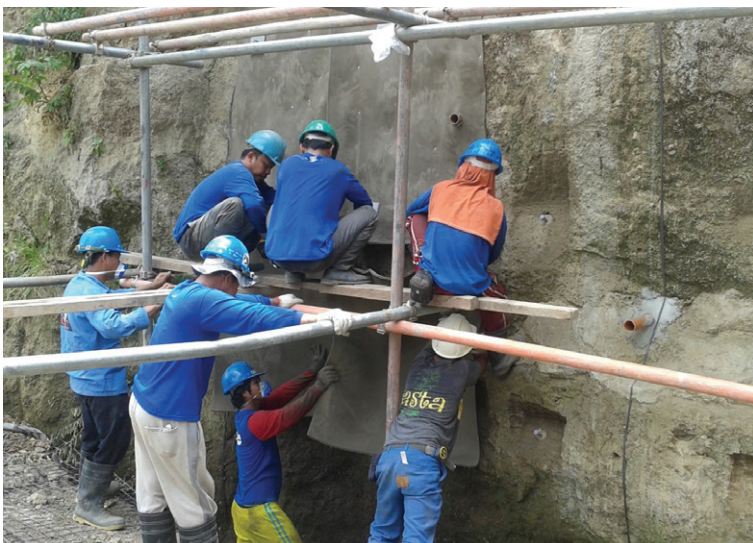
The CC was installed around the anchor protrusions

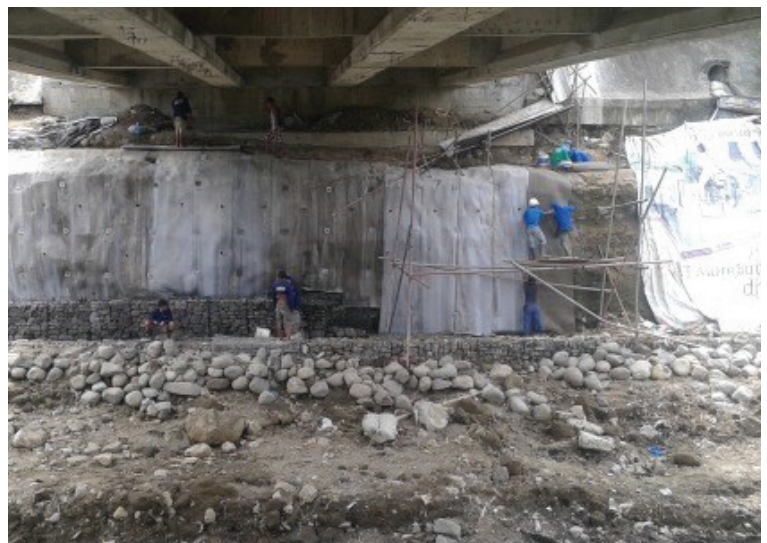
The installation nearing completion

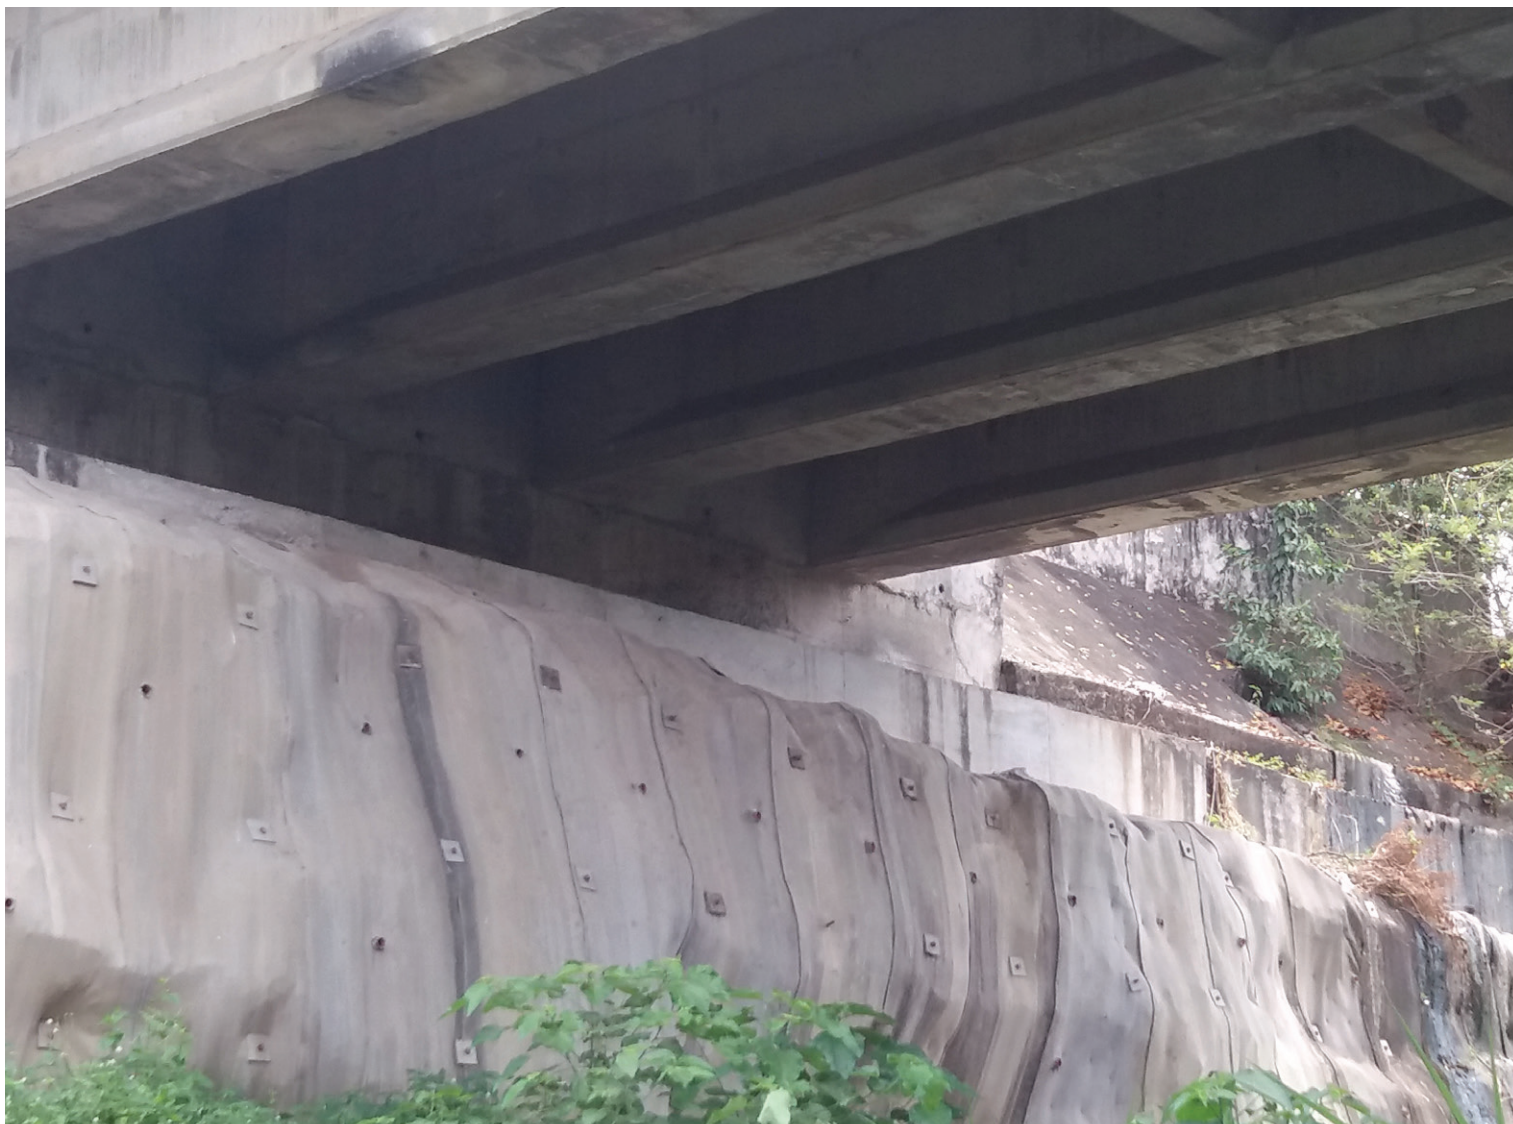
The complete installation, a further proposal including the use of CC was required for the other side of the bridge

The project was a success. On completion, a proposal was required for the other side of the bridge as Suntrust Properties wanted to plan preventative protection measures since viewing the completed installation.
