SLOPE PROTECTION

Project Introduction

In August 2020, Concrete Canvas® (CC) GCCM* was specified as a slope protection solution at a site situated near a railway line east of Sävast station in Sweden.

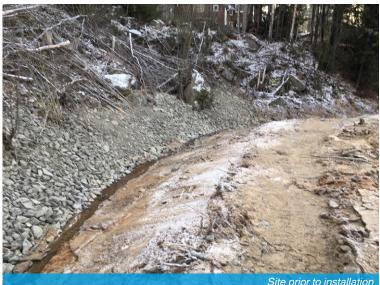
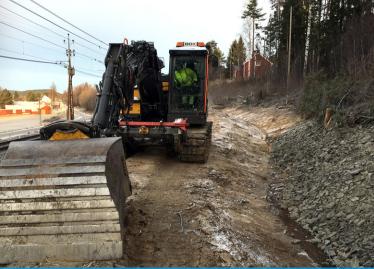
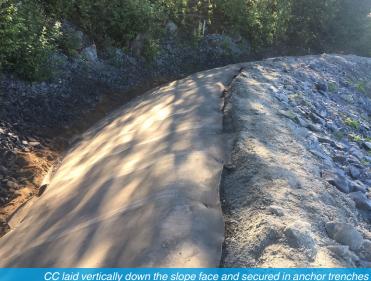
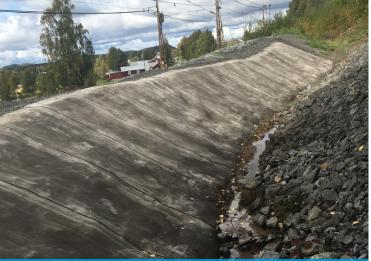
Prior to installation of CC any vegetation, stones and rocks were removed from the slope's surface and a fine, sandbased material added to provide a smooth surface on which to install the CC.

Bulk rolls of CC8™ were delivered to site and laid vertically down the face of the slope, with each subsequent layer positioned so as to overlap the last by 100mm. The CC was jointed along the overlaps using 30mm stainless steel screws positioned at 200mm centres, with the edges of each CC length secured within pre-dug anchor trenches using 250mm J-Pegs.

Once the installation was completed, the CC was hydrated and the anchor trenches backfilled to prevent ingress and provide a neat termination detail.

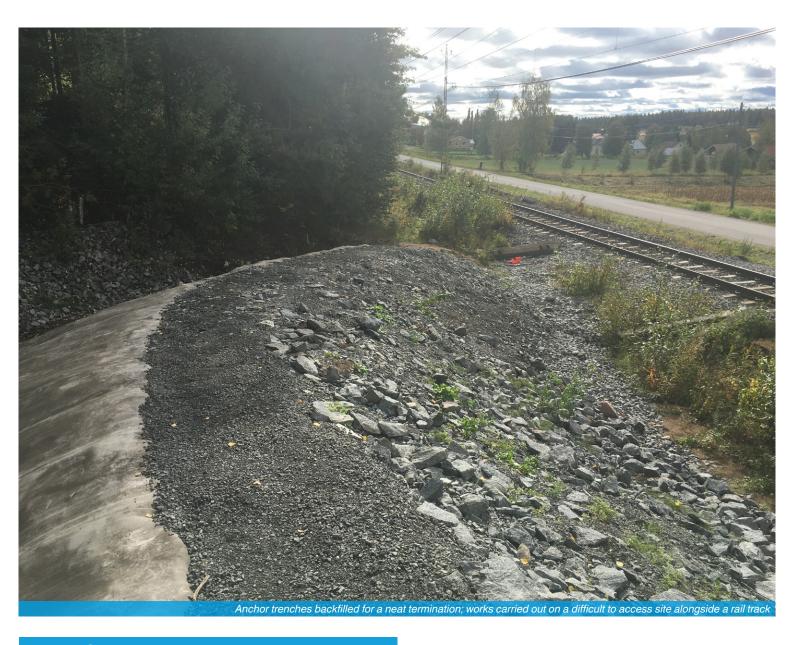
Project Summary

A total of 125m² of CC8[™] was installed by a three-person team (including the tractor driver) in just over 16 hours. The client is happy with the outcome of the project and will be closely monitoring the installation site during the winter-spring transition period next year to establish how well it performs in preventing embankment saturation.
