CC5™ Batched Rolls

Route FT68 KM37.9, Jalan Bentong Lama, Gombak, Selangor, Malaysia

Daengco Sdn Bhd

CC5™ was used to protect a slope which had been damaged by erosion caused by rain water flowing down the slope.

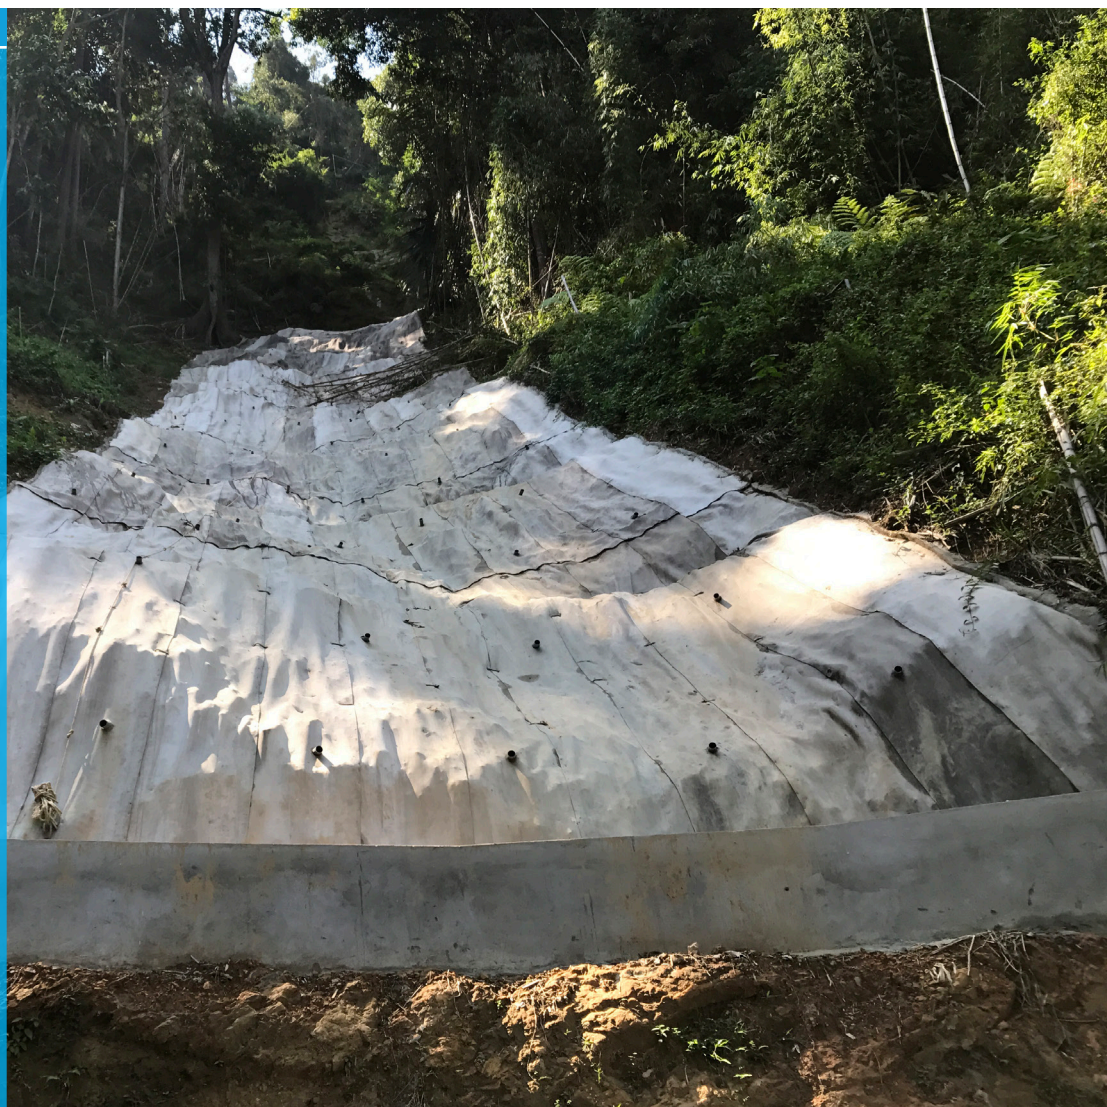
Completed installation above Route FT68 KM37.9 in Sengalor, Malaysia

In May 2017, Concrete Canvas® GCCM* (CC) was used to protect a slope above Route FT68 KM37.9 in Selangor, Malaysia. The slope formed part of a cliff face, adjacent to the road, and had over time, scoured to form a natural collection point of surface rainwater, channeling the water directly onto the road below. This had caused severe erosion over time and during the rainy season, mud, rocks, fallen trees and rain water made the road impassable to vehicles.

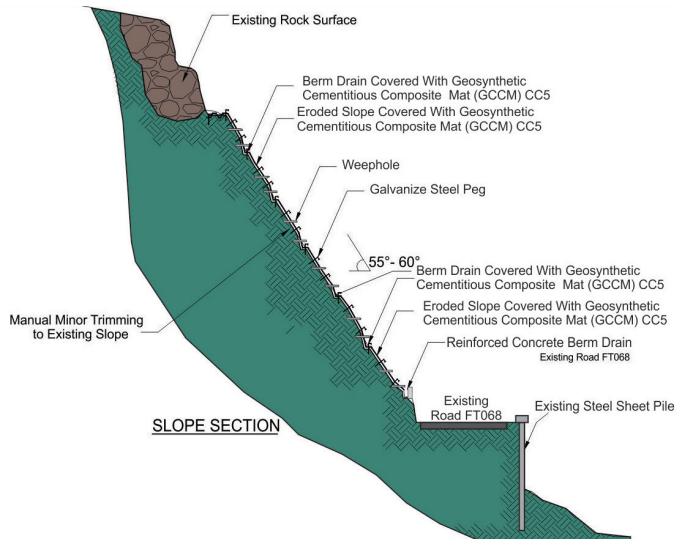
Diagram of slope cross section

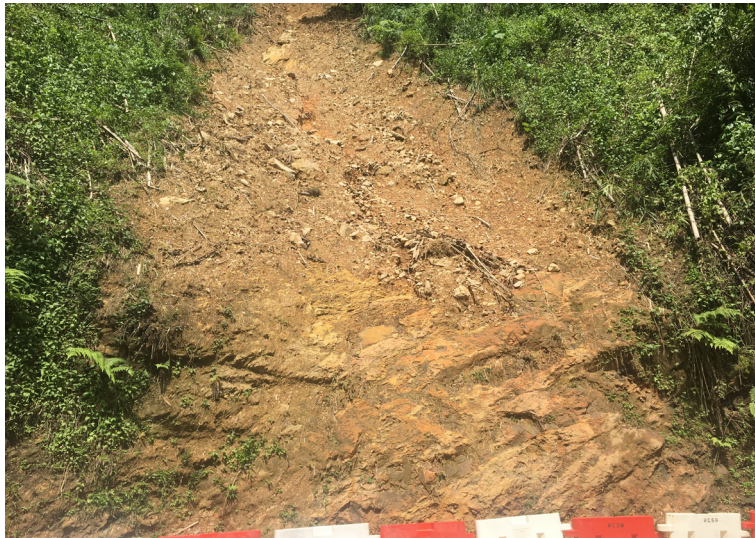
Slope prior to ground preparation

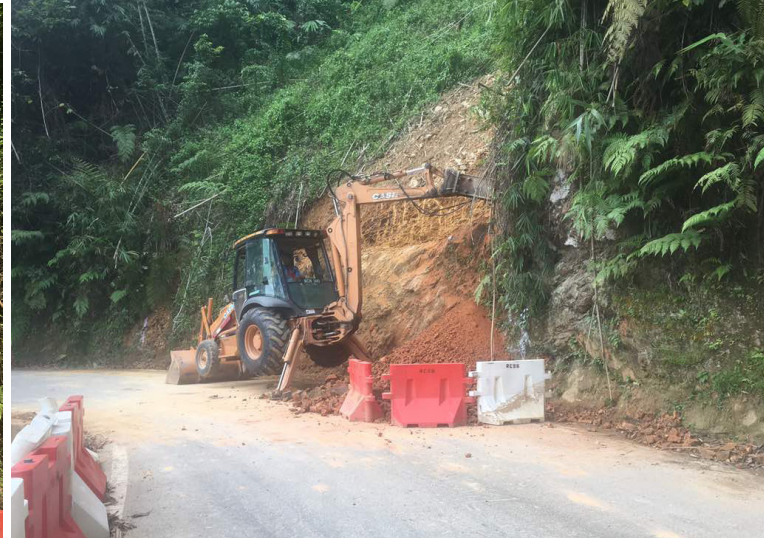
Debris was removed from the slope prior to installation

In preparation for the installation, debris was removed from the slope and the CC was delivered to site in man-portable batched rolls of CC5™. Batched rolls were specified due to the difficult access on site and steepness of the slope. These were placed at staggered starting points up the slope to reduce manual handling once work had begun.

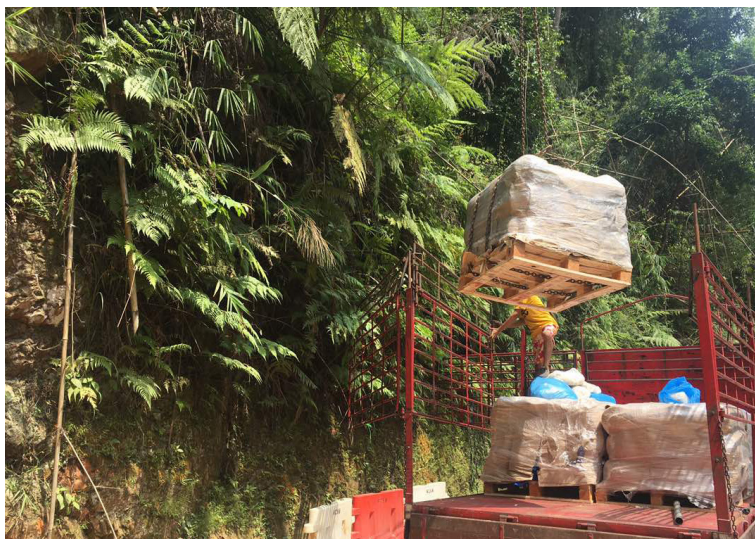
The CC was delivered to site in man-portable batched rolls

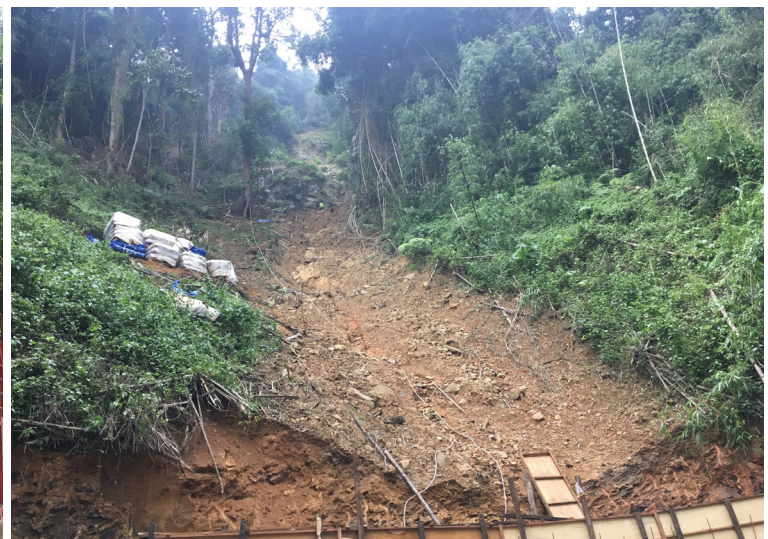
The CC was placed at intervals up the slope to minimise manual handling

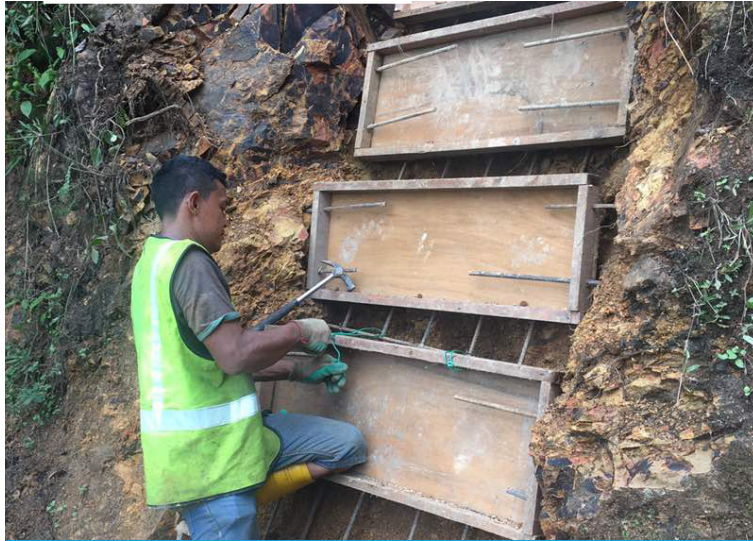
A concrete berm drain was also created as part of the works

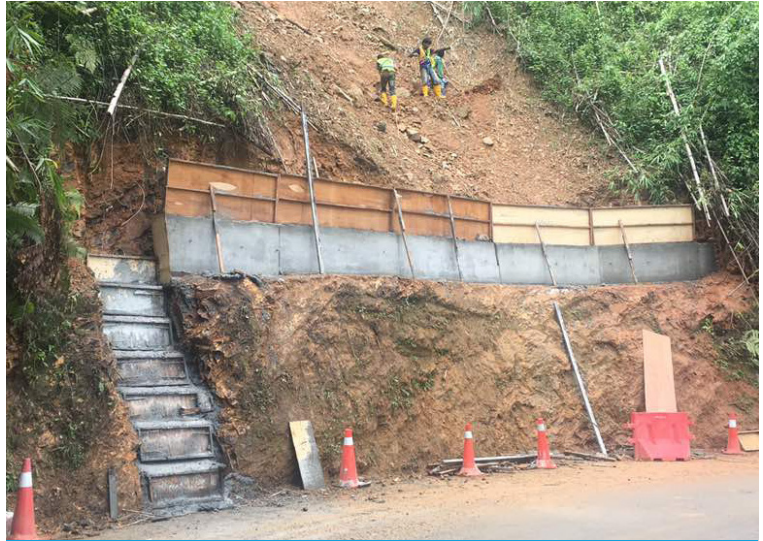
The berm drain was left to set while CC works were carried out

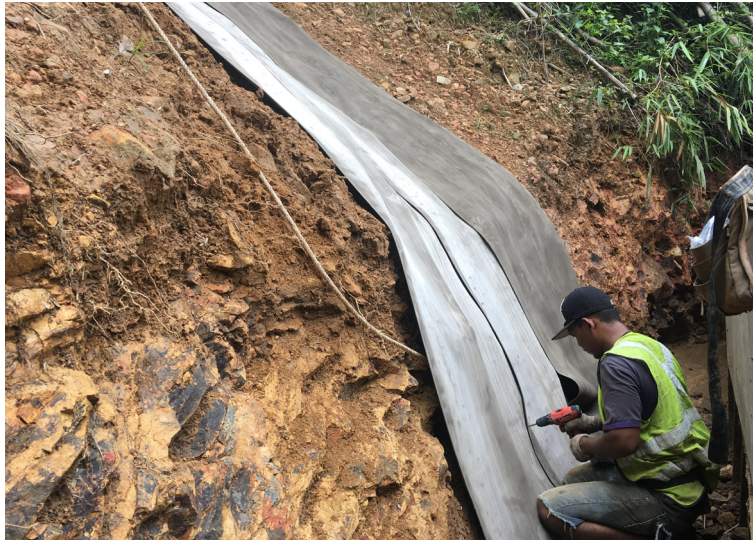
The CC was laid and overlaps secured using screws

Starting at the toe of the slope, which was wider than the crest, the team worked their way across and up the slope, laying the pre-cut batched rolls with layers overlapping by 100mm. The layers were fixed at the overlaps by 200mm using stainless steel screws at regular intervals to prevent ingress. The CC was then fixed to the substrate using steel ground pegs. As part of the works, 9 berm drains were also dug prior to installation, and weep holes created at 2m intervals to release any build-up of hydrostatic pressure within the slope to mitigate the risk of deep slip. Once installation was complete, the material was hydrated.

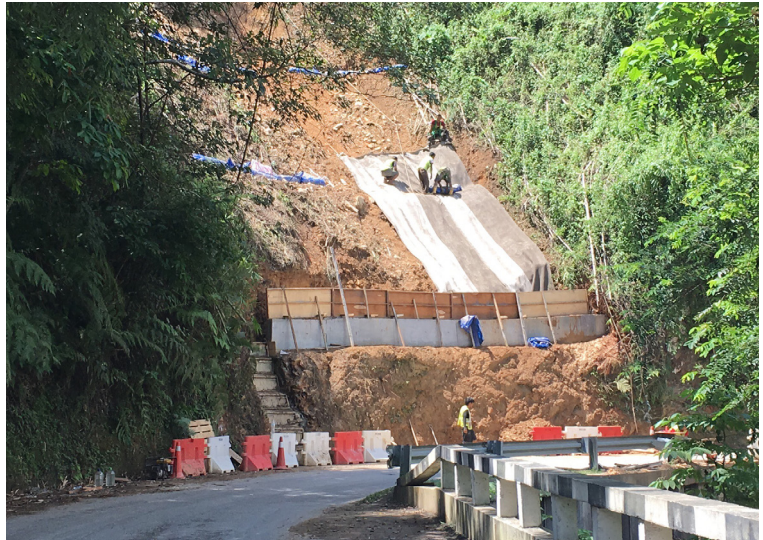
The team started at the toe of the slope, working across and up

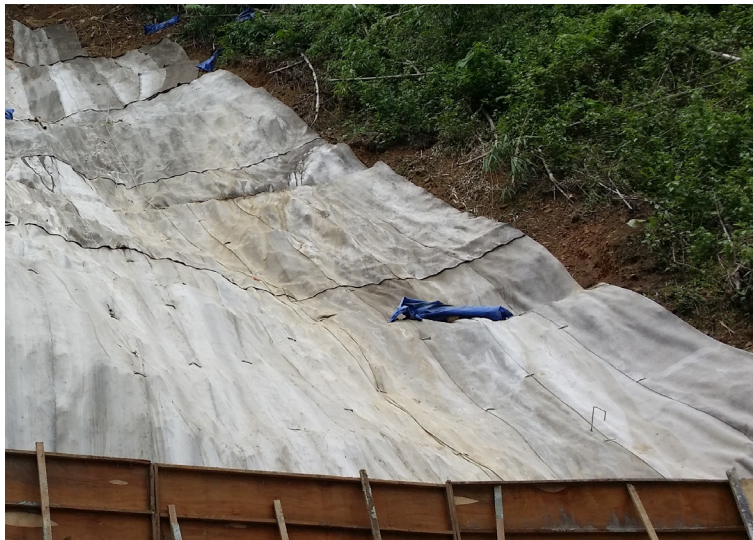
The CC was fixed to the substrate using ground pegs

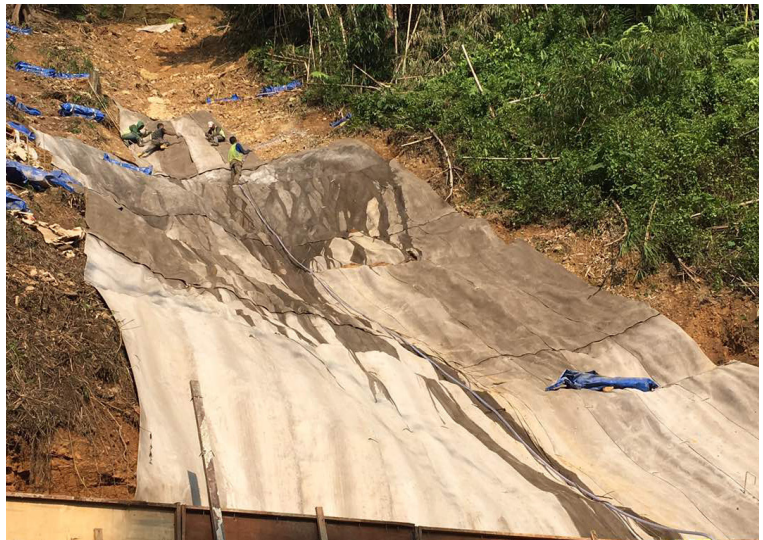
The CC was hydrated following installation

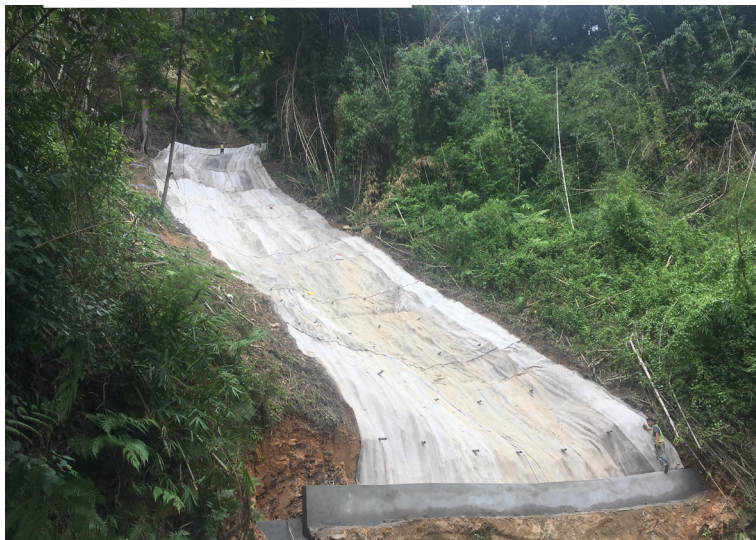
A full view of the completed slope from the road

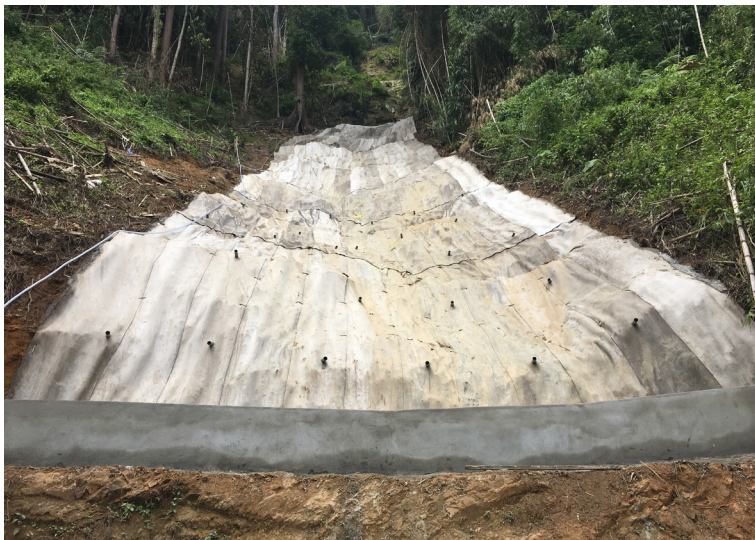
A view of the completed slope from the toe

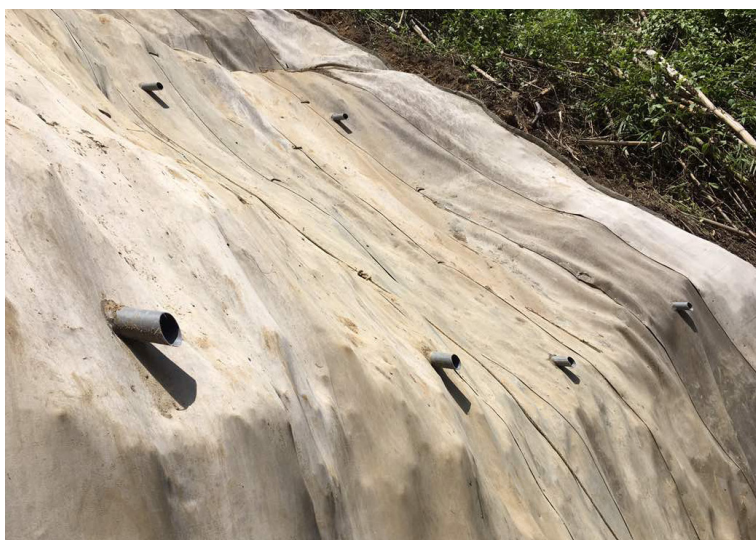
The CC was cut to fit around the installed weep holes

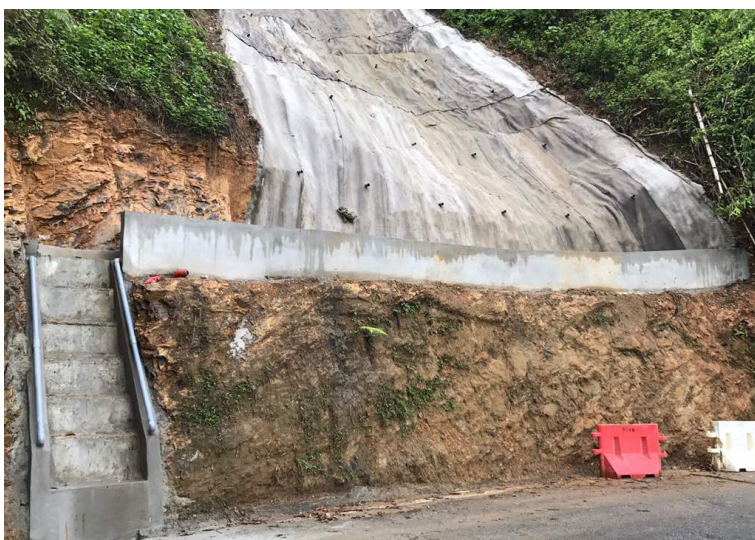
An overview of the completed berm drain system

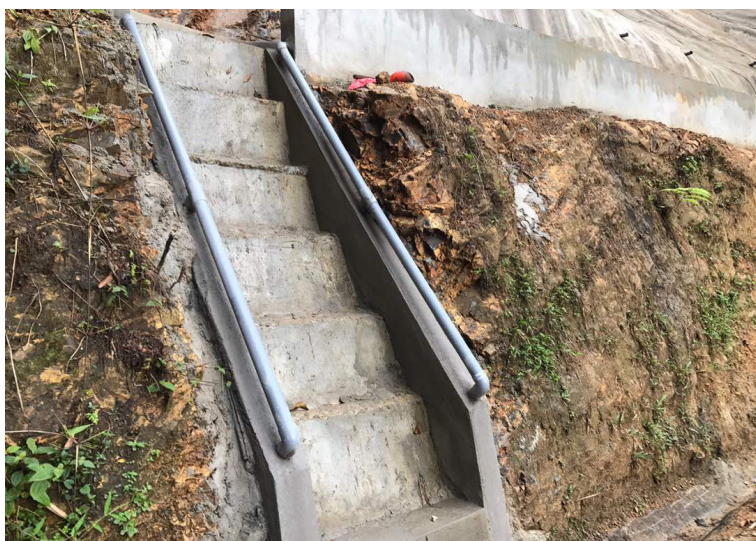
Close up of the concrete berm drain system

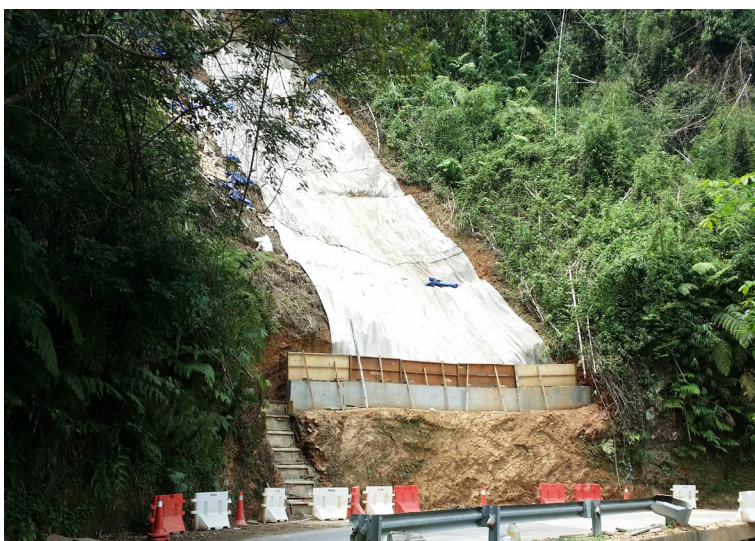
View of the completed slope from the road, before removal of berm supports

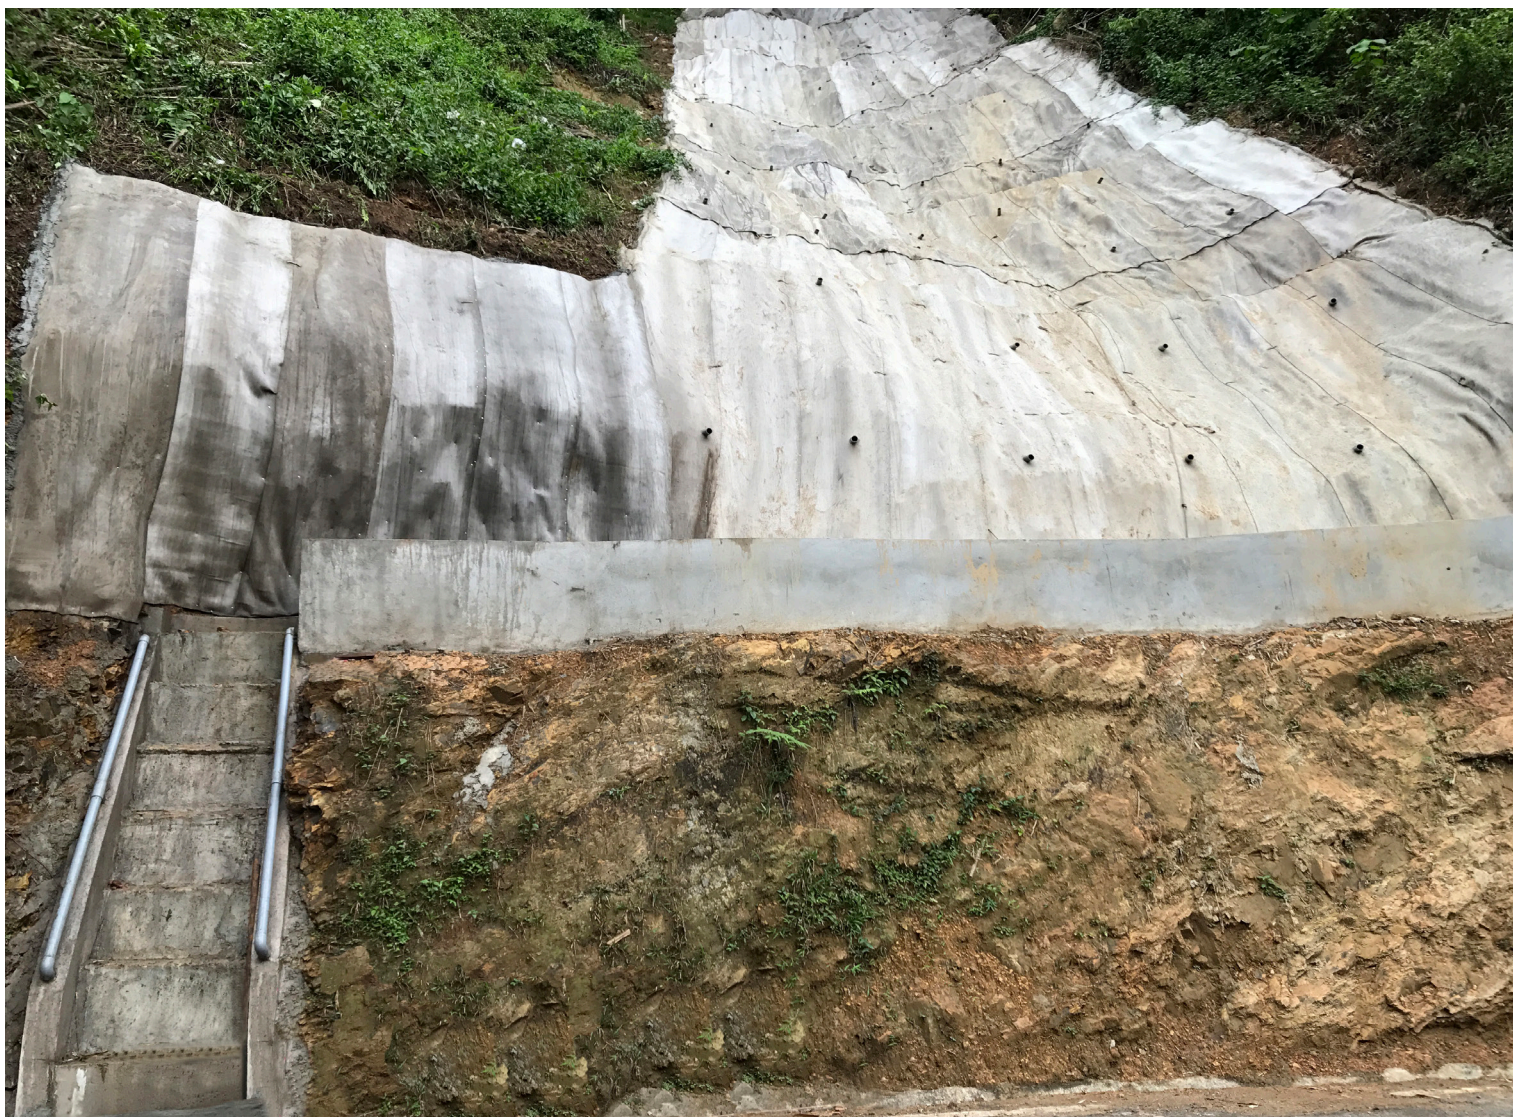
A view of the completed slope from the road below

In total, 1,000m² of CC5™ were installed in less than 3 weeks on a site with difficult access.
