SLOPE PROTECTION

In May 2014, Concrete Canvas® (CC) GCCM* was used to provide erosion control to a supporting embankment for a bridge at a water injection oil and gas site in south Iraq. The erosion was the result of environmental weathering, predominantly rainfall, causing surface slip which threatened to destabilise the bank. A low cost and rapid solution was required; a concrete slab was considered but it would have been more expensive and time consuming.

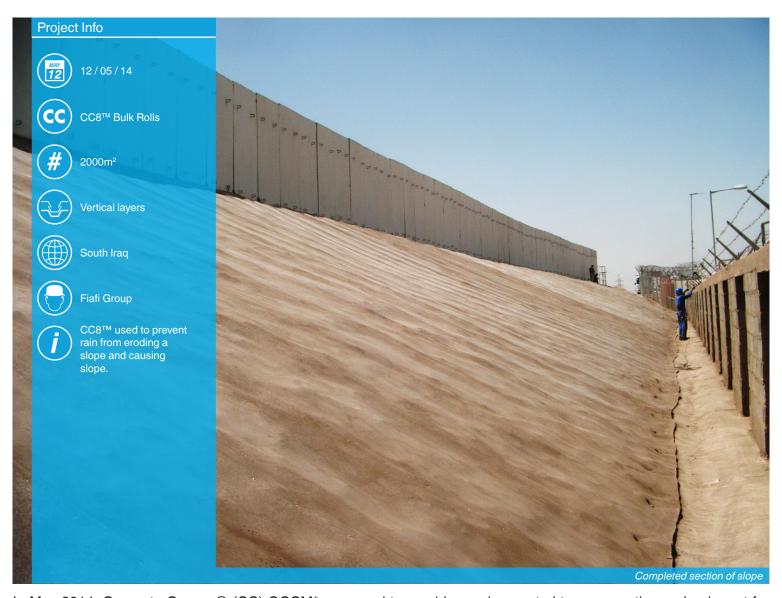
Installation was carried out by Fiafi Group. Prior to the installation of 8mm thick CC (CC8™), loose rock was removed and the surface levelled using a granular type 1a sub base, that was compacted and watered. Bulk rolls of CC were delivered to site and lifted using a mechanical digger, before being unrolled and cut to length using a utility knife. A drainage ditch was created at the toe of the slope, before the lengths of CC were positioned at the crest by the installation team and unrolled down its length. Each layer was overlapped by 100mm, pegged down and fixed to the existing wall using masonry screws. The CC was then hydrated along the overlap, sealed with CT1 sealant and screwed at 50mm intervals. The rest of the CC was then hydrated using a bowser and hose with a sprinkler attached.

2000m² of CC8™ were installed by 8 people (including supervisors) in just 2 days, instead of the 7 it would have taken with conventional methods. Furthermore it was installed in 40° C heat and 95% humidity, so the speed of install reduced the risk of dehydration and sunburn for the installers. The site was also difficult to access with plant equipment so cutting CC to length and transporting it by hand was logistically much easier.
