Project Info

CC5™ Bulk Rolls

Shelly Beach,
South Africa

Project Introduction

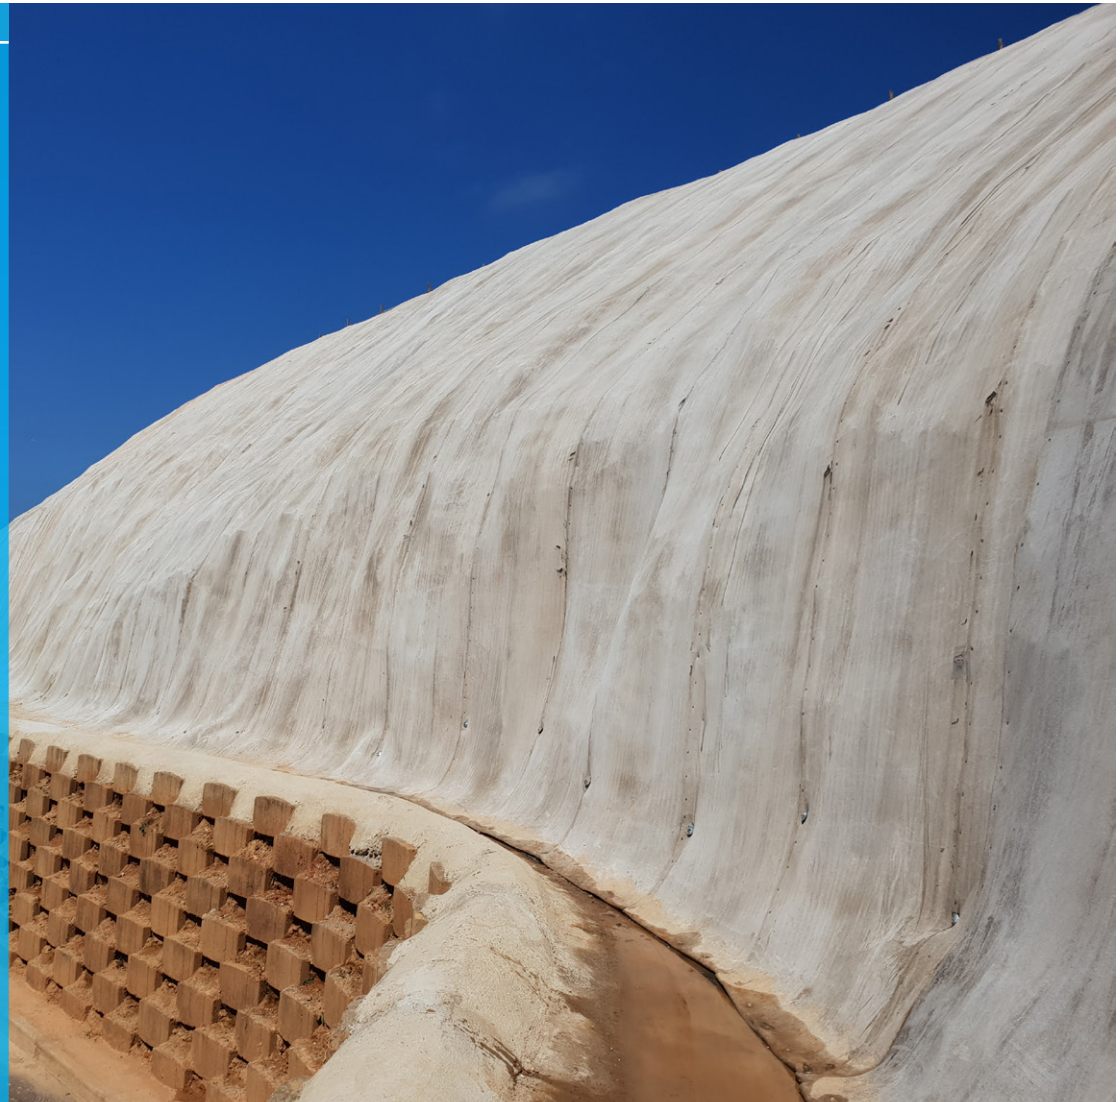
CC was used to provide an erosion protection solution to a slope face to prevent material falling onto the access road below

Completed installation at Southcoast Mall in South Africa

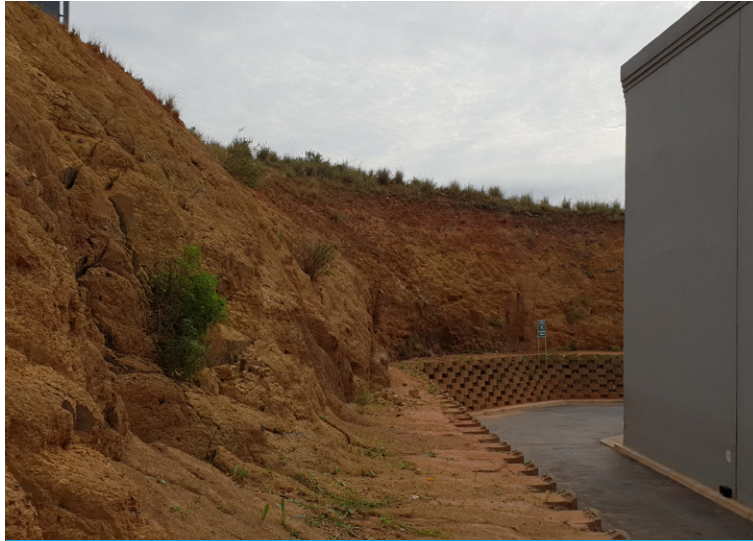
Proximity of access road to slope

The access road around the north west corner of the Southcoast Mall is adjacent to a steep cutting. This cutting experiences significant erosion caused by rain with detritus tending to collect on the access road below it, restricting vehicular access.

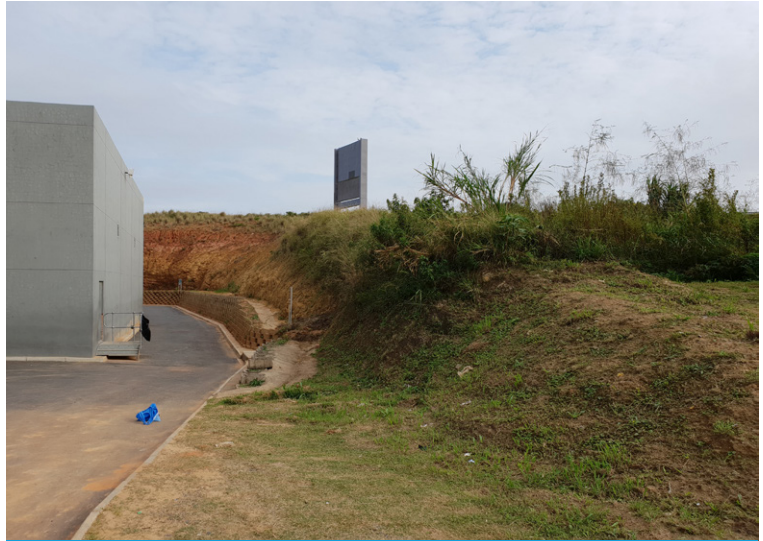
Regular scour meant vegetation couldn't grow in many areas

The existing slope was very steep at a gradient of approximately 1:0.5 initially, then flattening off until it reaches the natural ground line about 20m above the access road. The material between the steep section of the cutting and natural ground line is highly erodible with ground water weeping through the face of the slope almost continuously during the rainy season. The slopes were sparsely vegetated as a result and continuously prone to scour.

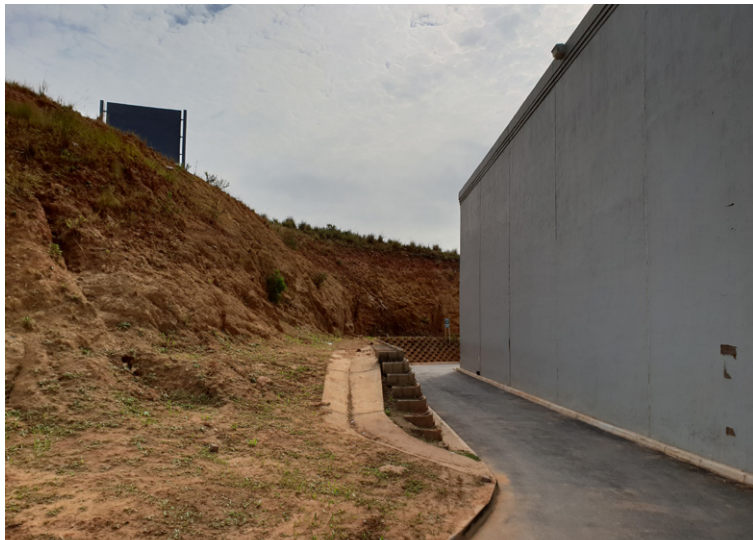
Without a solution, there was risk of slope material blocking the road

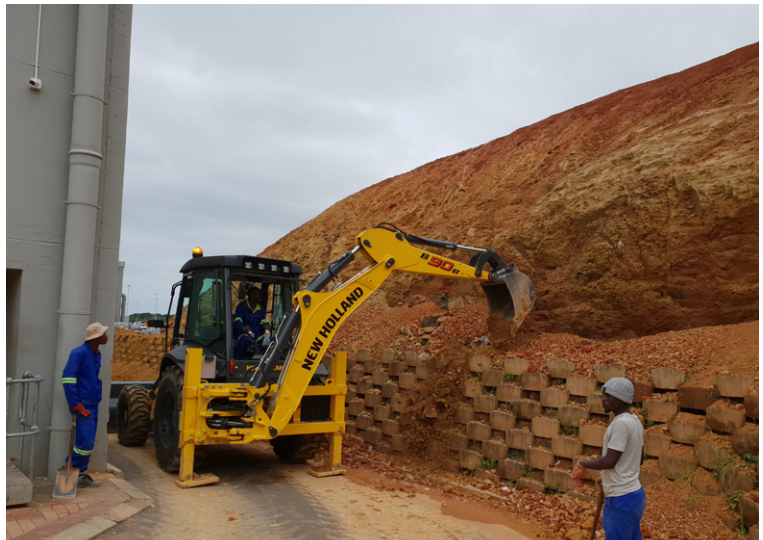
Slope face was trimmed for a smoother profile

Prior to installation, the slope was de-vegetated and prepared, and anchor trenches were dug at the crest and toe. A layer of 210g/m² Bidum A4 geotextile was then laid from the crest anchor trench to the toe v-drain termination.

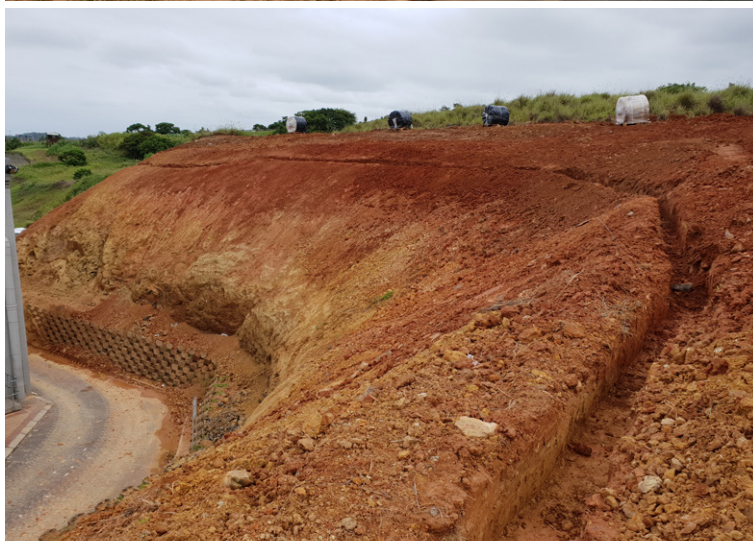
Anchor trenches were prepared at the crest

The CC installation was terminated at the crest of the slope within the 300mm deep anchor trench and pegged at the overlaps with 300mm long galvanised, round-head pegs. The anchor trench was then backfilled with a non-erodible cement-stabilised gravel and compacted with a mechanical rammer. At the bottom of the slope, the material edges were folded over to form a 100mm wide knuckle termination and then fixed on the top edge of the V-drain with mechanical fixings. It was ensured that the CC5™ material conformed to the variable profile of the slope face by inserting further ground pegs through the overlaps where required.

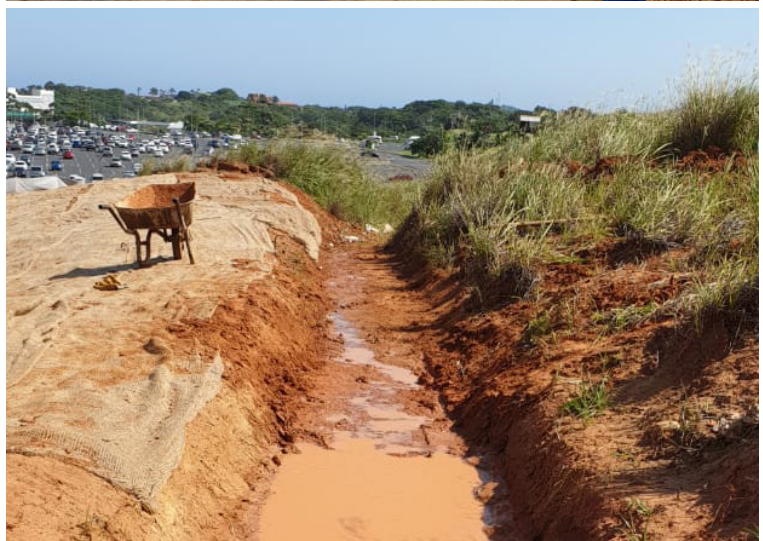
Cut-off drain prepared between cutting and natural ground level

Another consideration was the surface water run-off from the land between the Mall property and the adjacent highway. In order to manage this run-off, a cut-off drain was required at the transition from the shallow cutting to natural ground level.

Ultimately, CC5™ was specified for the lining of the slope and was also deemed suitable for lining of the inaccessible cut-off drain.

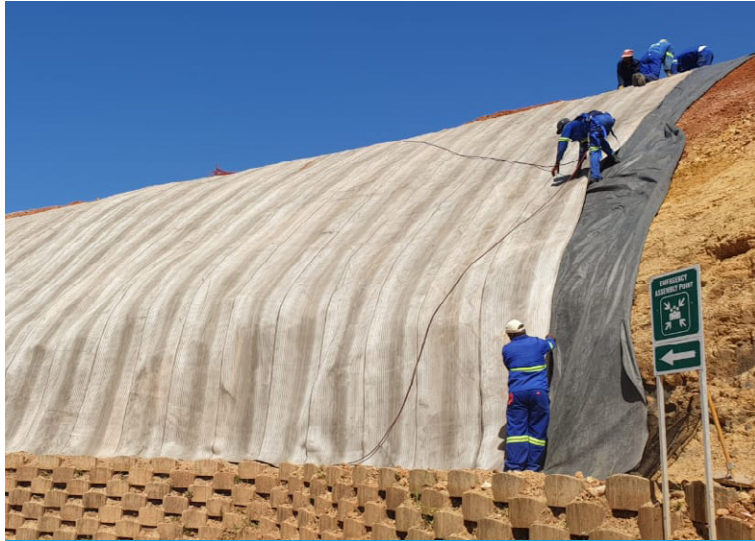
CC was laid over a geotextile layer which acted as a filtration layer

The geotextile acted as a filtration and separation layer to allow water to permeate through the fabric and run down the back face of the CC5™ whilst ensuring there was no migration of fines contained within the flow. This filtered subsoil water was then transferred to a drainage layer that spanned approximately 1m from the toe of the slope to a shallow V-drain. This allowed the daylighting of subsoil water collected in the filtration system into the drain.

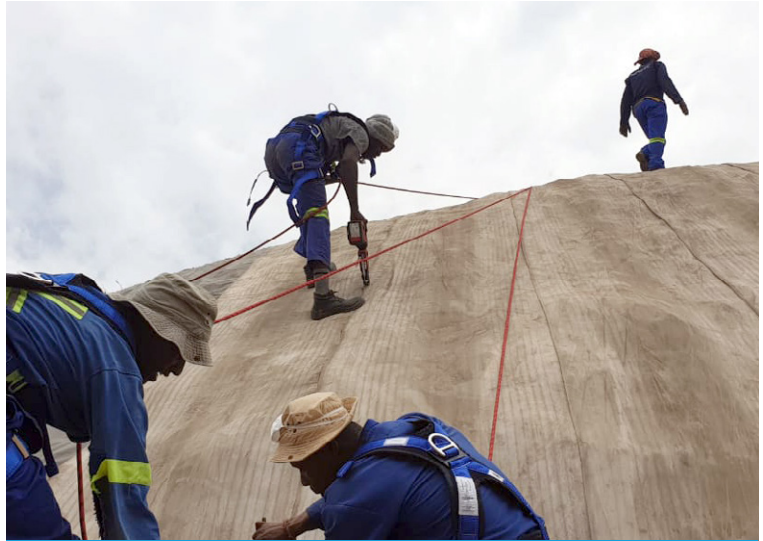
Overlapping CC layers were thermally bonded and screwed

CC5™ was laid vertically down the face of the slope on top of the geotextile with subsequent layers overlapping by 100mm. The overlaps were thermally bonded to seal the joint and then screwed together with stainless steel screws at 100mm spacing positioned 30mm from the edge of the upper layer at the overlap.

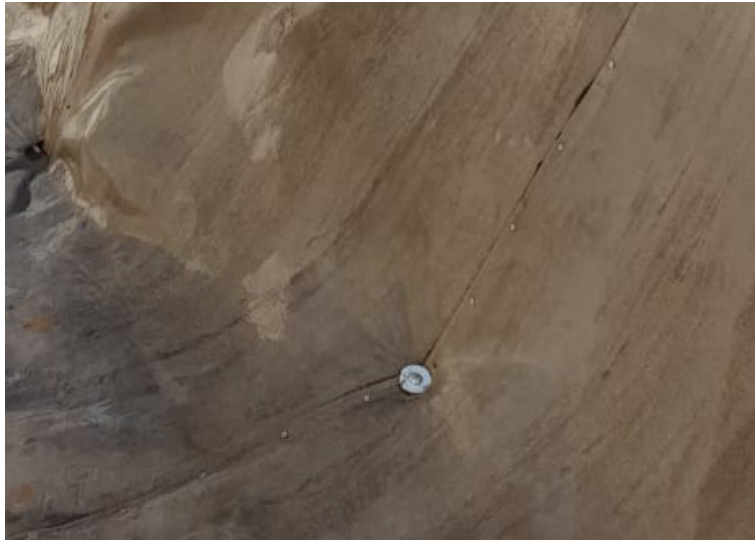
Round head pegs were used to secure CC to the slope face

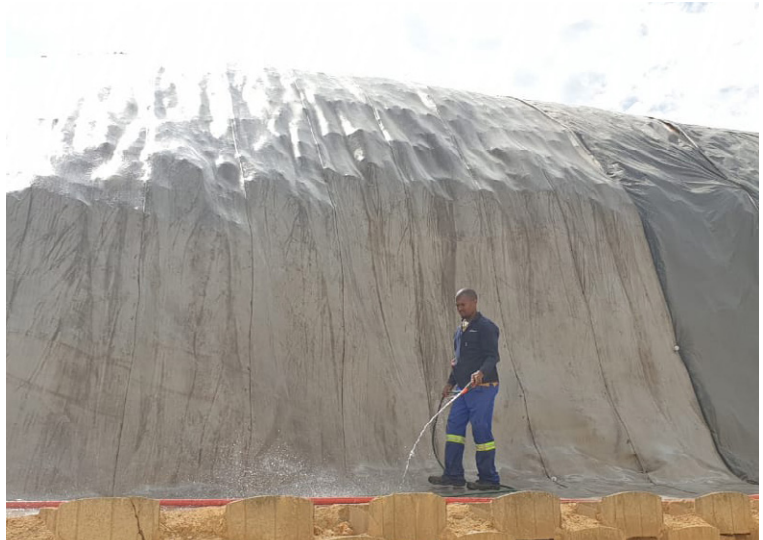
Hydration was given three times to ensure saturation in the hot conditions

CC was hydrated by spraying water onto the surface three times at 45 to 60-minute intervals until saturation. A final hydration was provided at the end of each day's installation.

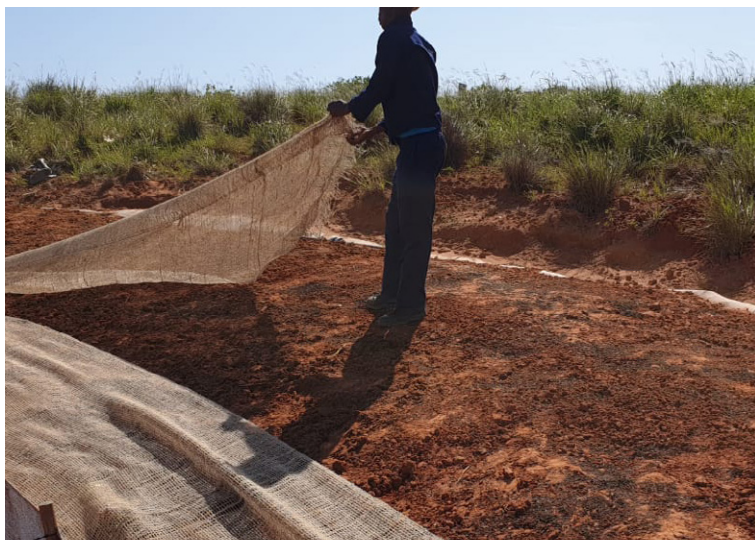
A vegetation mat was laid at the top of the slope to encourage regrowth

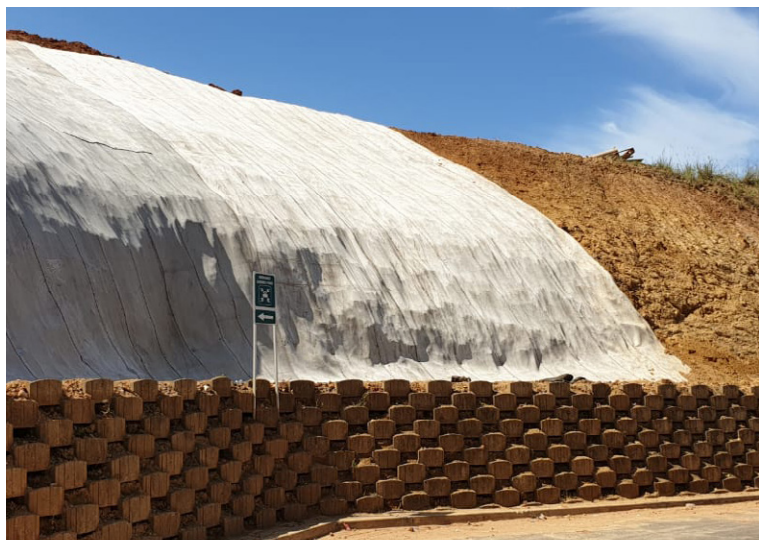
Completed section of slope installation

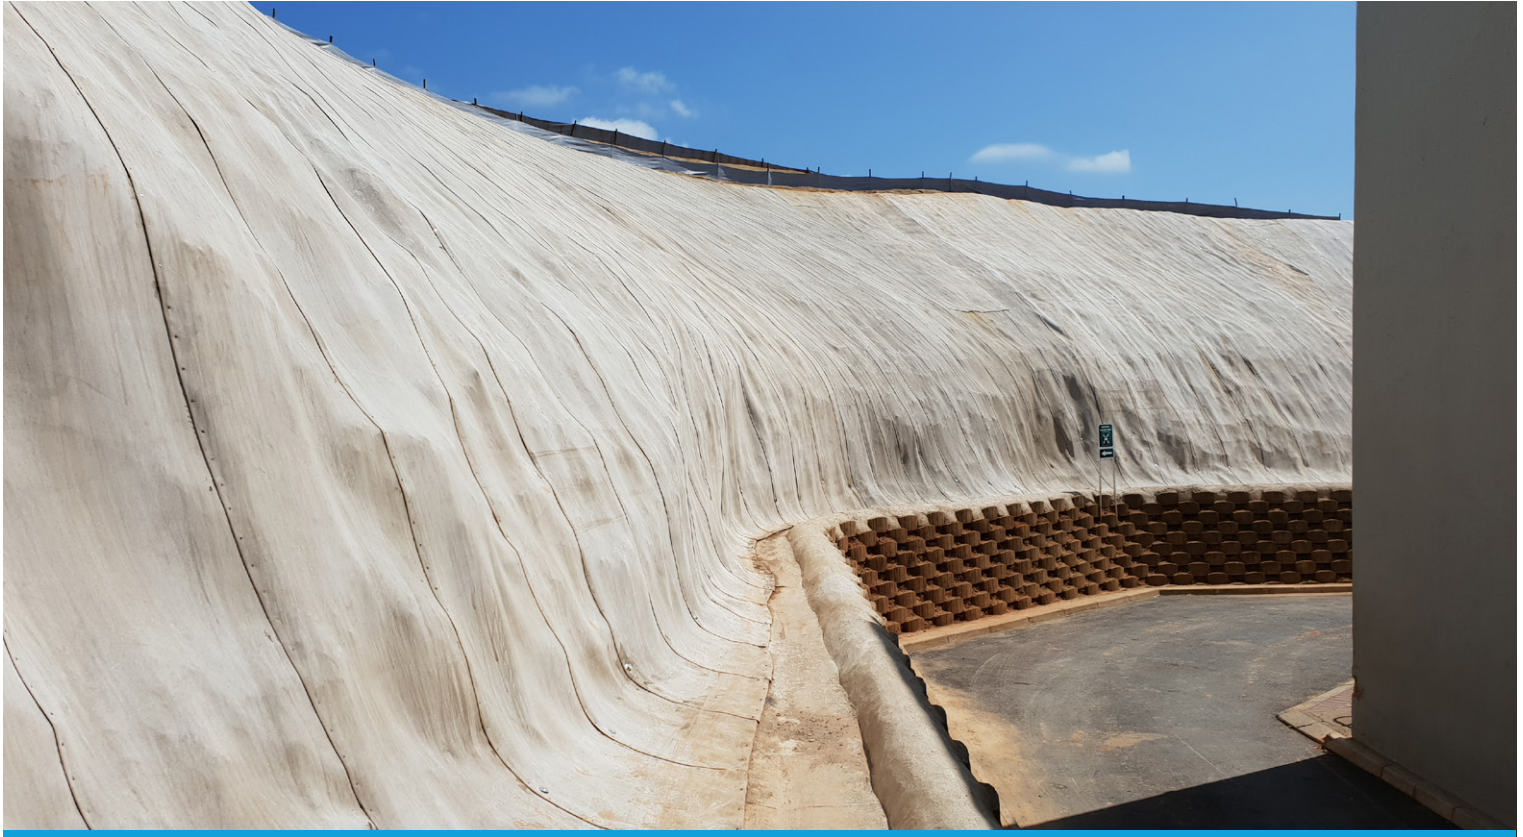
Completed CC slope protection installation in Shelly Beach, South Africa

A total of 800m² of CC5™ was installed over a period of four days by a team of six installers by rope access from the top and ladder access from the bottom of the slope. The project has been deemed a success and, as a result, CC is being considered for other projects by both client and consultant alike.
