CC5™ Bulk Rolls

Pozuelo dde Alarcón,  
Madrid, Spain

TEDECON on behalf  
of Metro Ligero Oeste

CC5™ used to prevent  
rainwater runoff  
infiltrating a slope and  
causing slip.

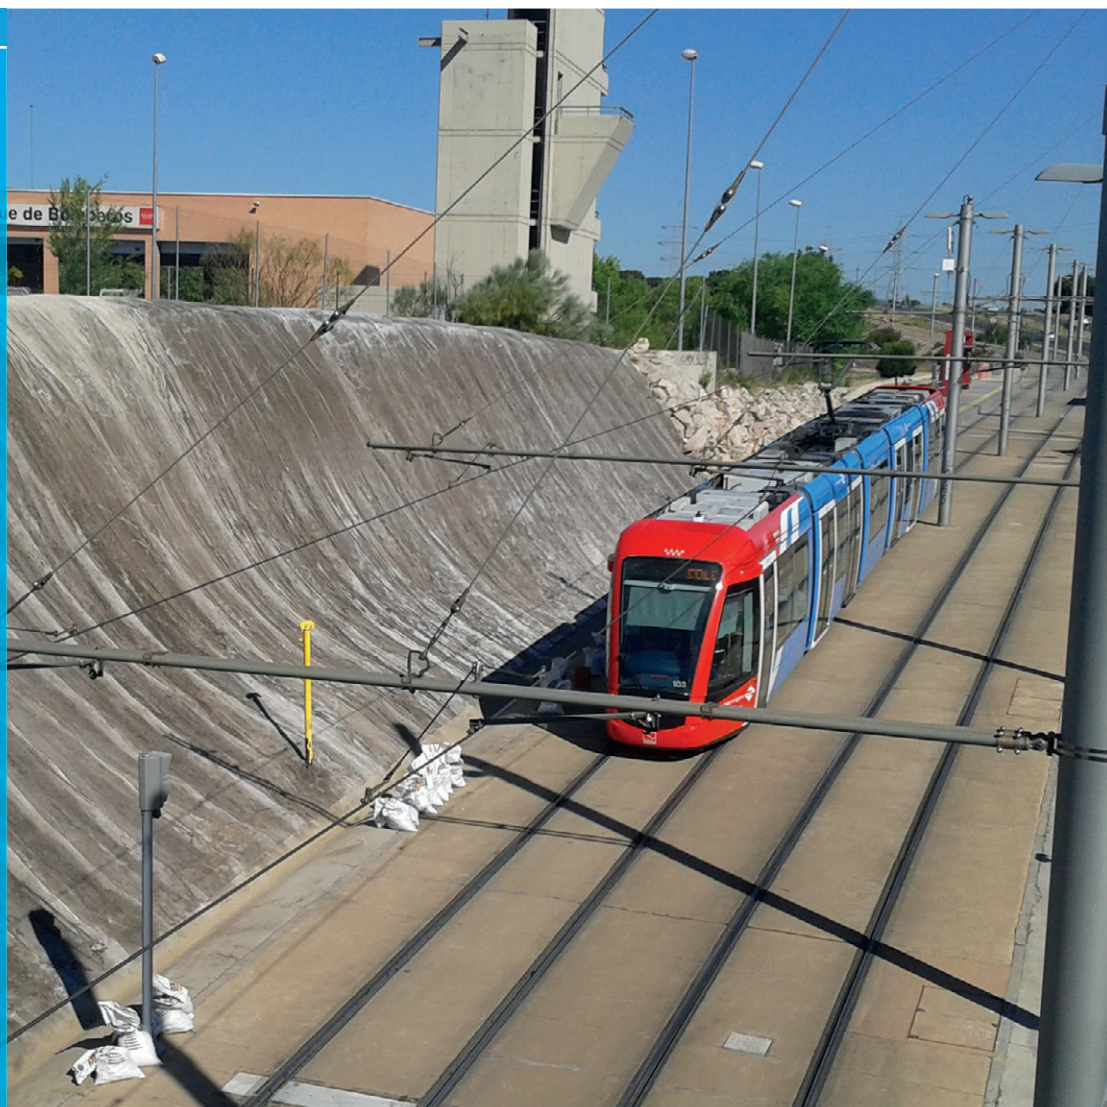
Completed installation

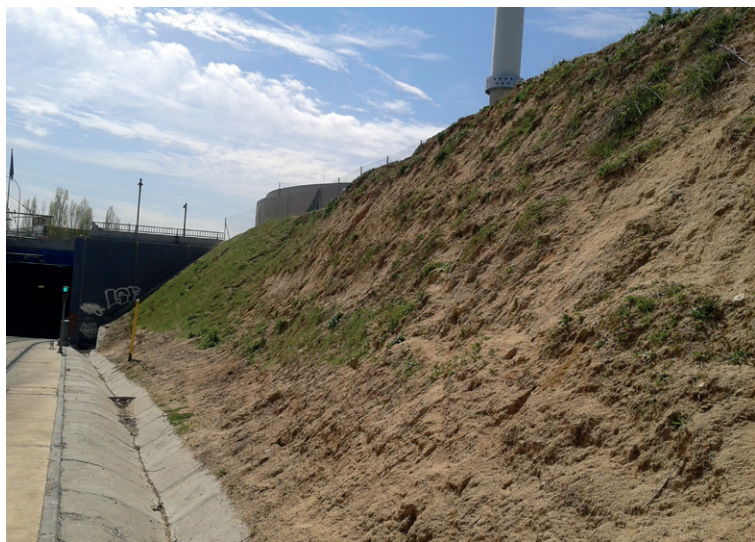
*Site before works began*

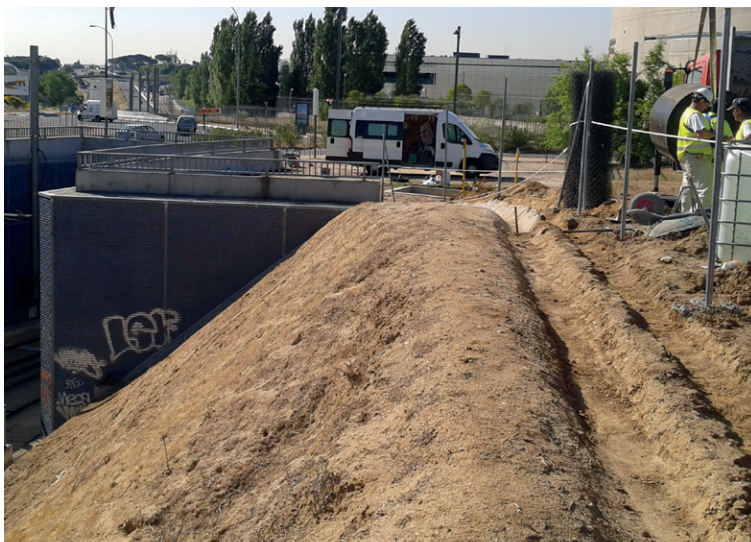
*Prepared slope, drainage channel and anchor trench*

The slope was graded and any vegetation or loose rocks were removed to ensure CC was in intimate contact with the substrate. A channel was cut into the crest of the slope, allowing the rainwater to be channelled toward the existing water management infrastructure, namely a channel running down the side of the slope and another channel at the toe. An anchor trench was excavated adjacent to the channel to prevent water ingress under the CC.

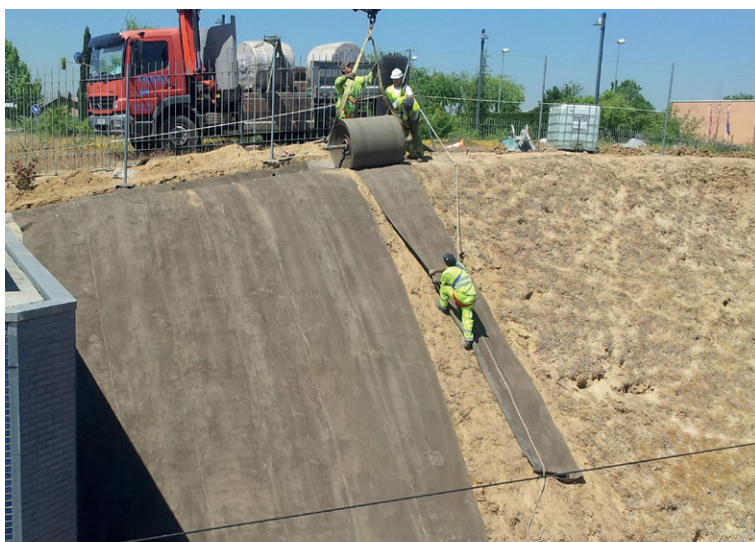
*CC5™ spooled down slope*

Bulk rolls of CC5™ were delivered to site and mounted onto a spreader beam hung from a crane. The CC was spooled transversely down the slope with an overlap of 100mm created between layers, before being fixed at the crest with ground pegs inserted every 500mm.

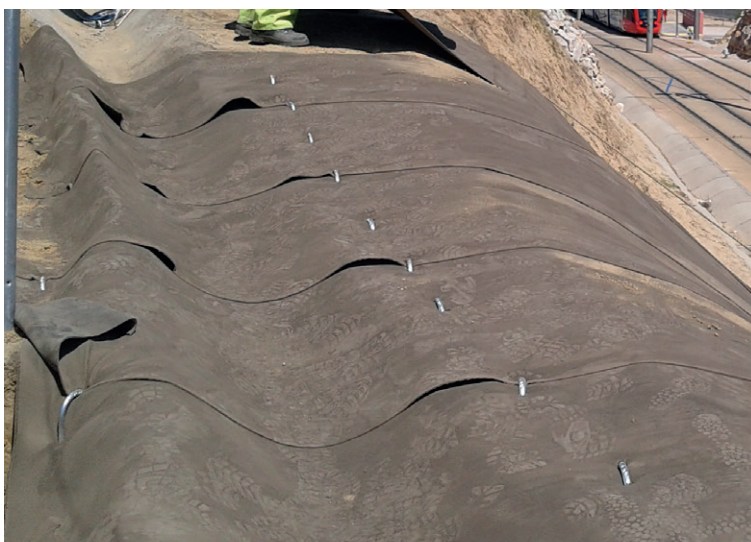
*Pegs inserted every 500mm prior to screwing*

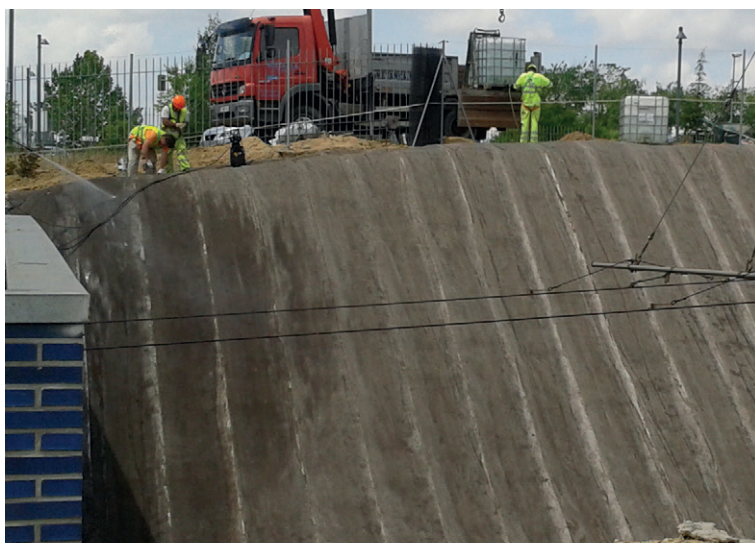
*Hydration*

The overlaps were sealed and screwed with 20mm screws at 500mm centres and masonry screws were used to fix the CC to the existing concrete infrastructure. Hydration was achieved using a 5000L water bowser and hose with spray nozzle attached. Once hydration was complete, the anchor trench was backfilled to prevent undermining of the CC. The CC was rehydrated after 1 hour to counteract the affects of surface evaporation due to the high temperatures.

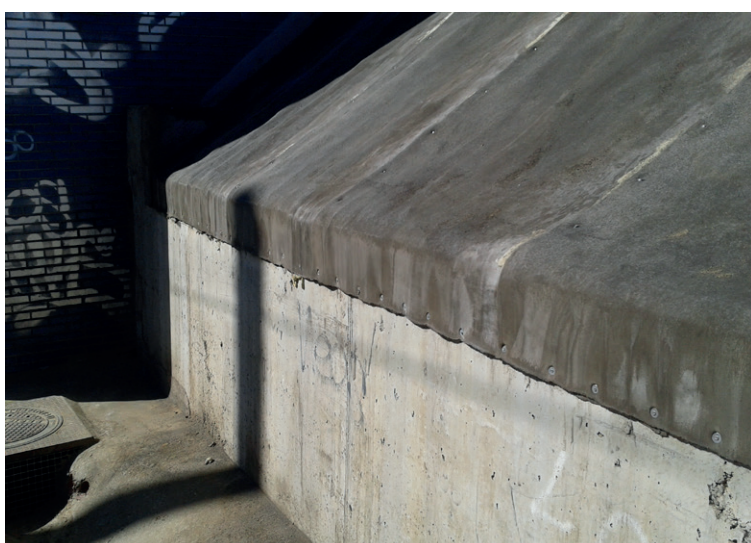
*Fixing to existing concrete infrastructure*

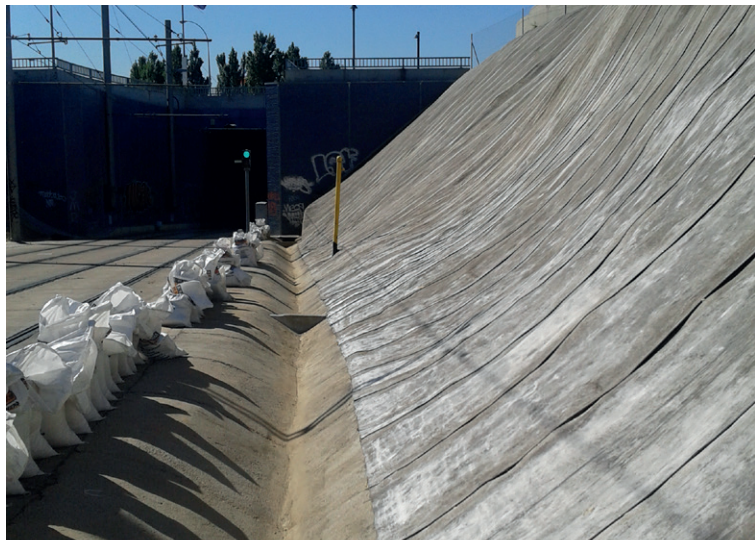
*Drainage channel at toe of slope*

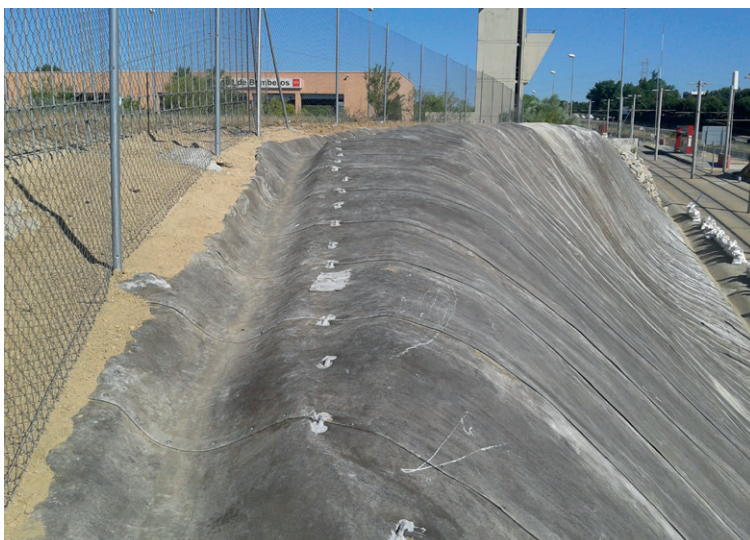
*Backfilled anchor trench and drainage channel*

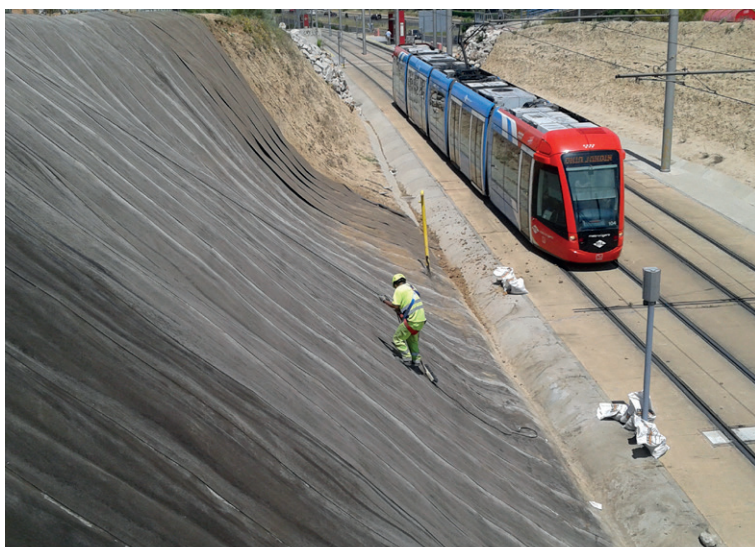
*Completed section of slope*

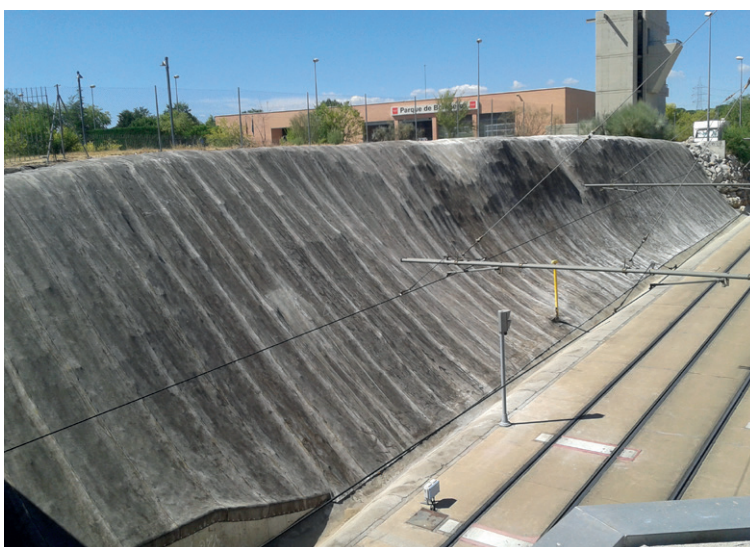
*Completed installation*

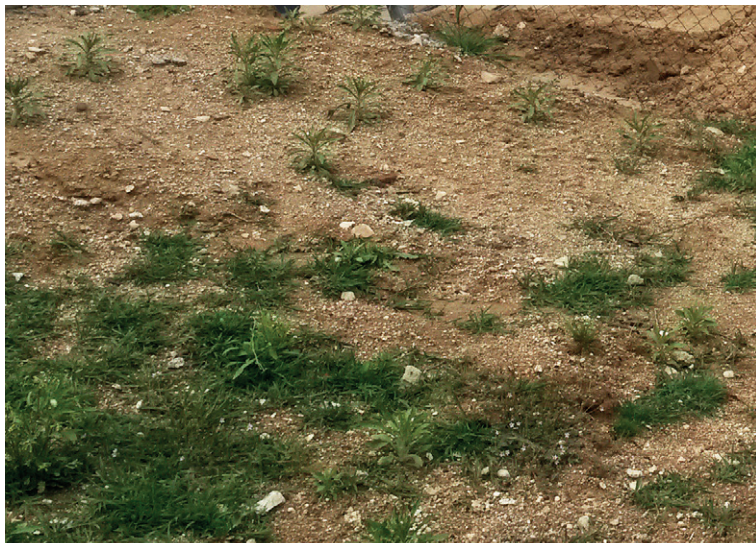
*Substrate before works began*

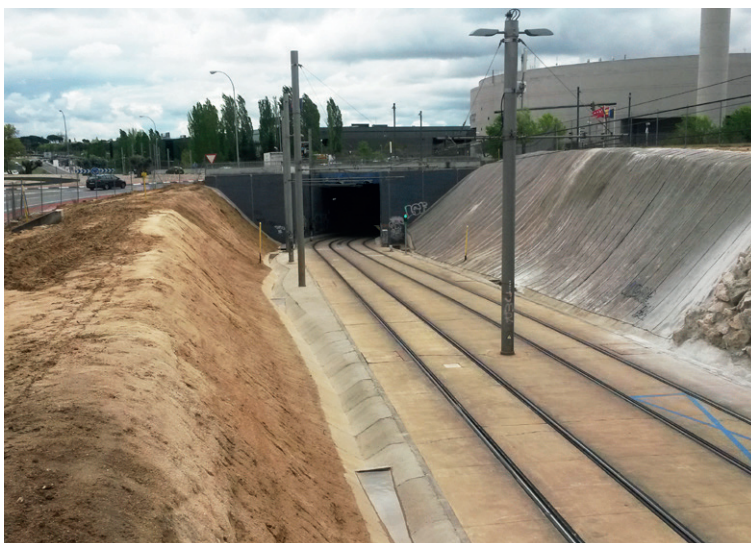
*Prepared slope opposite existing CC installation*

The client specified this installation as a trial, deliberately choosing a slope which would be more challenging to line to see how CC would perform. After two years the client approved CC for further use and immediately specified CC to line the slope on the opposite side of the track. The process was much the same, with the slope graded and any vegetation removed before installation. An anchor trench was cut at the shoulder before bulk rolls of CC5™ were unrolled down the face of the slope. Ground pegs were used to fix the CC to the substrate and the overlaps were sealed and screwed at 200mm centres.

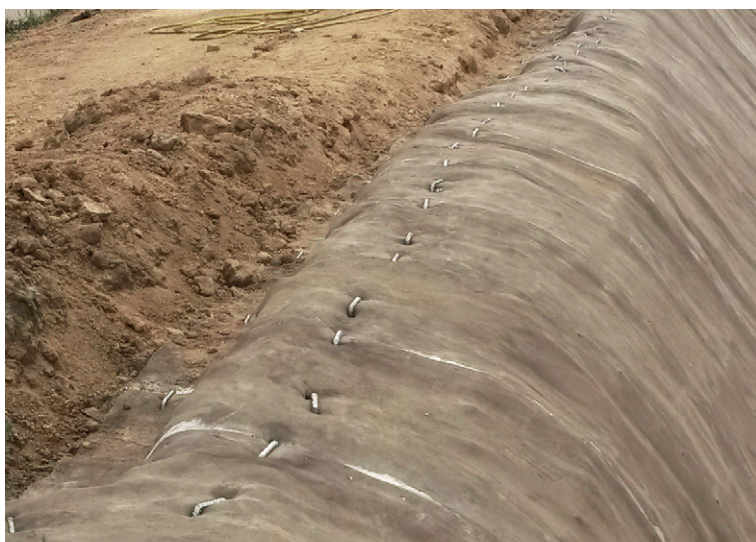
*Ground pegs and anchor trench*

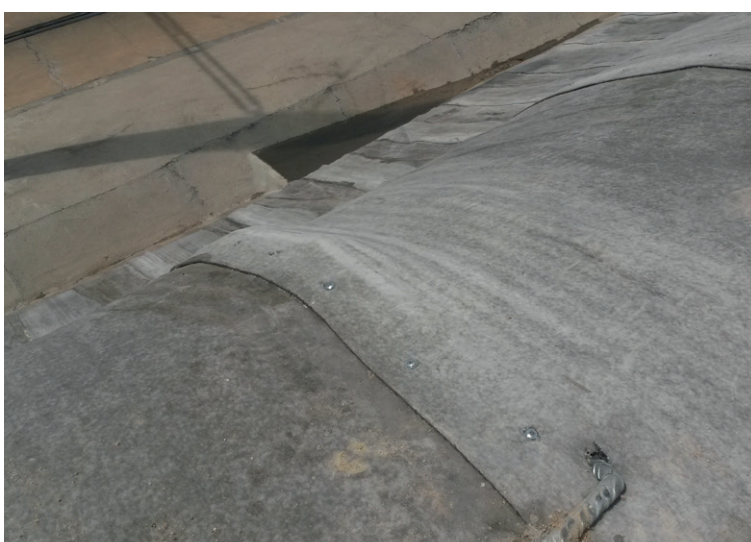
*Screws inserted every 200mm*

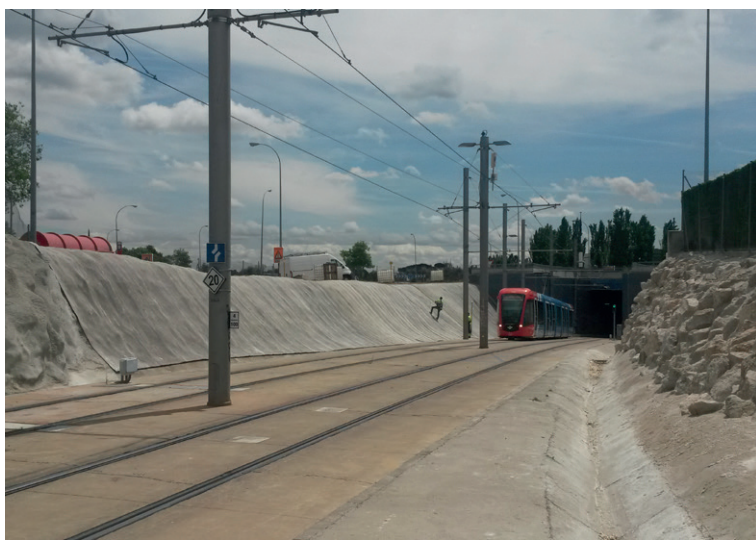
*Train line remained open throughout the install*

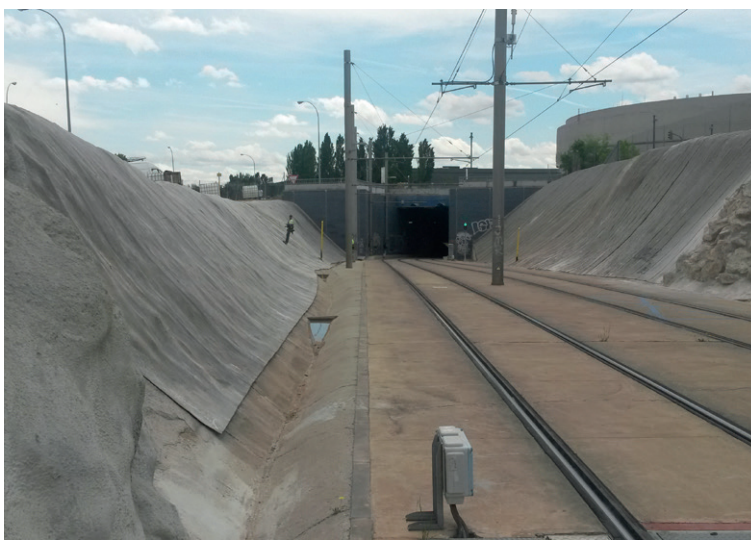
*Both completed CC installations*
