SLOPE PROTECTION

In June 2018, Concrete Canvas® GCCM* (CC) was used to protect a slope adjacent to a rail line in Parla, Madrid, Spain.

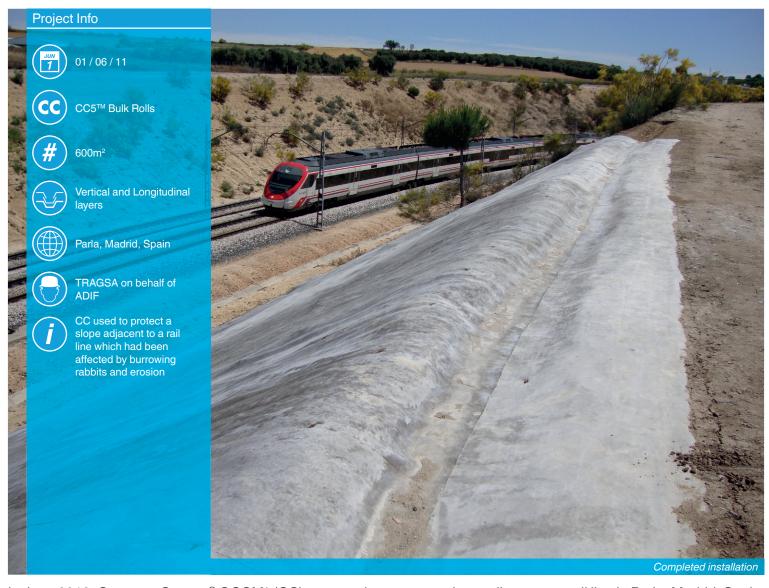
The slope, a suburban rail embankment, had been undermined by rabbit burrows and had suffered weathering erosion. Both issues were compromising the integrity of the slope, and resulted in a requirement for protecting it to prevent slip and further damage. The works were carried out by TRAGSA on behalf of ADIF.

In preparation for the installation, all vegetation was removed from the slope section to be lined. Bulk rolls of CC5TM were then delivered to the site and deployed vertically down the slope, starting above a small drainage channel which was created prior to installation to divert rainwater. The bottom edge were captured in an anchor trench and secured using ground pegs, and the top edge then covered with a longitudinal length of CC, overlapping by 100mm and secured using screws. The top edge was then captured in another anchor trench before both were backfilled to prevent undermining and ingress. Following installation, hydration was given.

600m² of CC5™ were installed in a single day and without any need for line possession, allowing trains to run as usual.
