CC5™ Batched Rolls

Taman Warisan,
Tasek Merimbun, Brunei

CC5™ used to provide
slope protection below
Balai Purun hall

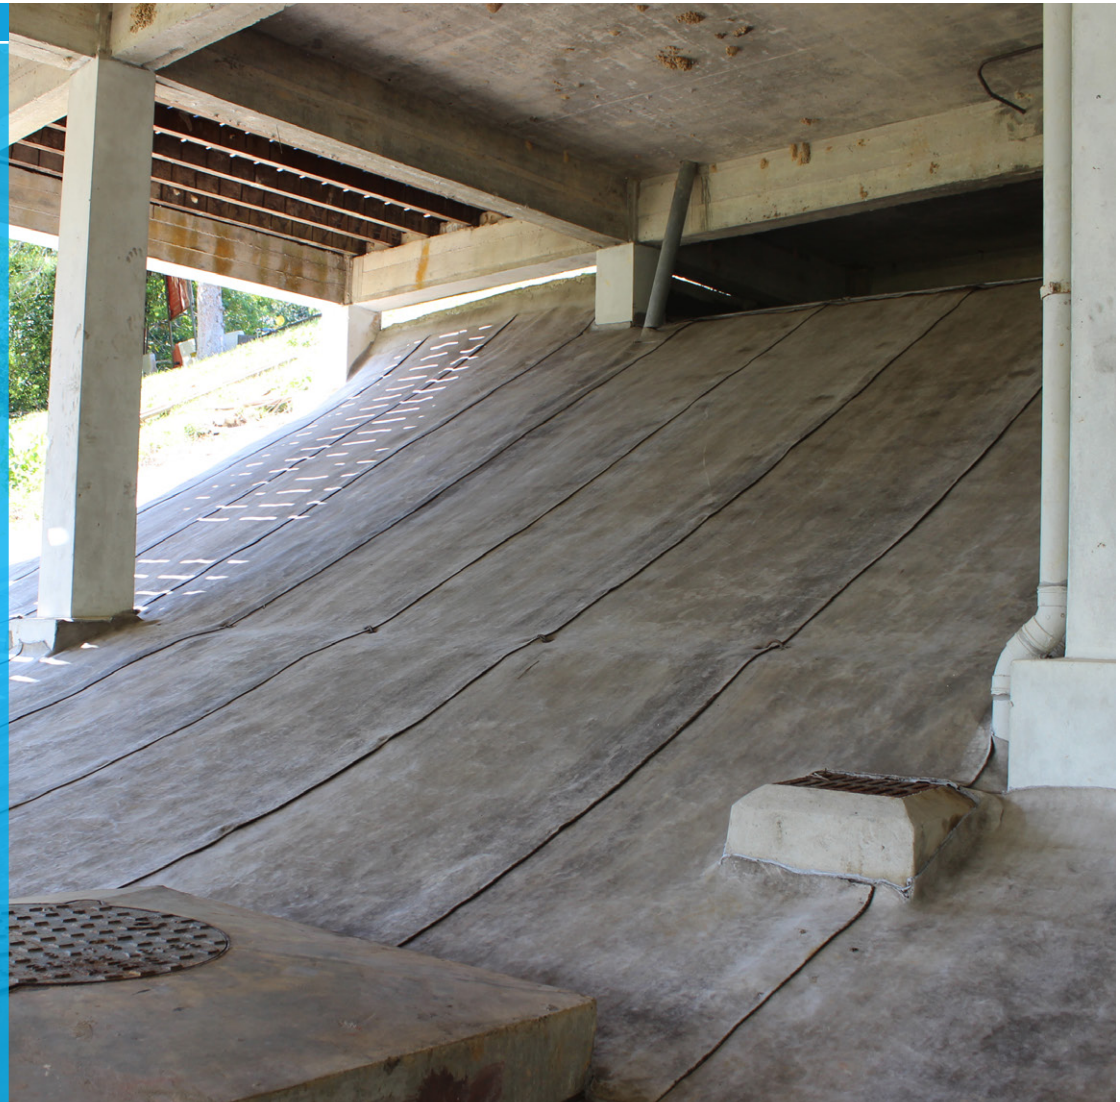
Completed slope protection installation

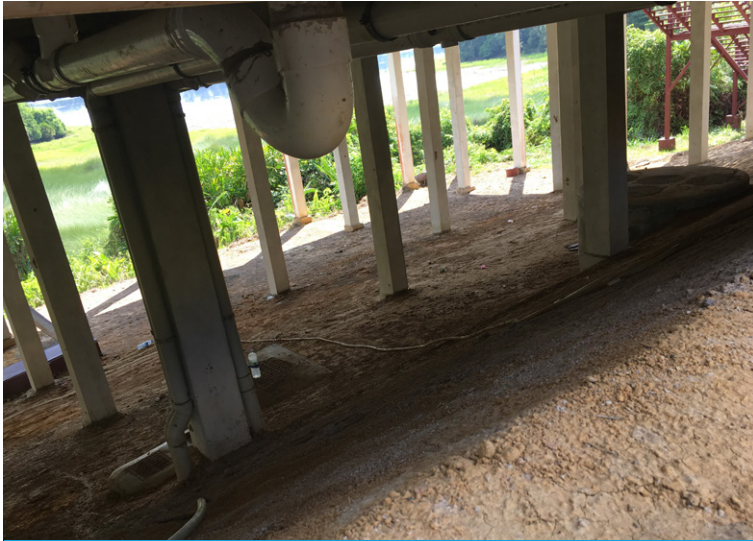
View of slope from crest

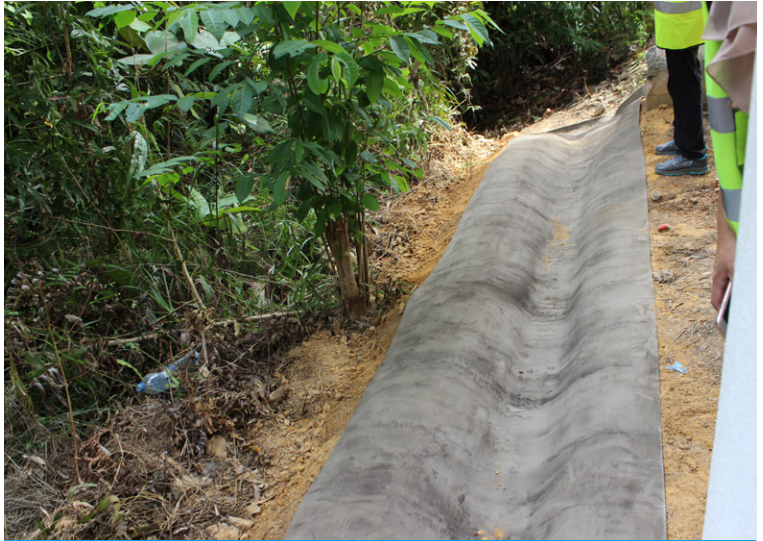
Installing CC within the drain at the side of the slope

Works began in March 2019, with 390m² of CC5™ delivered to the site in batched rolls following ground works which involved reprofiling the substrate. Gullies were backfilled with soil in order to provide a smooth surface, while side drains were created and later lined with CC to divert surface water away from the slope to prevent ingress and saturation.

The CC batched rolls were installed in a vertical layout. The contractors began the installation by covering the earth drain next to the slope, and then working their way across the slope itself, from crest to toe. Edges of the material were secured within an anchor trench using ground pegs at the crest, with each additional layer laid so as to overlap the previous by 100mm.

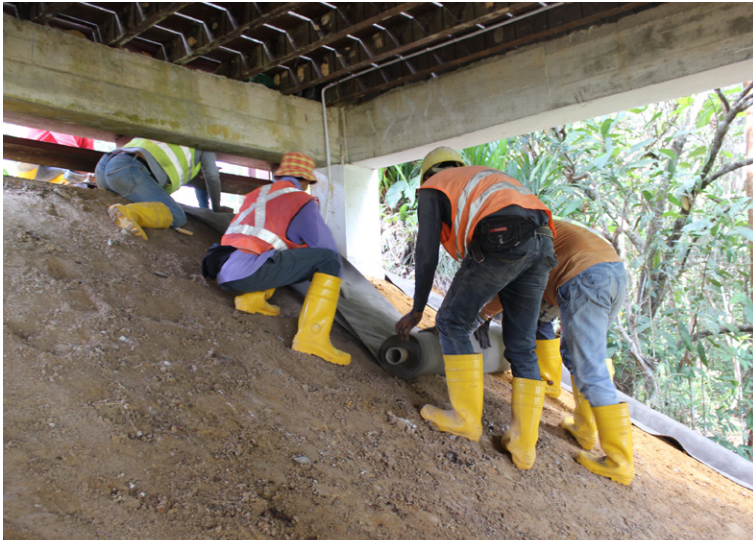
Laying the first batched roll

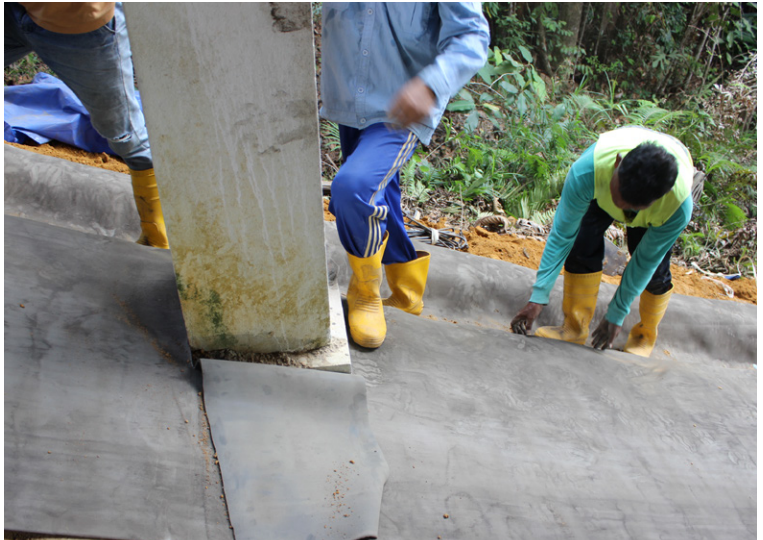
Cutting CC to accomodate existing concrete columns

Screws and sealant were used to joint overlapped layers of CC following hydration of the lower overlapped section. Where pipes and existing columns had to be accommodated, CC's flexibility allowed for the installation crew to cut the material to fit around the infrastructure and sealed with adhesive sealant to prevent water ingress.

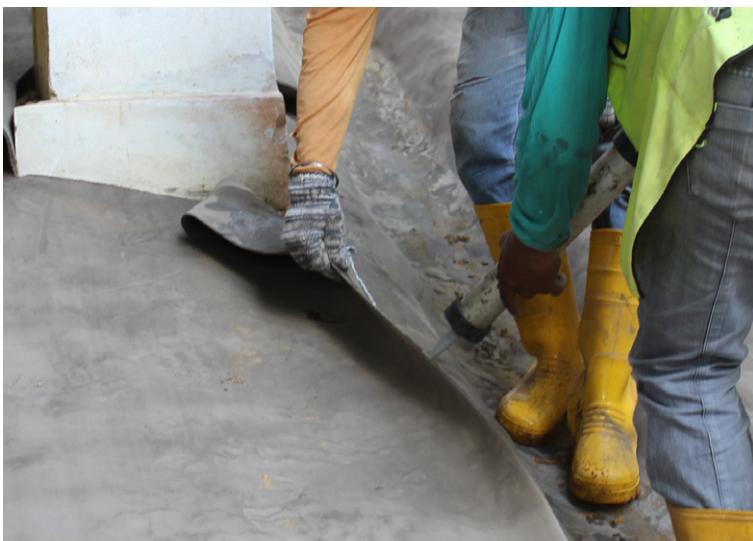
Applying sealant

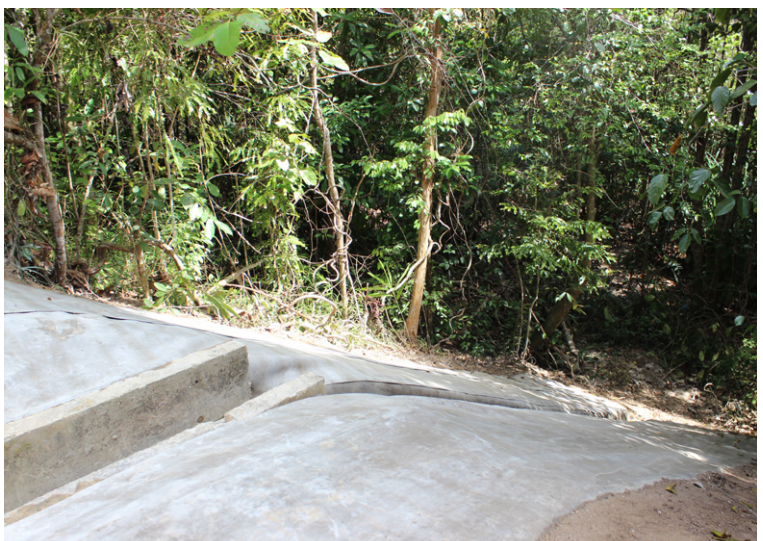
Installation around a concrete drain 100m from the hall

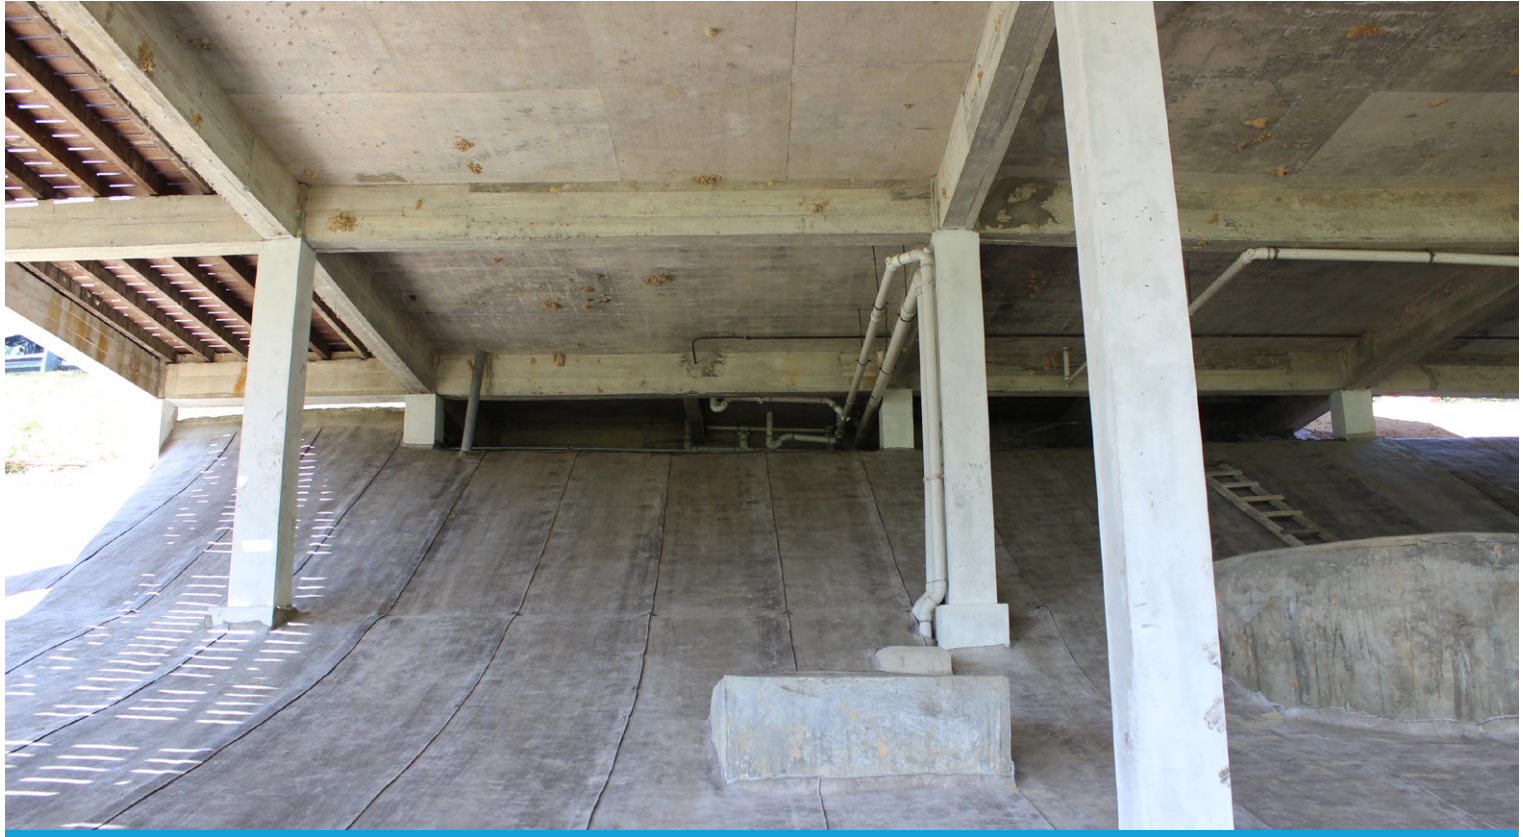
View of completed installation from toe of slope
