CC5™ Bulk Rolls

Tutong, Brunei

Installation of CC as slope protection solution in Brunei

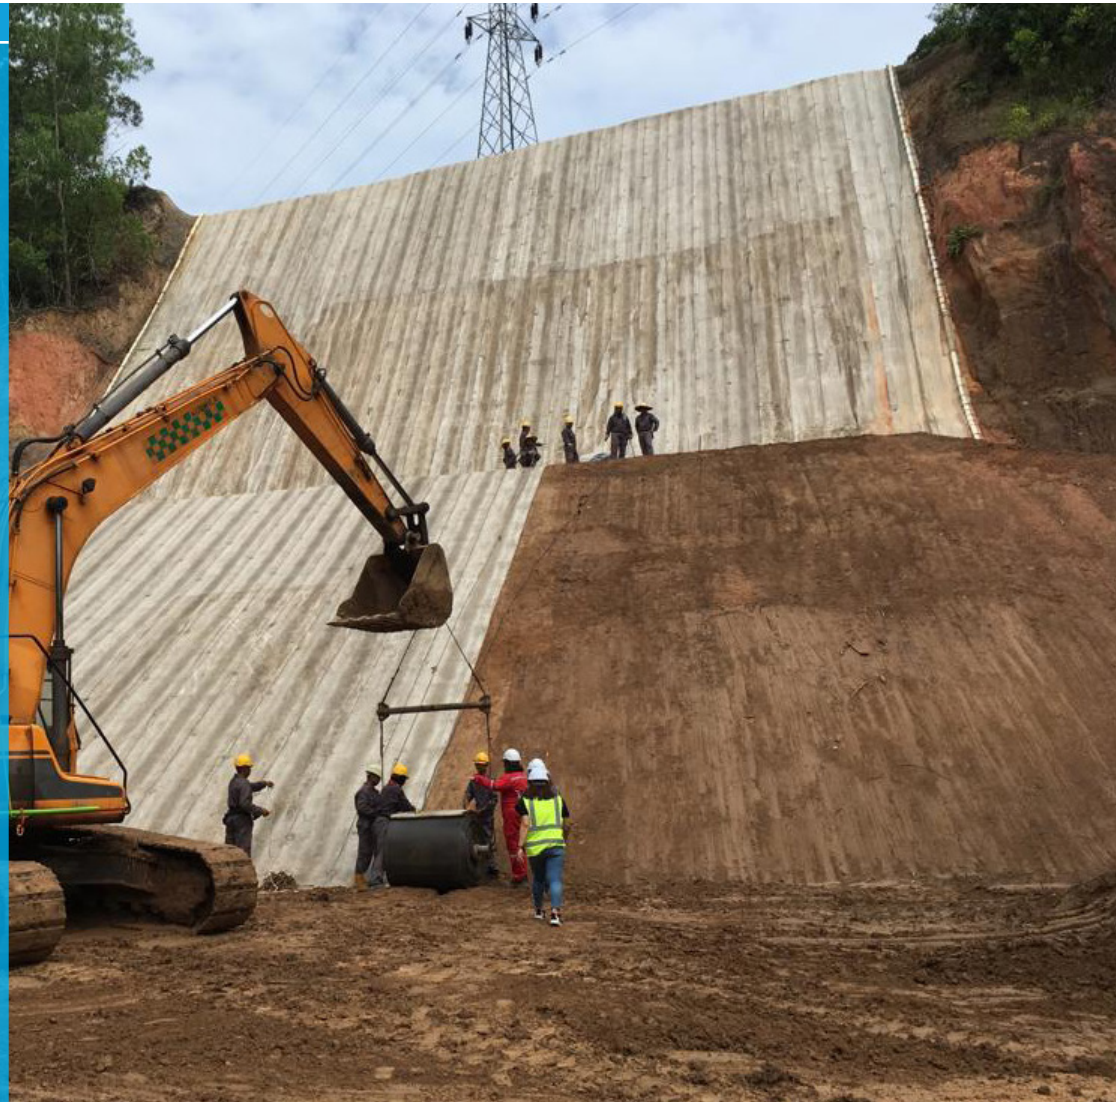
CC was used to provide erosion protection to a steep slope near a large electric pylon

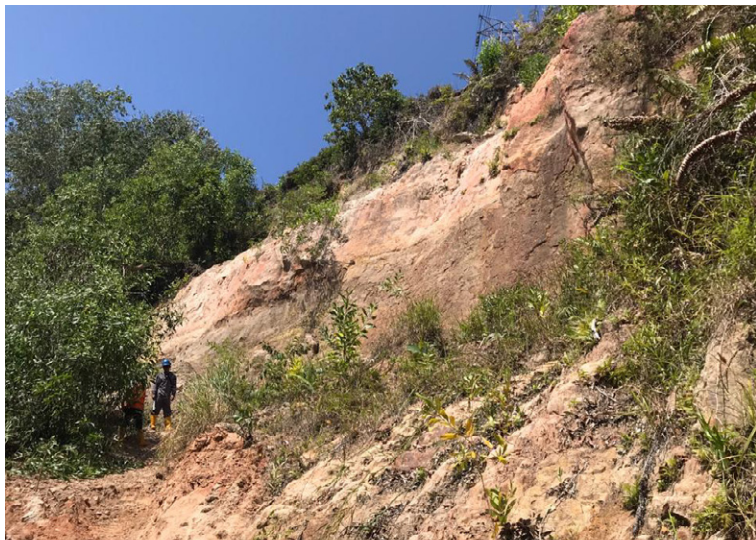
Slope prior to installation and preparatory works

Prior to the installation, the slope was profiled by removing vegetation and grading its surface. The preparatory works on the slope also involved building in a step half way down the slope to allow the excavator to effectively access and prepare the top and bottom halves of the slope without unnecessary risk to the operator while also providing additional water management by slowing the flow of surface runoff down the slope.

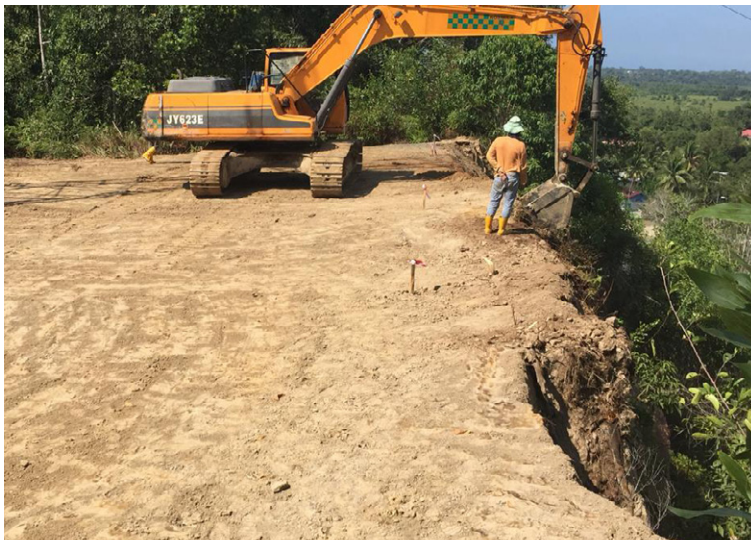
Removal of vegetation from crest of the slope

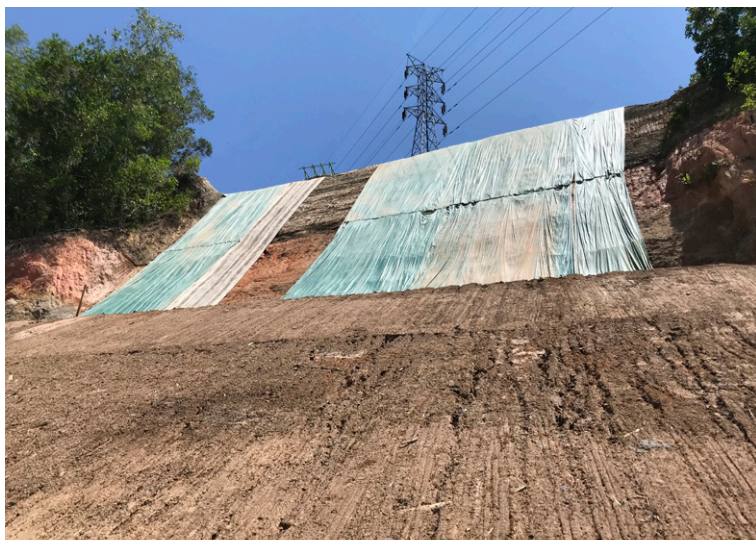
Slope following preparation

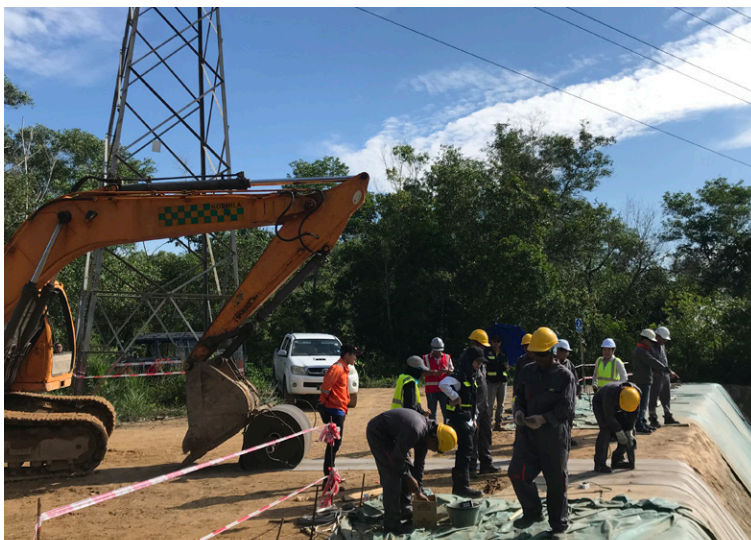
Deploying CC bulk roll for installation

The CC was deployed via spreader beam down the face of the slope, positioned and cut to the required length. The edges of the material were secured within anchor trenches using ground pegs at the crest and toe. Due to the hard nature of the substrate, pre-drilling was required before inserting fixings into the soil. Adjacent layers were overlapped and the lower layer hydrated along the overlap before applying adhesive sealant and finally jointing with screws. Further steel ground pegs were used to fix the material to the substrate down the face of the slope; these were inserted through the overlaps with a minimum of 1m spacing between pegs.

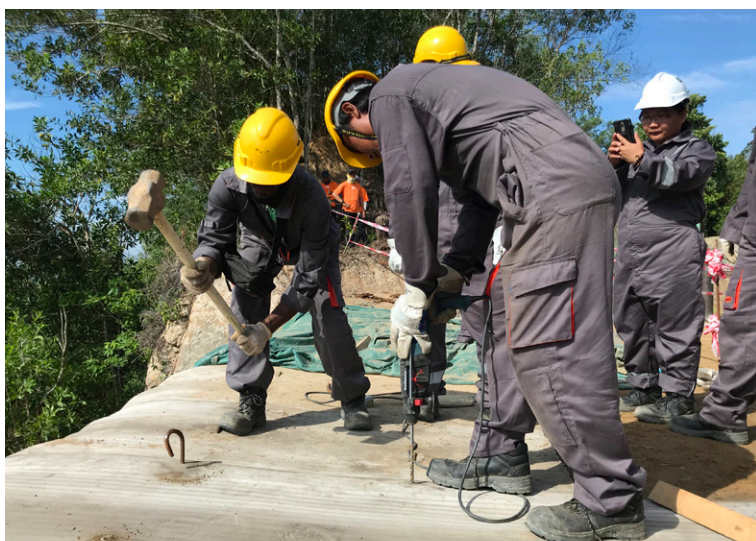
Fixing CC to ground using steel pegs

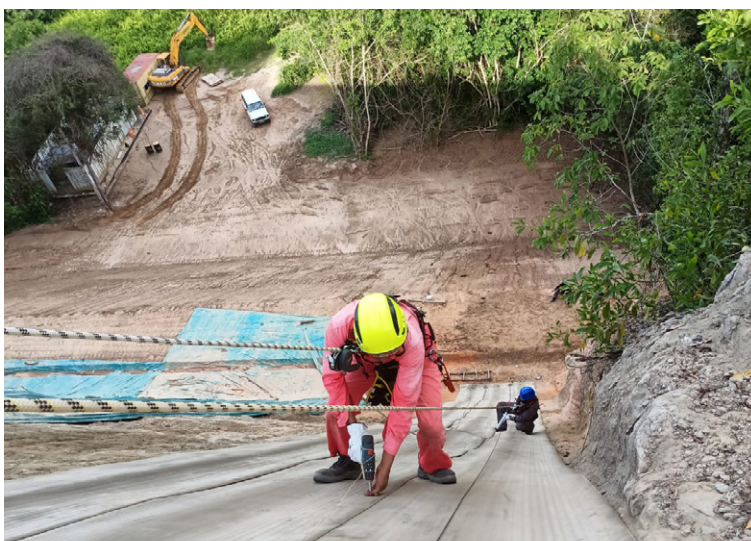
Screwing overlapped joints

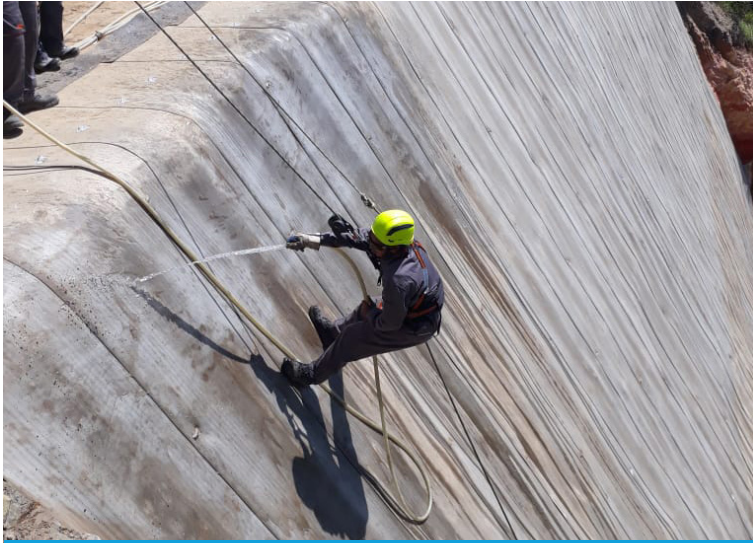
Hydration

Once installation was complete or at the end of each day, the CC was hydrated using a portable water tank. The project was carried out in two phases, with the top section of the slope lined first, taking around 14 days. While the second phase saw the bottom section of the slope lined in seven days.

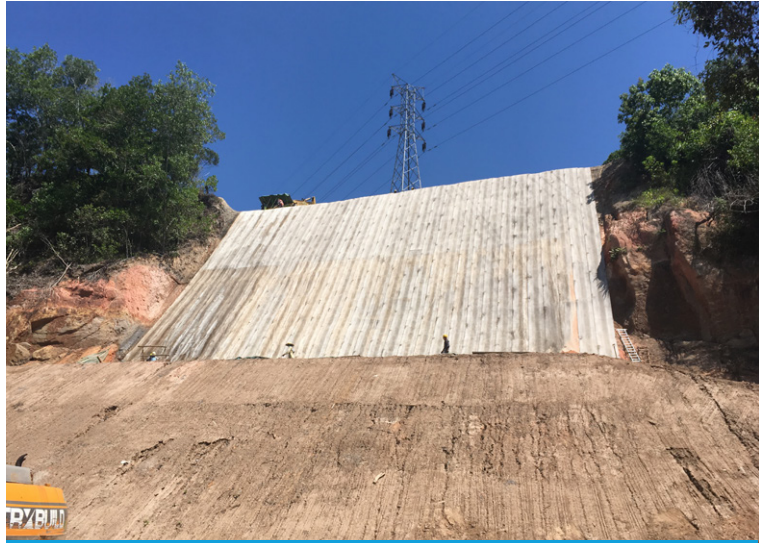
Completed upper slope section

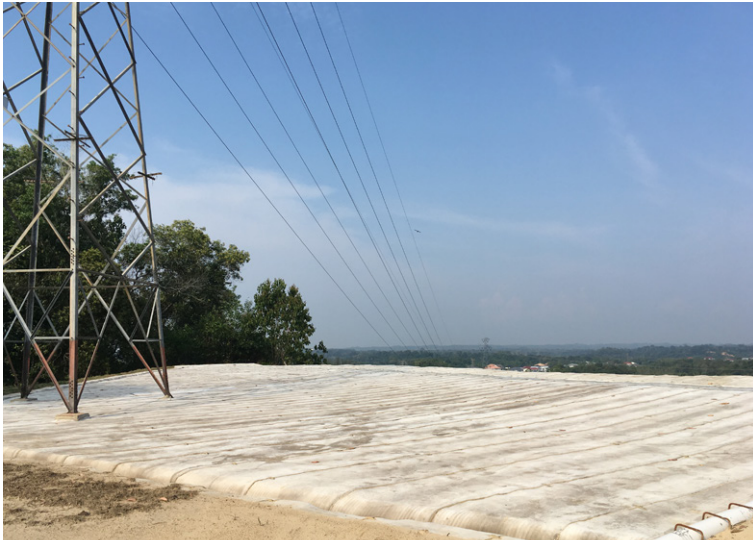
CC was also installed around the pylon

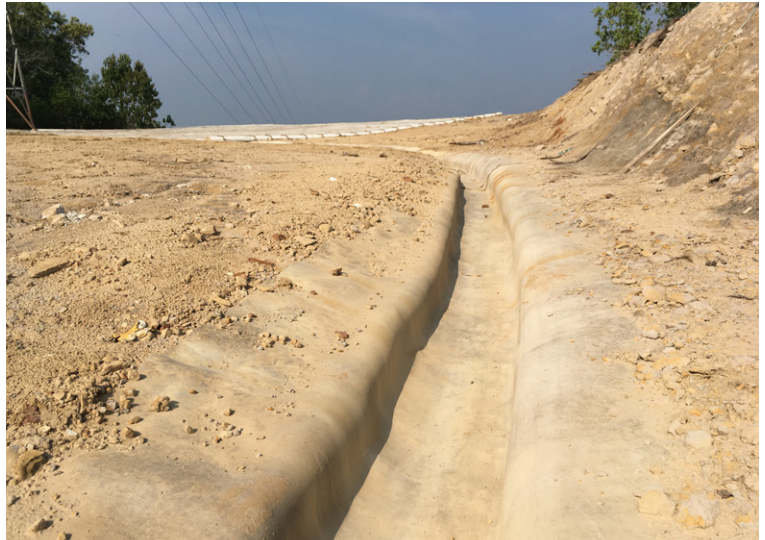
Small drainage channel created and lined for runoff management

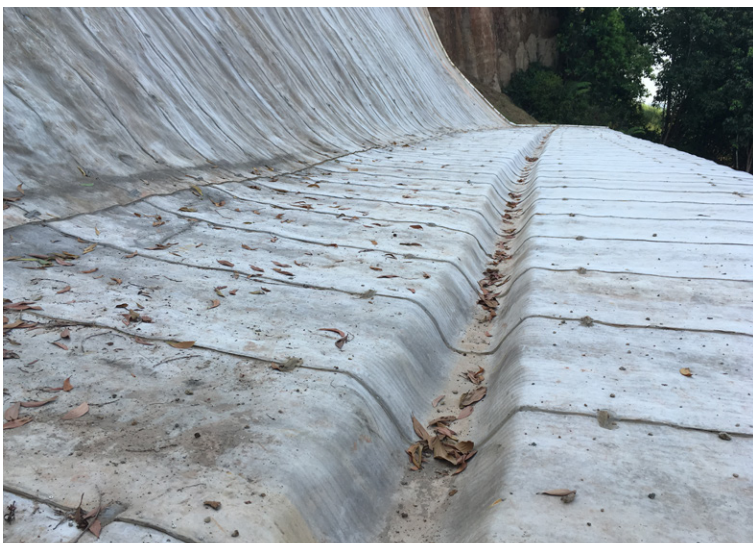
Lined step part way up slope - 2nd drain for further water management

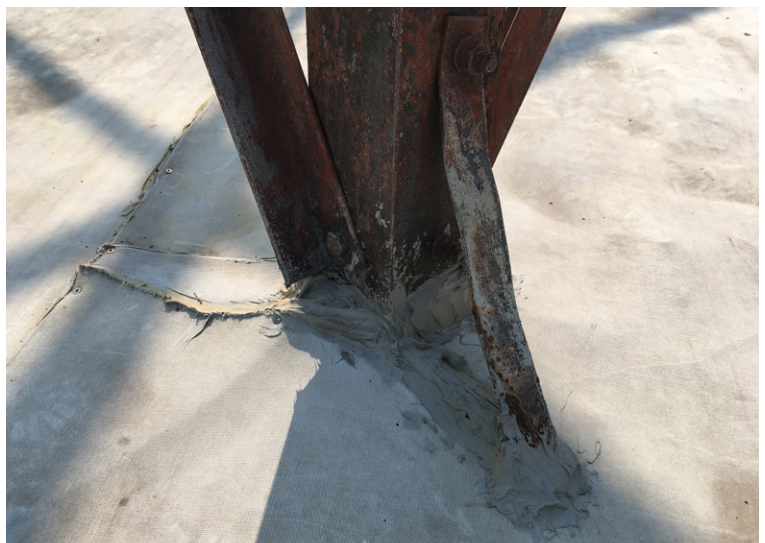
CC was easily installed around the pylon

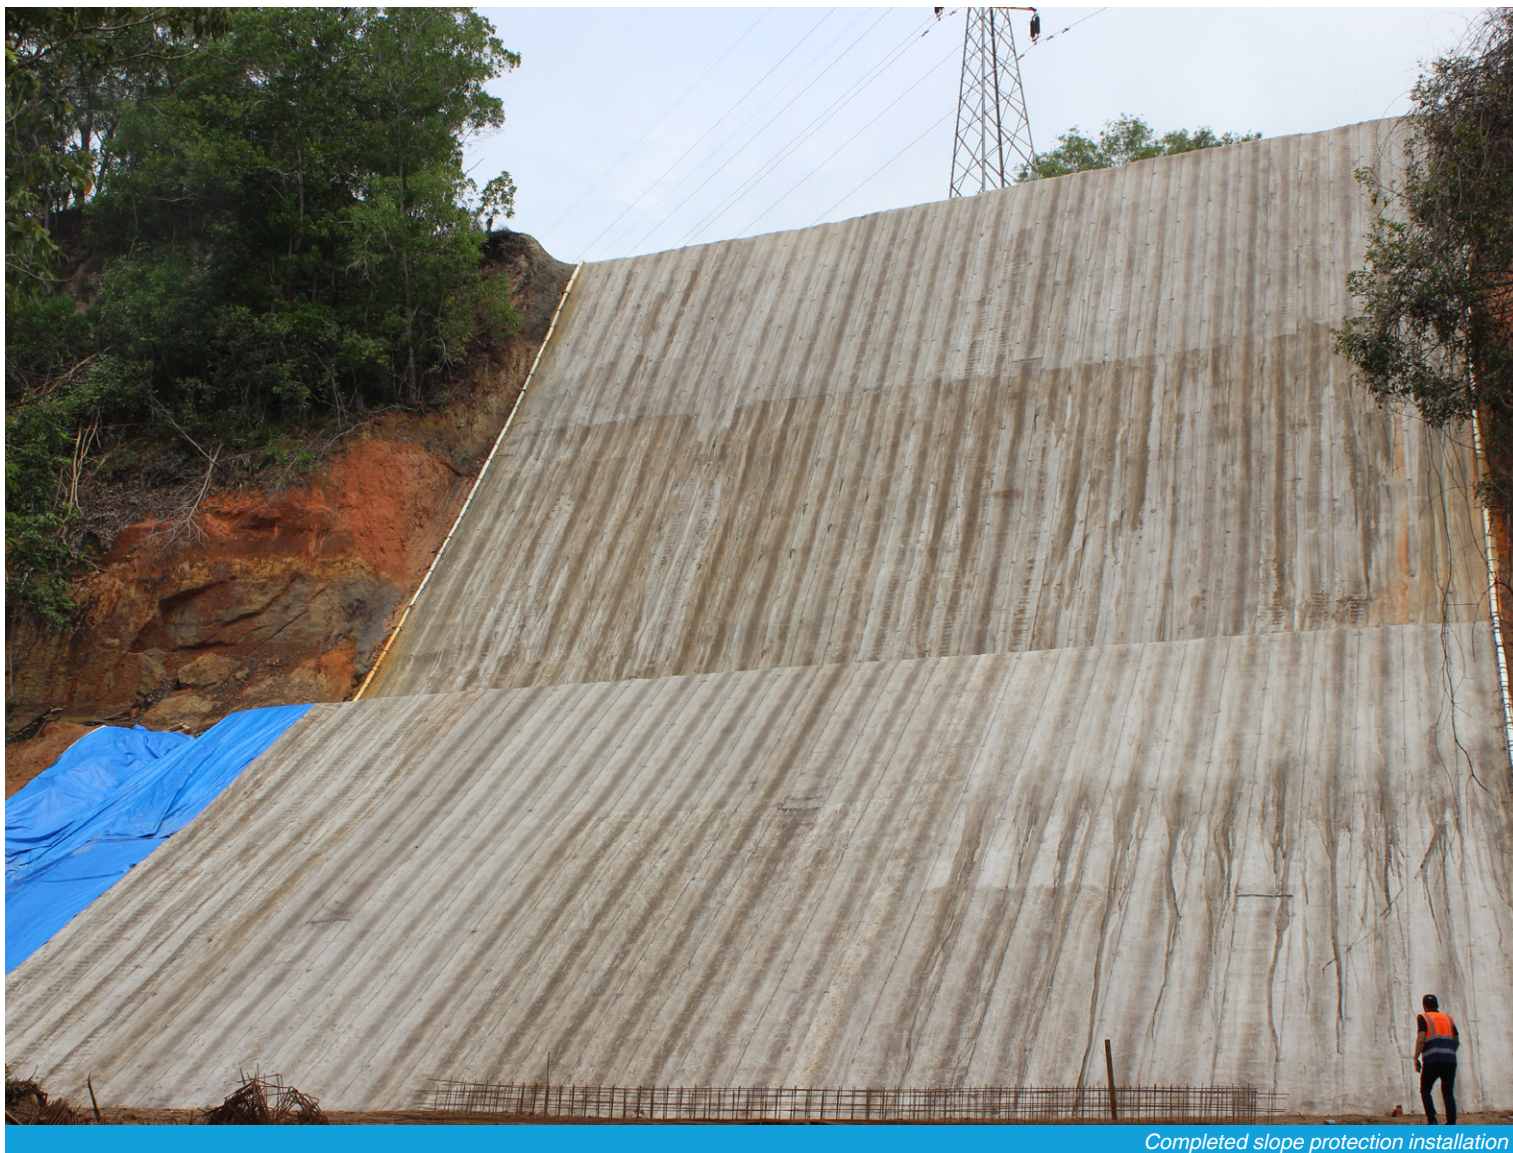
Completed slope protection installation

A total of 2000m² of CC5™ were installed by the team of ten, including climbers, in a total of 21 days. The CC material was provided by Concrete Canvas Ltd's official partner in Brunei, [ATH Chevron Sdn Bhd](#).
