CC5™ Batched Rolls

Fairlight Cove,  
East Sussex, England,  
UK

CC5™ was used to  
protect slopes affected  
by landslide regression  
to prevent further slip and  
protect nearby dwellings

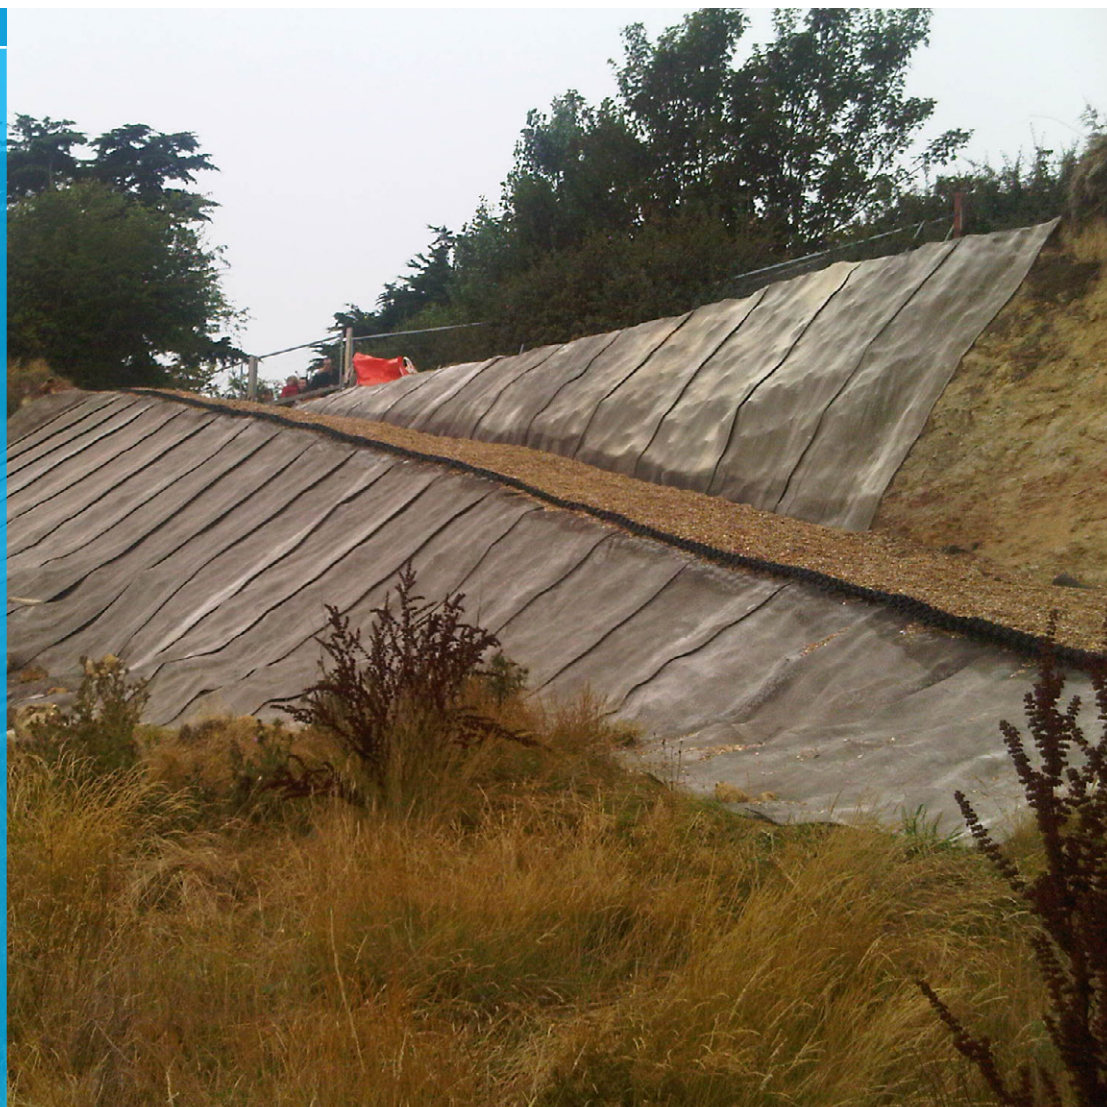
Completed installation

CC5™ was specified for the project, and delivered to site in pre-batched rolls. The material was lifted to the top of the slopes which required protection, and unrolled vertically, from crest to toe. The leading edges of the material were secured in anchor trenches, which were later backfilled, while overlapping layers of CC were jointed to prevent ingress.

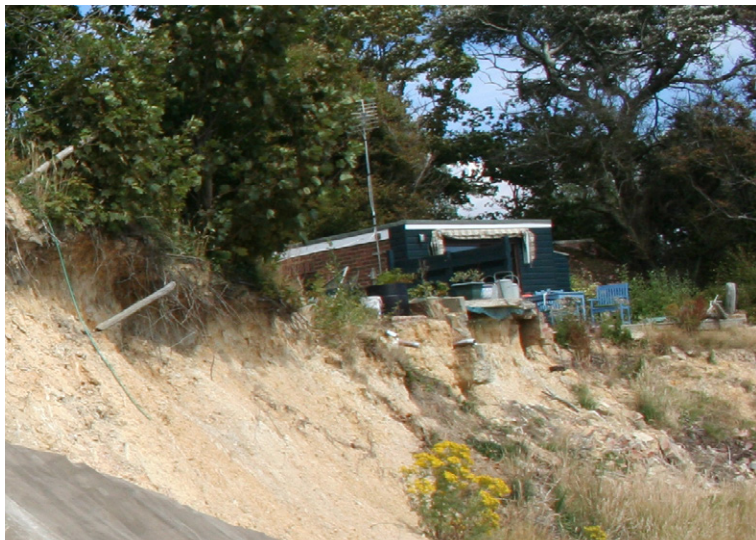
Nearby dwellings were at risk due to danger of further landslide

The area had suffered from extreme landslide regression resulting in the loss of residential property and further threatening a large number of dwellings. A long-term, durable solution was required to protect the sub-vertical failure surface close to a key drainage facility. The steep nature of the slope prevented conventional slope protection techniques such as vegetation growth, while the restricted access on site prevented the use of many conventional concreting methods such as shotcrete.

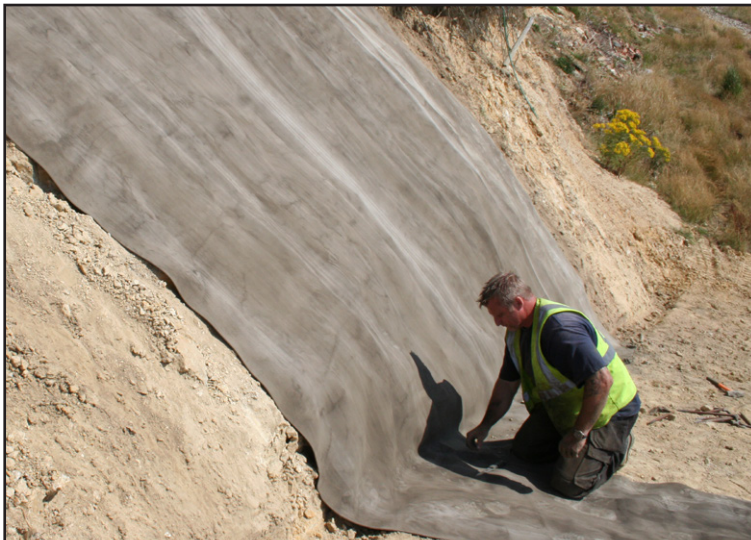
CC was fixed to substrate using ground pegs

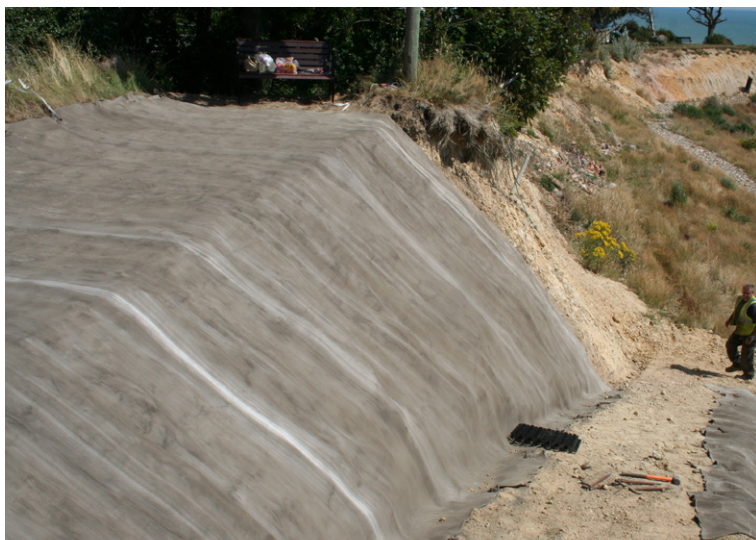
Completed first slope section

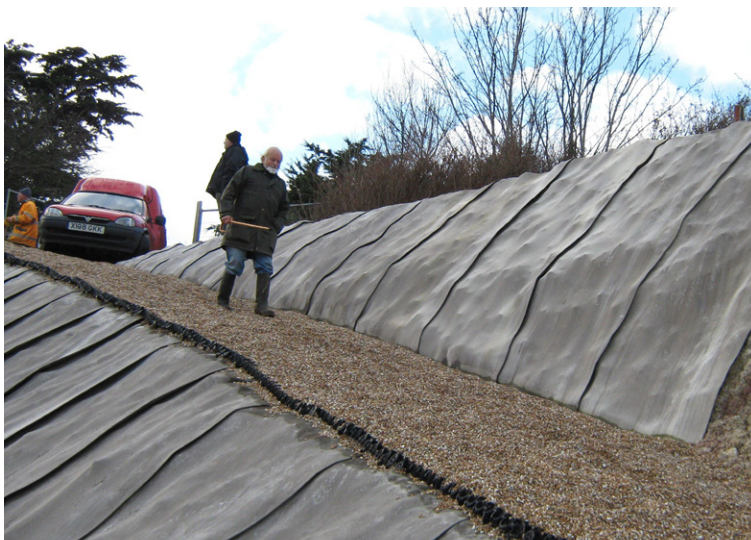
CC edges were buried following installation
