CC5™ Bulk Rolls

Warrego Highway, Roma,
Australia

CC5™ was used
to provide erosion
protection to a slope to
prevent shallow slip and
protect road users

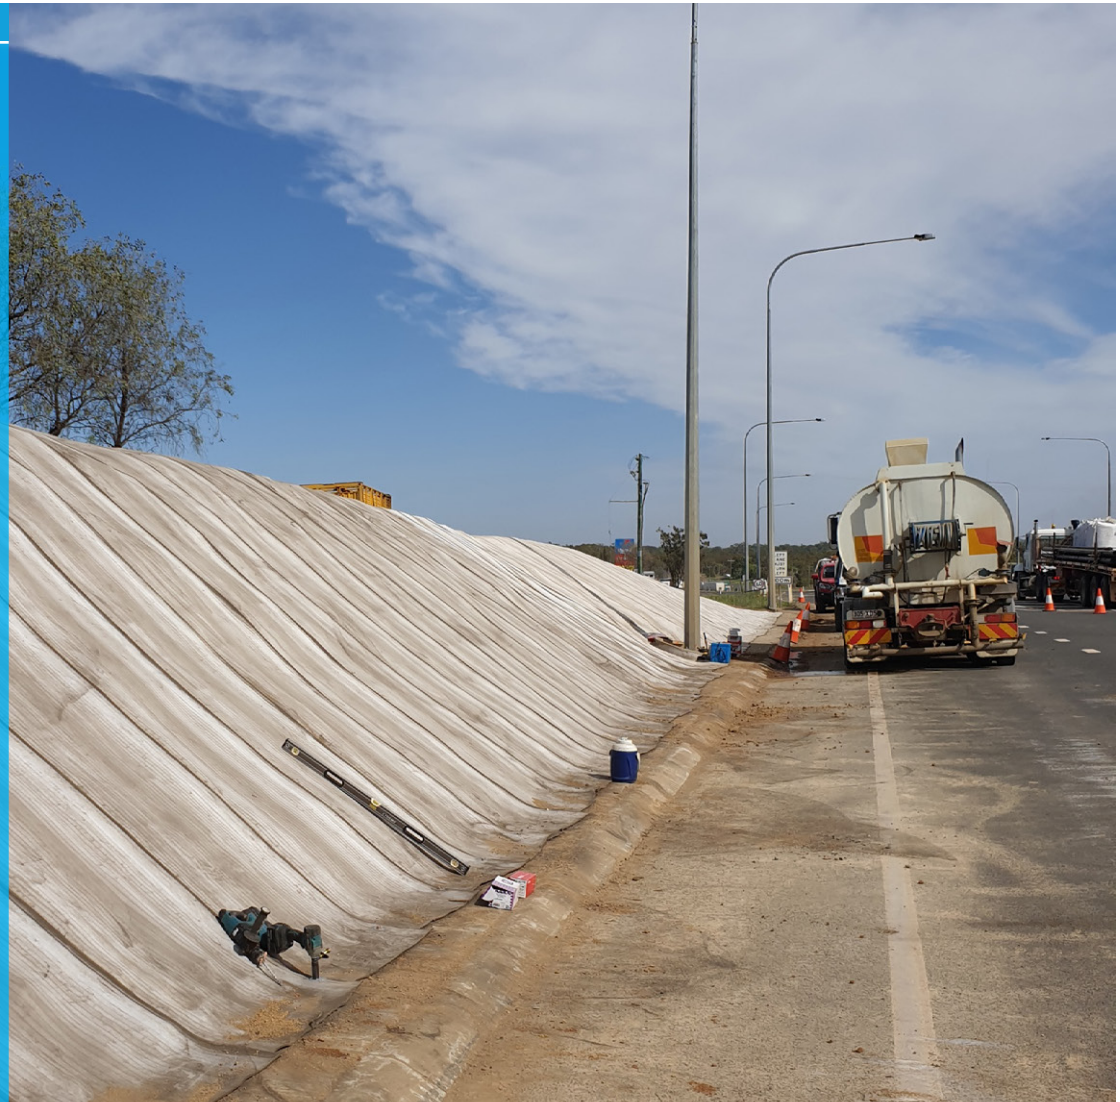
Completed slope protection installation alongside the Warrego Highway in Roma, Australia

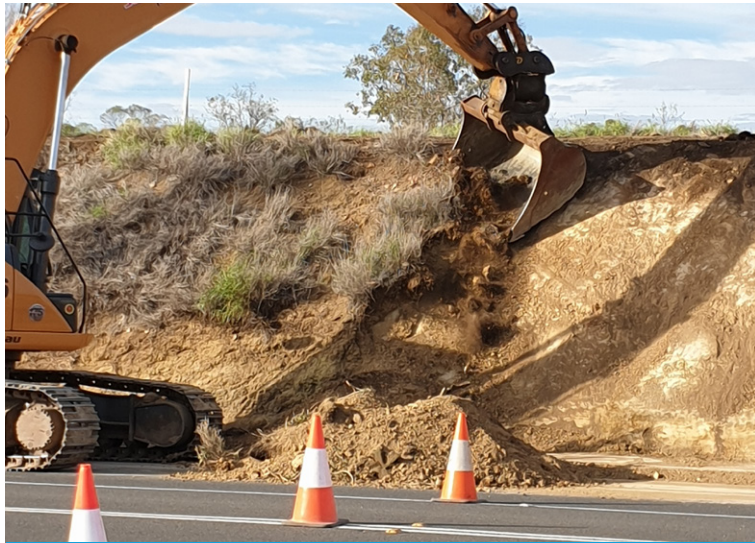
Removing vegetation with excavator

Prior to installation, Public Underground Plants (PUPs) were identified and the batter slopes were cleared of vegetation. The substrate was then graded and levelled to provide a smooth profile on which the CC could be successfully installed.

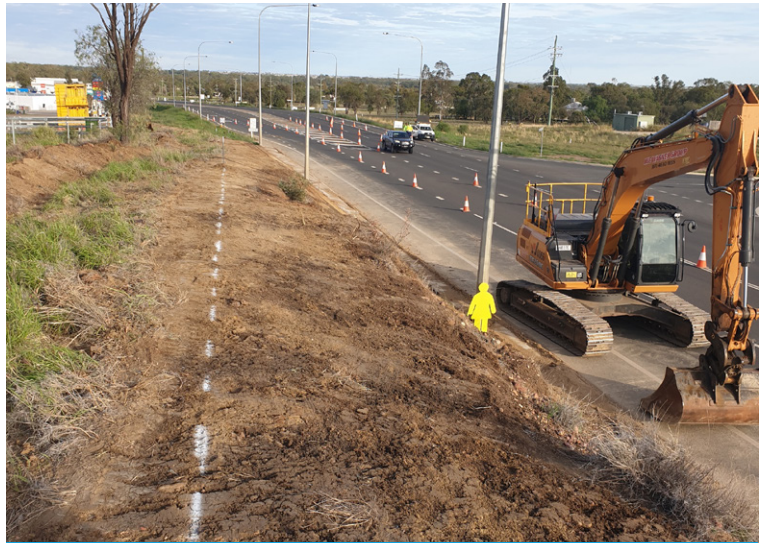
Anchor trench marked out following initial ground preparation

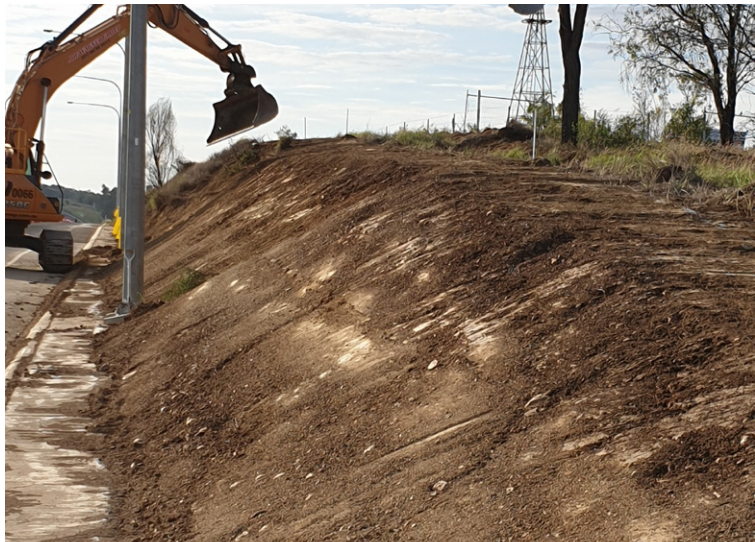
Grading the slope profile

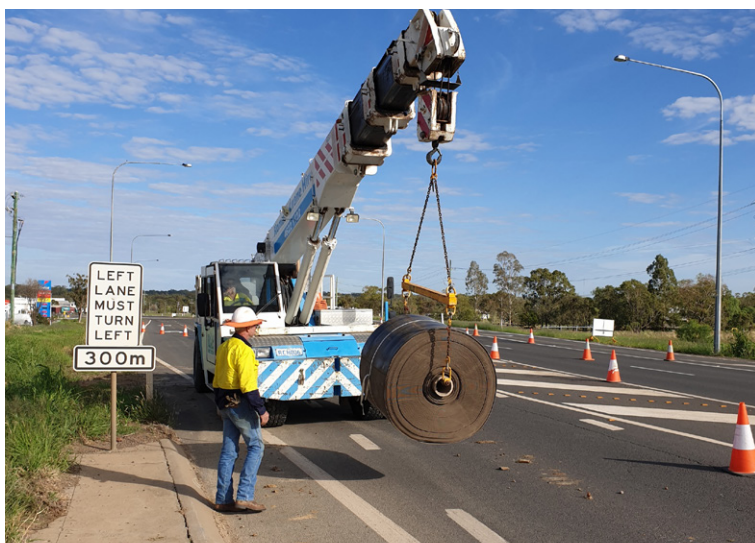
Mounting CC bulk rolls to spreader beam

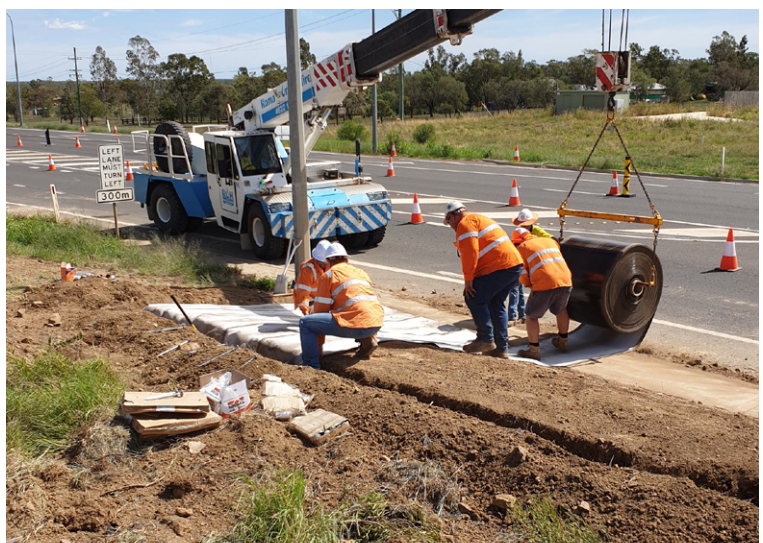
Securing CC within anchor trenches

The CC was laid vertically from crest to toe, with each subsequent layer overlapping the last by 100mm. The edge at the crest was fixed within an anchor trench using 380mm ground pegs, through the overlaps of the material. At the toe, CC was fixed with masonry bolts, again through each joint. Joints were then hydrated beneath the overlap, sealed using a single bead of adhesive sealant and jointed using stainless steel screws at 200mm centres. Intermediate pegs were also inserted down the length of the slope at 3m spacings through the overlaps to ensure intimate contact between the material and substrate.

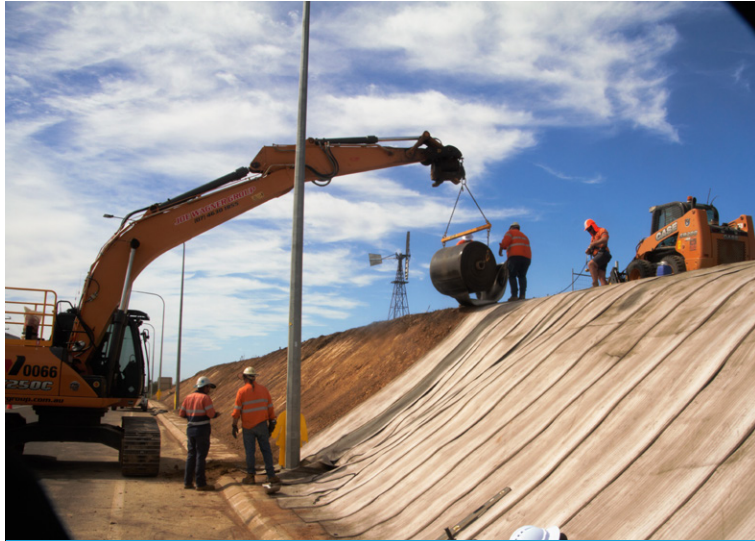
A spreader beam and plant made installation easier

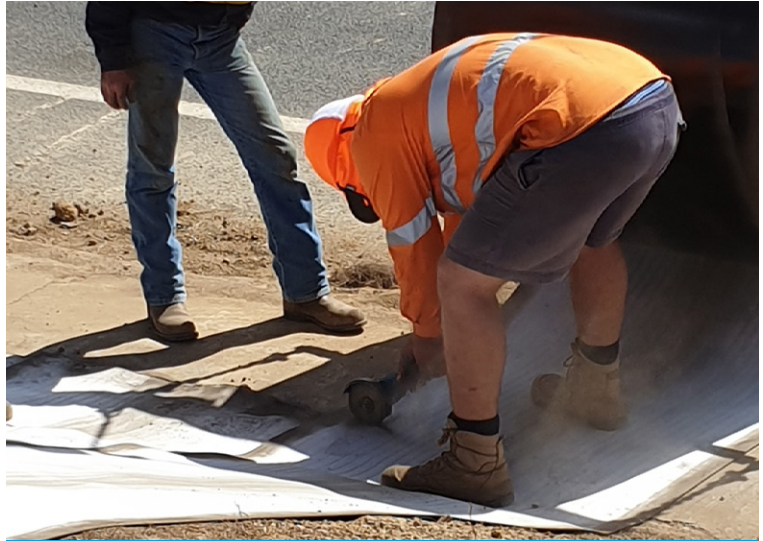
Cutting CC to length with a disc cutter

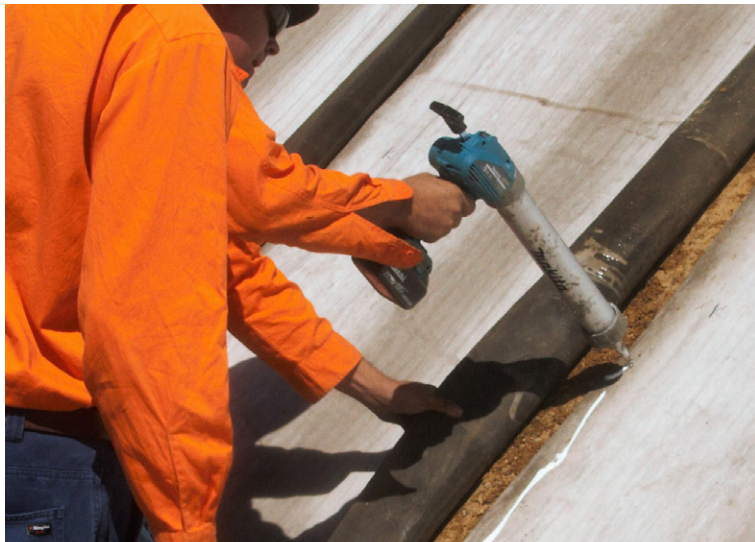
Sealant used to provide a low permeability joint

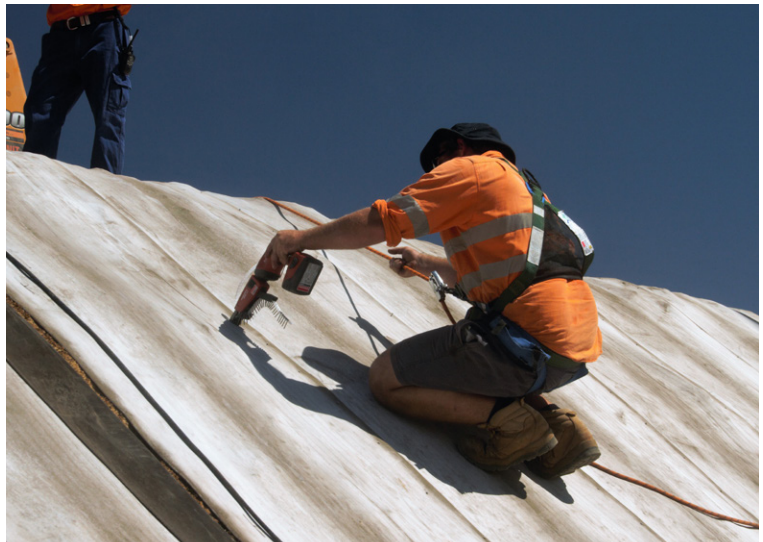
Joining with screws

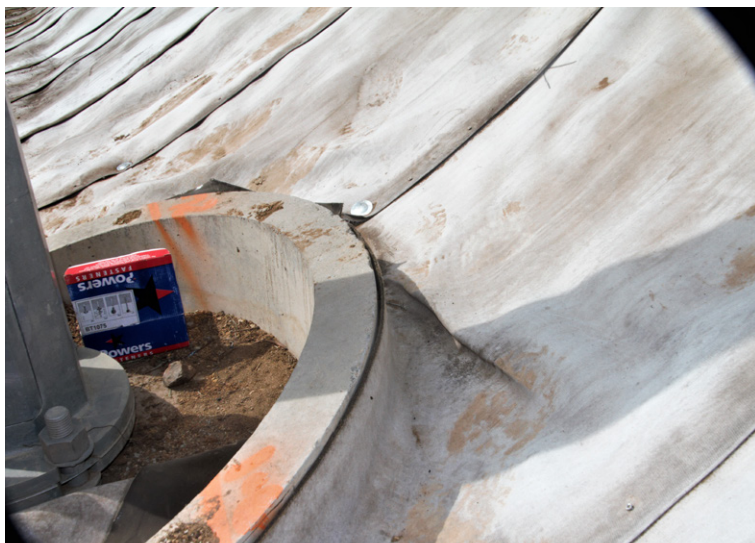
Termination around concrete kerb

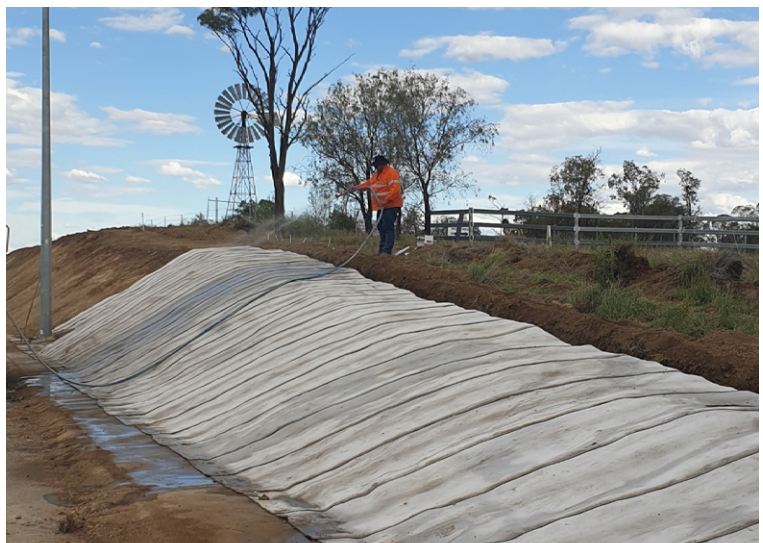
Hydration

Following completion of the installation, the material was hydrated three times at 30-minute intervals from both the crest and toe of the slope to ensure sufficient saturation. The anchor trenches were then backfilled to prevent ingress beneath the material and provide neat termination.

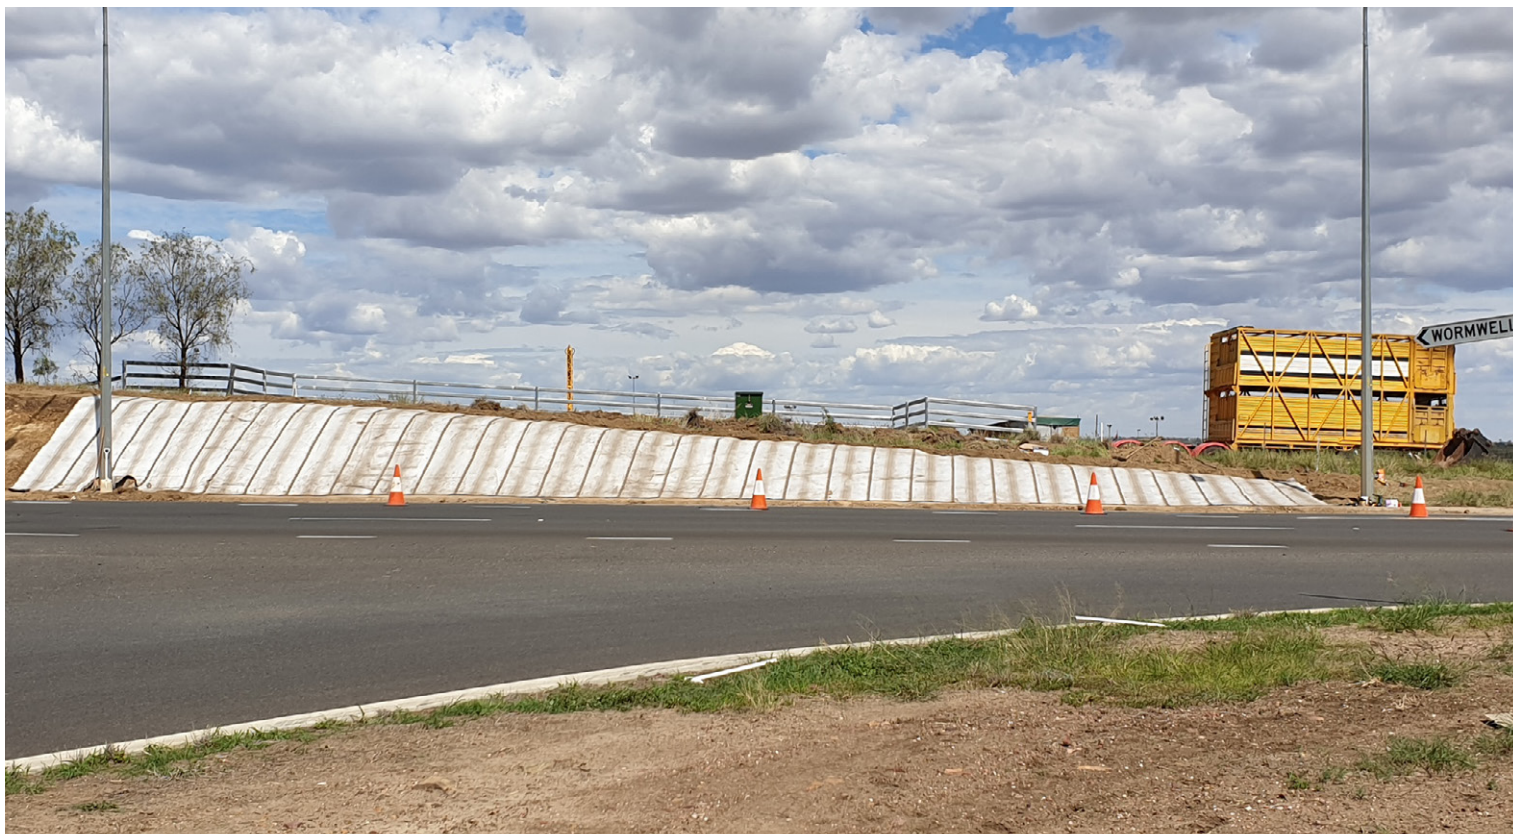
Completed installation on slope
