## 10.12.10 Case Study : Goldhanger, Maldon, Essex

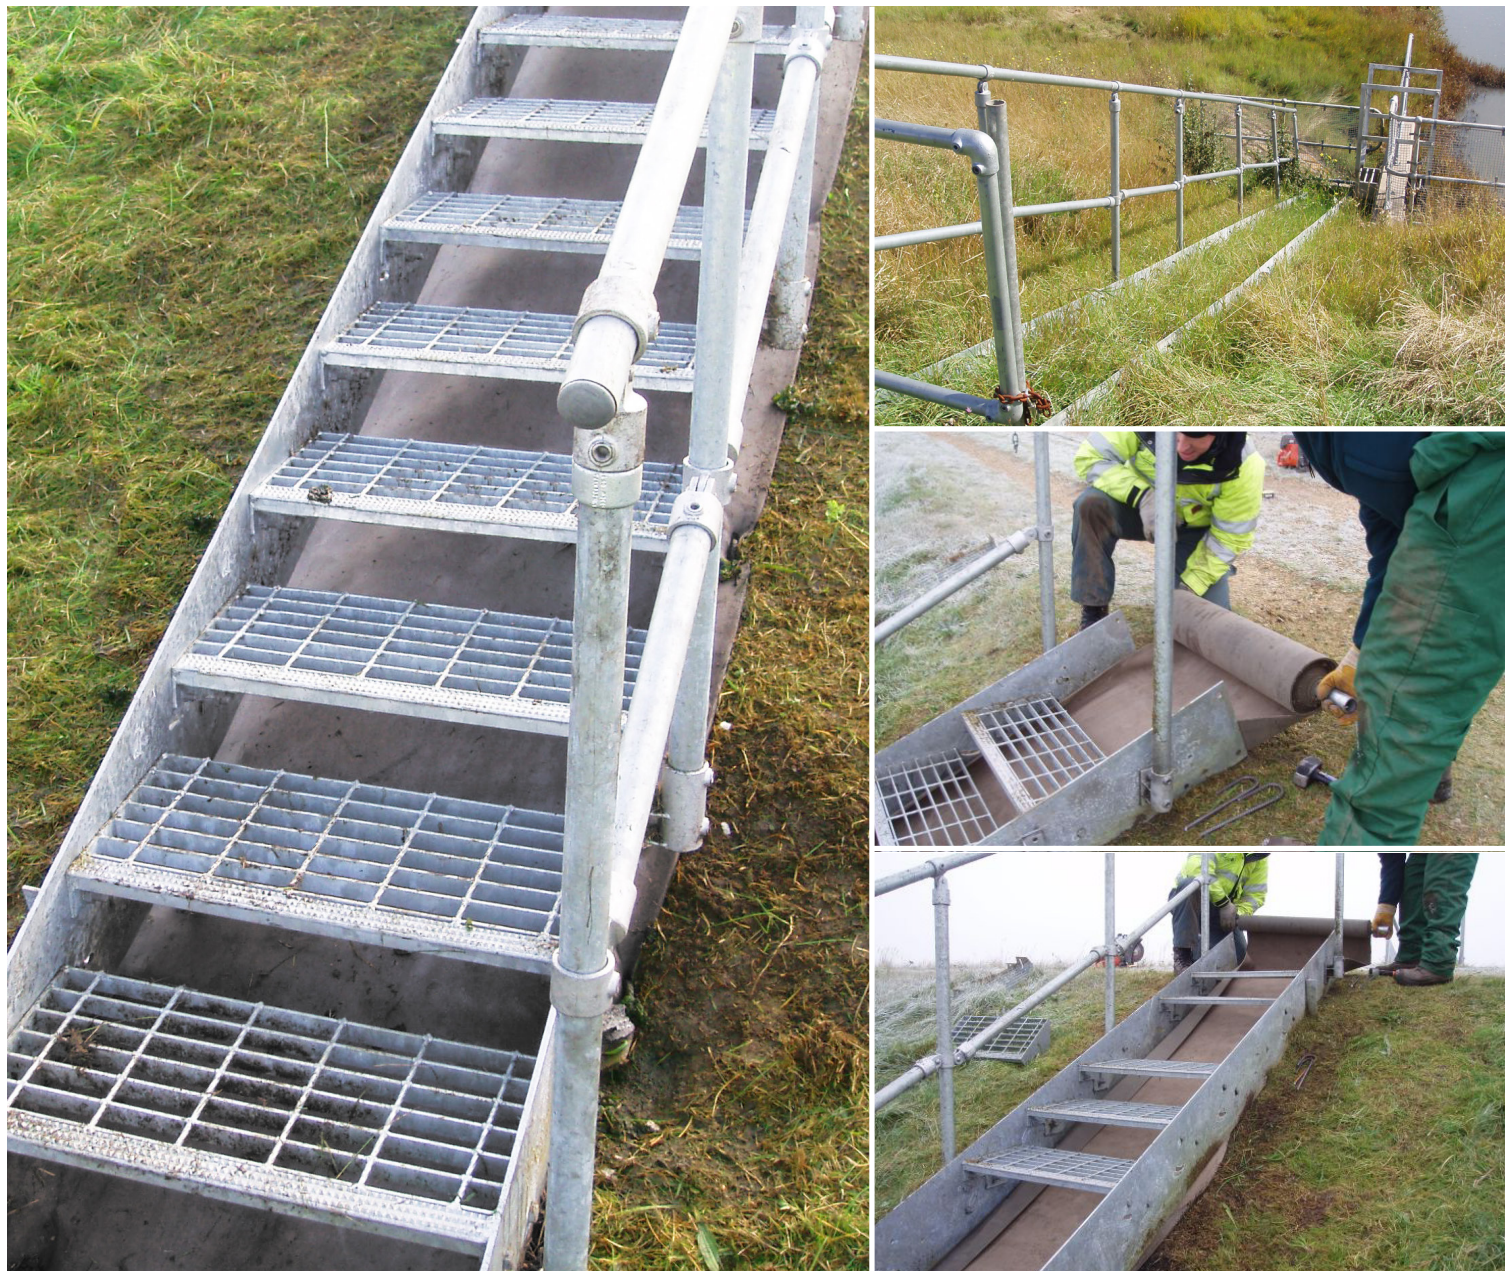
In December 2010, Concrete Canvas (CC) was trialled to inhibit weed growth beneath a set of steel seawall steps. The steps provide Environment Agency (EA) operatives safe access up/down their seawall embankments to structures such as sluices and pumping stations. The steps have an open tread mesh which allowed grass to grow up from beneath, meaning that additional maintenance was required to keep them clear from obstructions.

The grass and vegetation below the steps could not be removed using strimming equipment and herbicides were discounted as many of the seawalls that the stairs gave access to were environmentally designated sites (SSSI, RAMSAR, SPA, SAC etc.) and had nearby water. The decision was reached that the best way to prevent grass growth was to suppress the area beneath the stair access. A layer of geotextile or filter Canvas was considered but it was thought that this would degrade in UV and wouldn't provide a long term solution. CC4 was chosen instead for its durability and protection from weathering and UV degradation. The Canvas was installed quickly, by removing several of the step treads and unrolling a 10sqm batched roll down the embankment. This was advantageous as the steps did not have to be fully removed, which saved on time and did not require plant equipment. The EA were also able to take advantage of the borrow dyke ditch behind the seawall to collect water for hydrating the CC.

The project was considered a success and plans are being considered to apply Concrete Canvas to a number of other seawall step sites.
