CC5™ Wide Rolls

Agria, Volos, Greece

CC8™ and CC13™ used to line containment bunds at a petroleum tank farm owned by ELINOIL Hellenic Petroleum Company S.A.

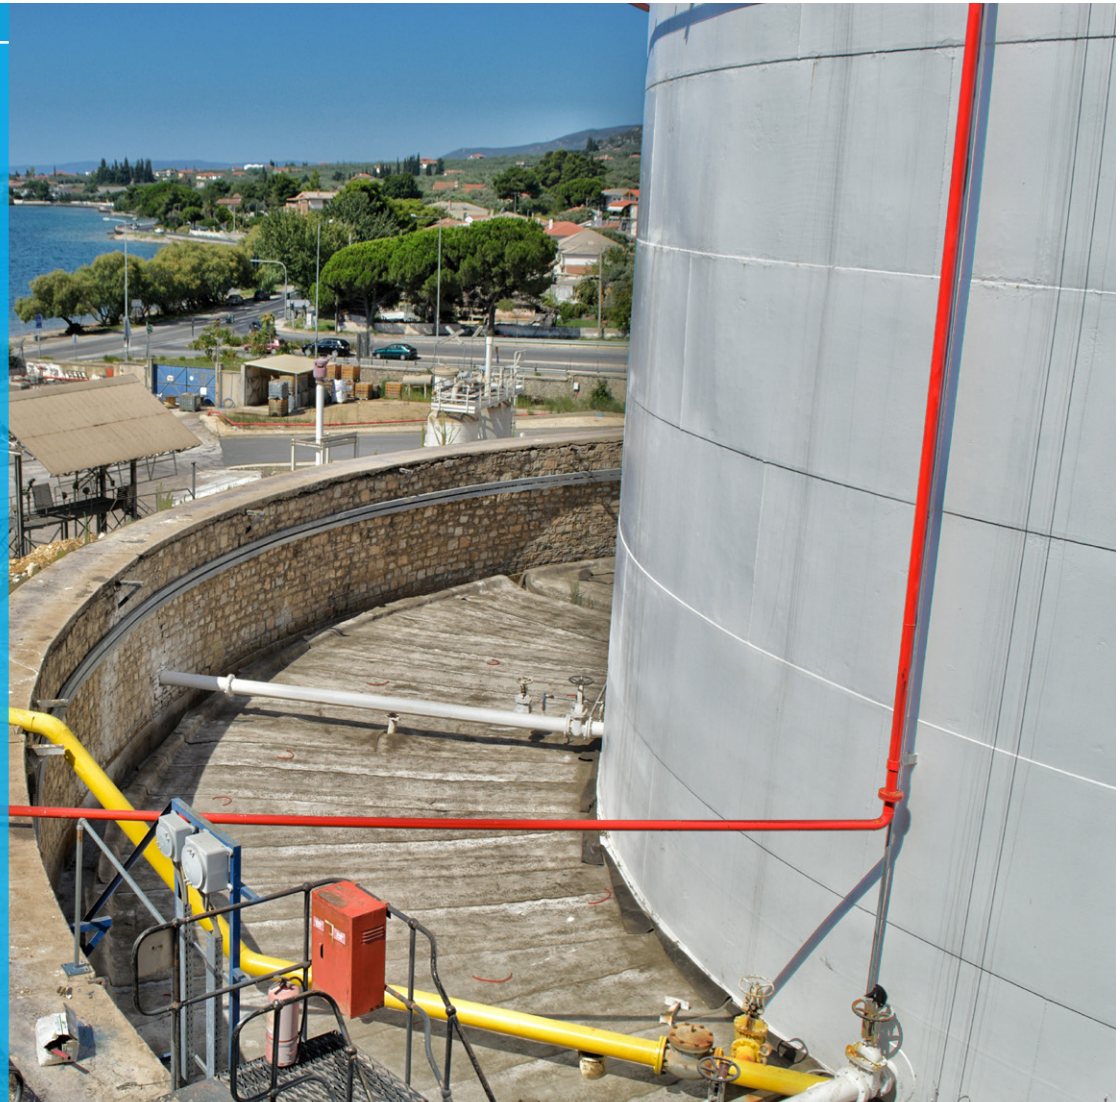
Completed CC lined bund area floor

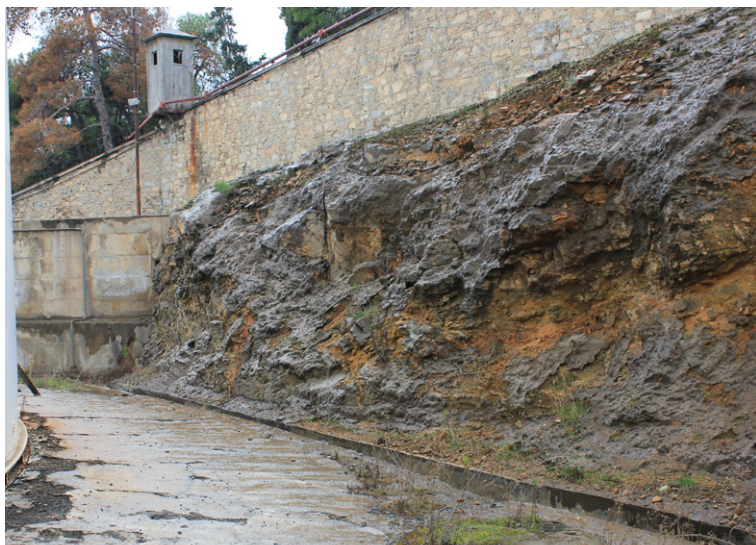
Slope around tank prior to works

The original concrete at the containment bund of liquid fuel tanks had cracked due to bad weather conditions, resulting in the requirement for CC to increase their impermeability and to prevent the surface of slopes from weathering and surface slip. The overall project involved laying CC around seven containment bunds as well as on vertical slopes and intermediate areas of the facility.

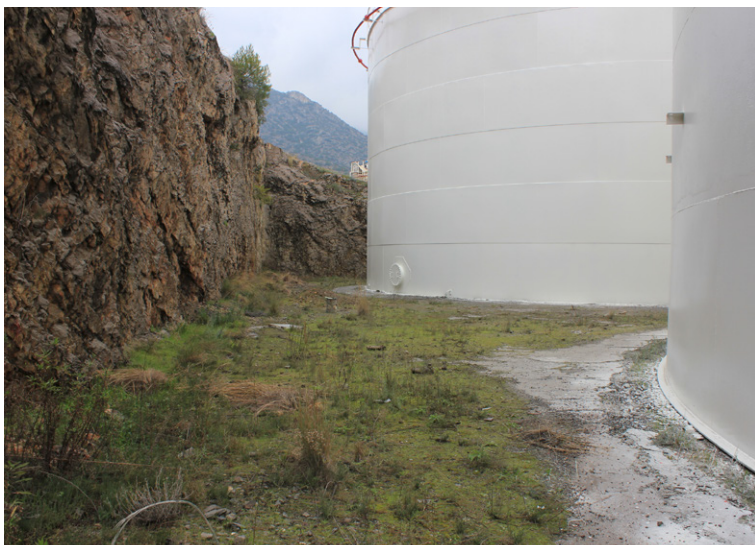
Vertical slope and bund floor prior to works

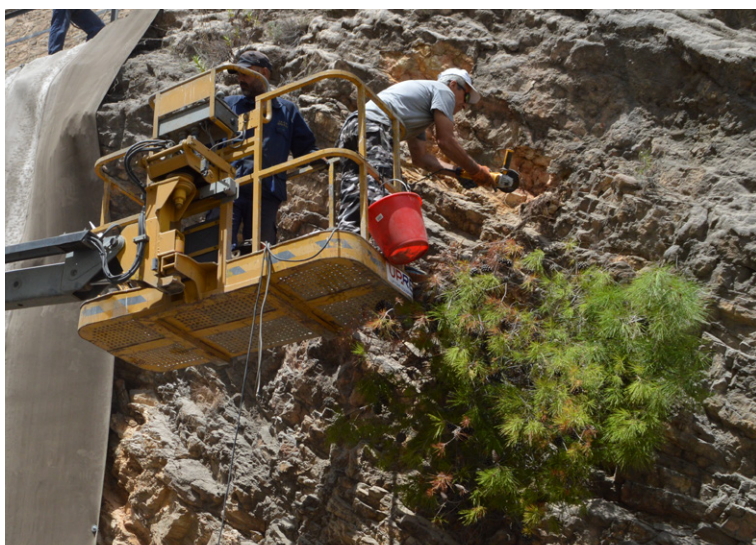
Removal of tree from slope prior to installation

In preparation for the installation of CC, all plants, rocks and debris were removed from the substrate in order for soil preparation to be carried out. The existing surfaces of the tank floors were cleaned and quarry sand applied to eliminate voids under the CC.

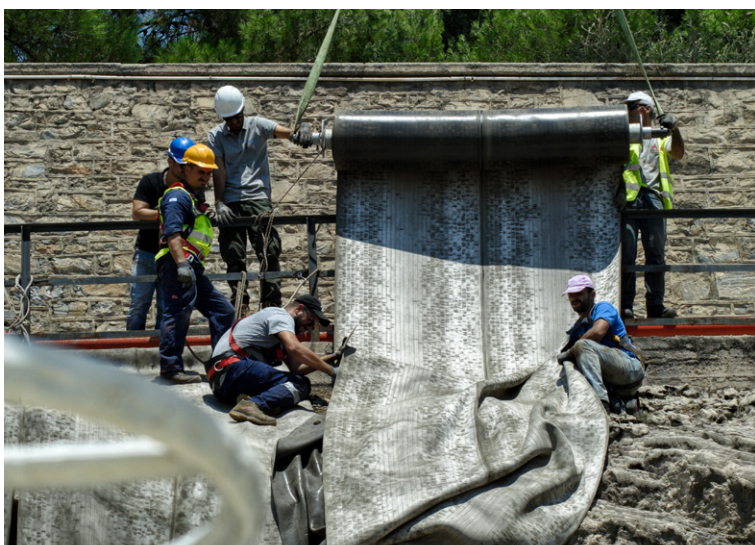
CC 2-wide rolls deployed from spreader beam from slope crest

The CC was mounted onto a spreader beam hung from a crane. The 2-wide rolls were then unrolled from the top of the slopes, with the team ensuring an overlap of 100mm between layers. The CC was cut to required length to prevent wastage and accommodate the varying height of the slope.

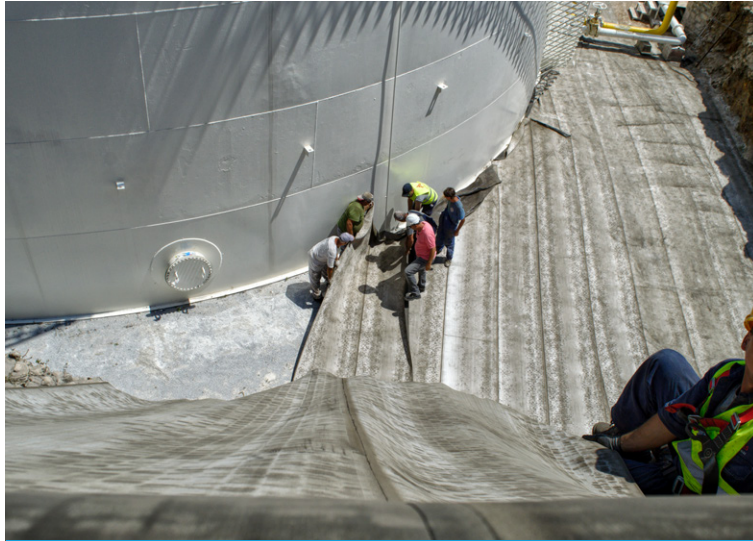
Length of CC deployed down slope and along bund floor

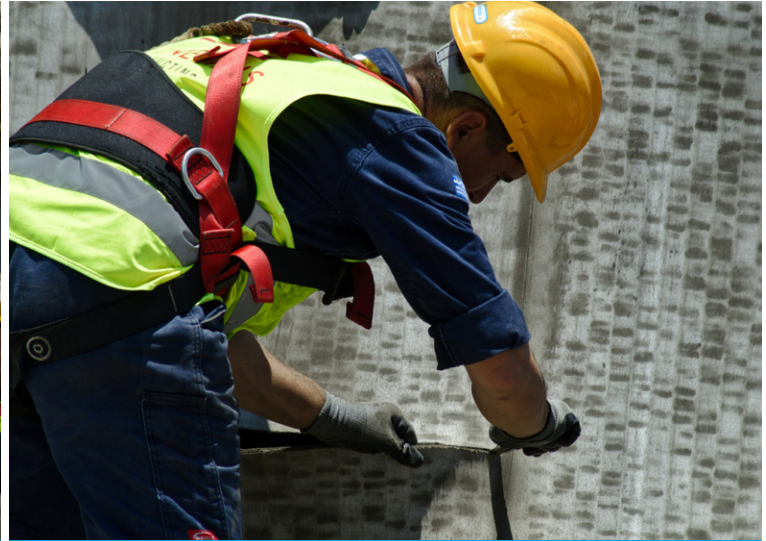
Cutting CC to required length to prevent wastage

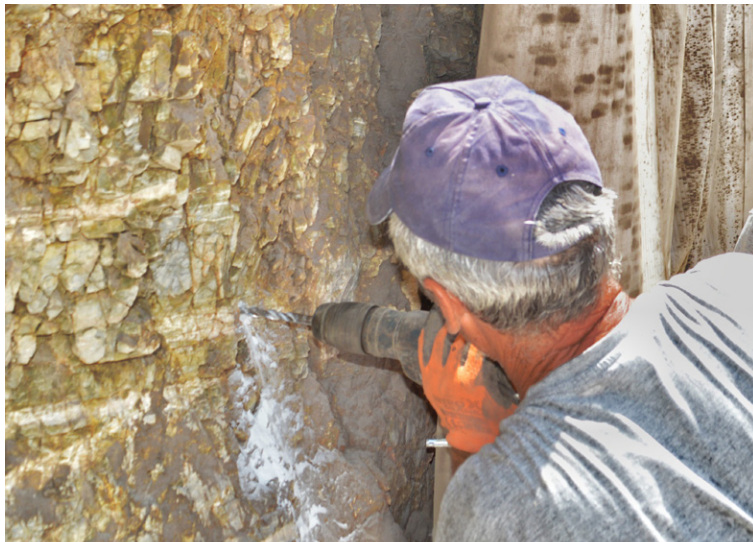
Drilling into rockface to allow fixing of CC to slope

The product was initially secured by fixing to the concrete surfaces with 37mm x 3.5mm Hilti nails with 23mm steel washers to prevent pull through. Between concrete walls and the crest of vertical slopes, 12mm x 250mm J-pegs were used to anchor layers of CC to the ground at 2m intervals. The slope's rocky surface was drilled and 14mm x 200mm anchor bolts used to secure the material to the substrate. All overlaps were sealed with an adhesive sealant and jointed using 25mm screws at 200mm intervals using an auto-fed screwdriver prior to hydration.

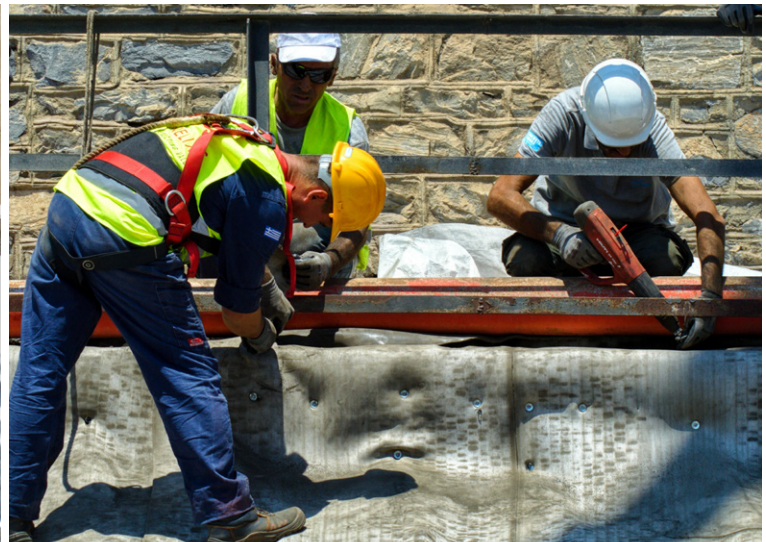
Fixing of CC to concrete wall at slope crest using Hilti nails

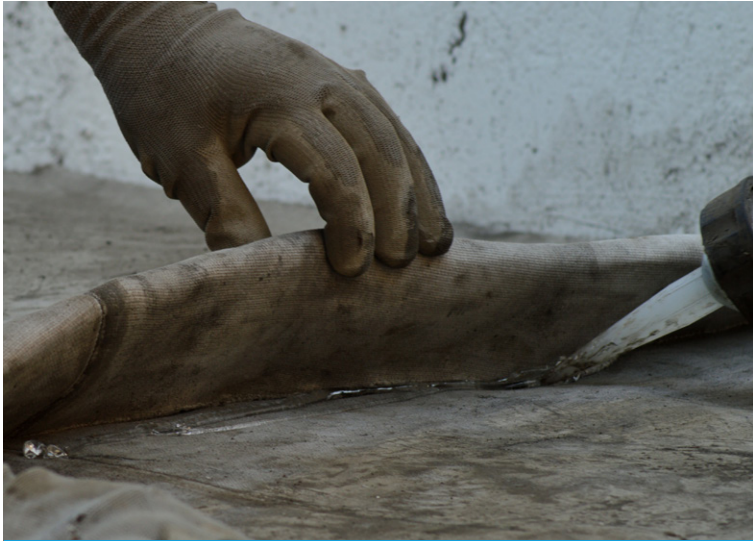
Adhesive sealant used to joint overlaps and prevent ingress

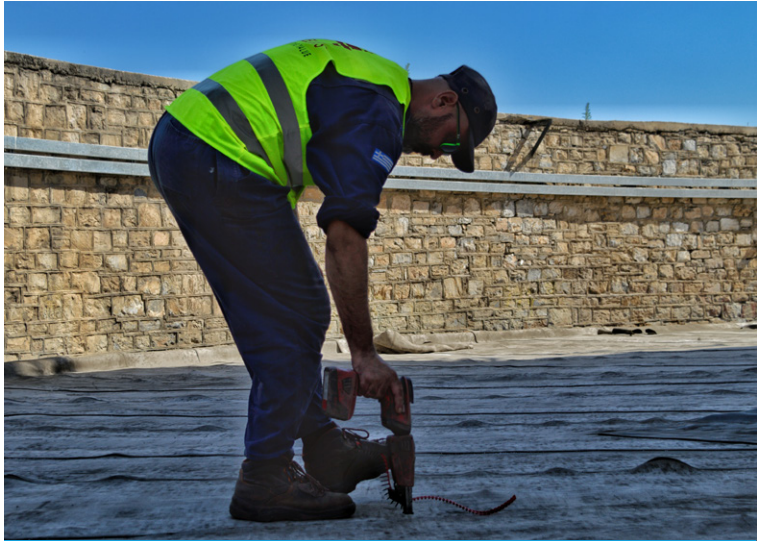
Overlaps on bund floor jointed using screws

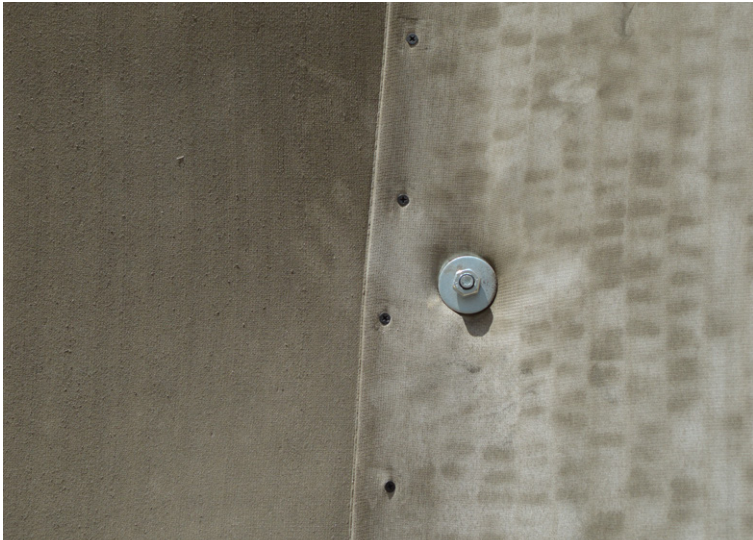
Screws and Hilti nails used to joint and fix CC to slope

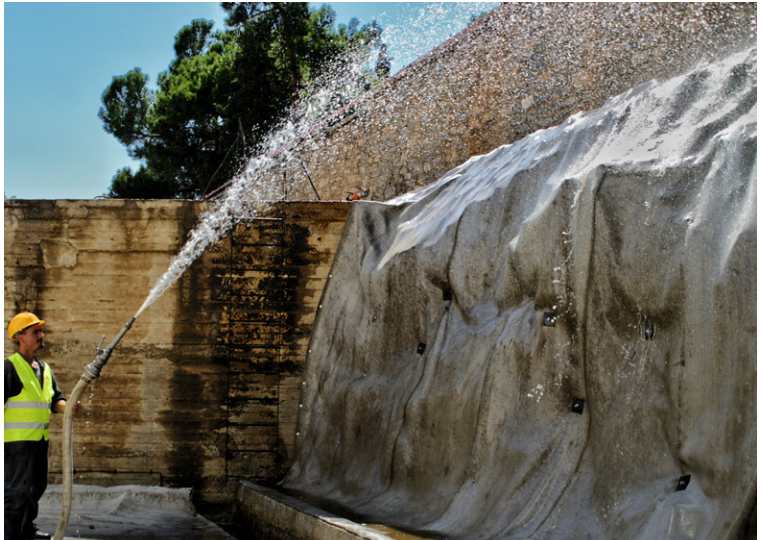
Hydration

The material was hydrated with sea water. Due to the high temperatures of around 35°C, hydration was carried out for over an hour twice to ensure adequate hydration.

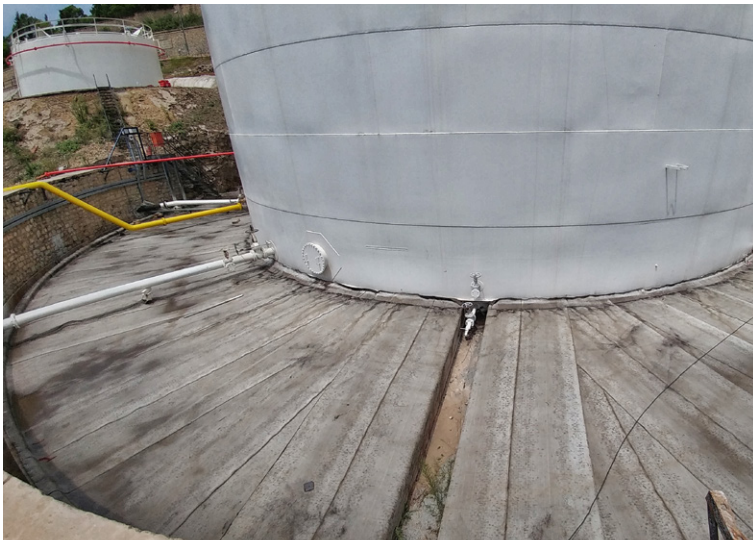
Completed bund floor area installation

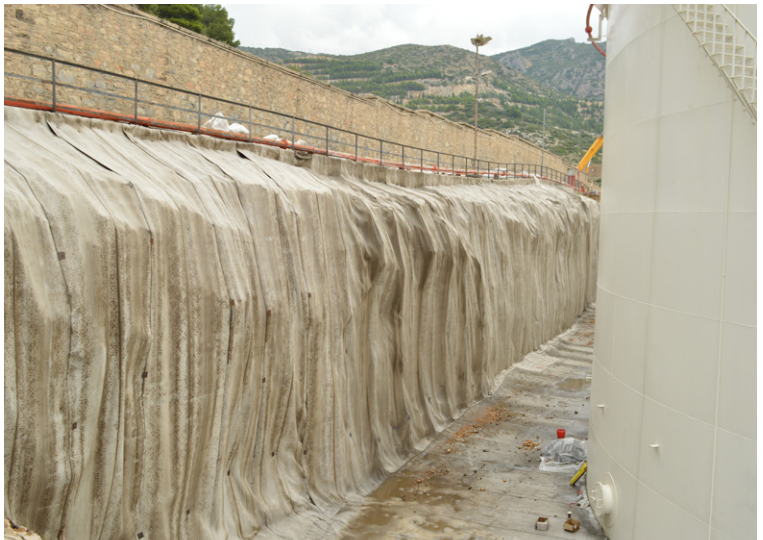
Completed slope and bund floor installation

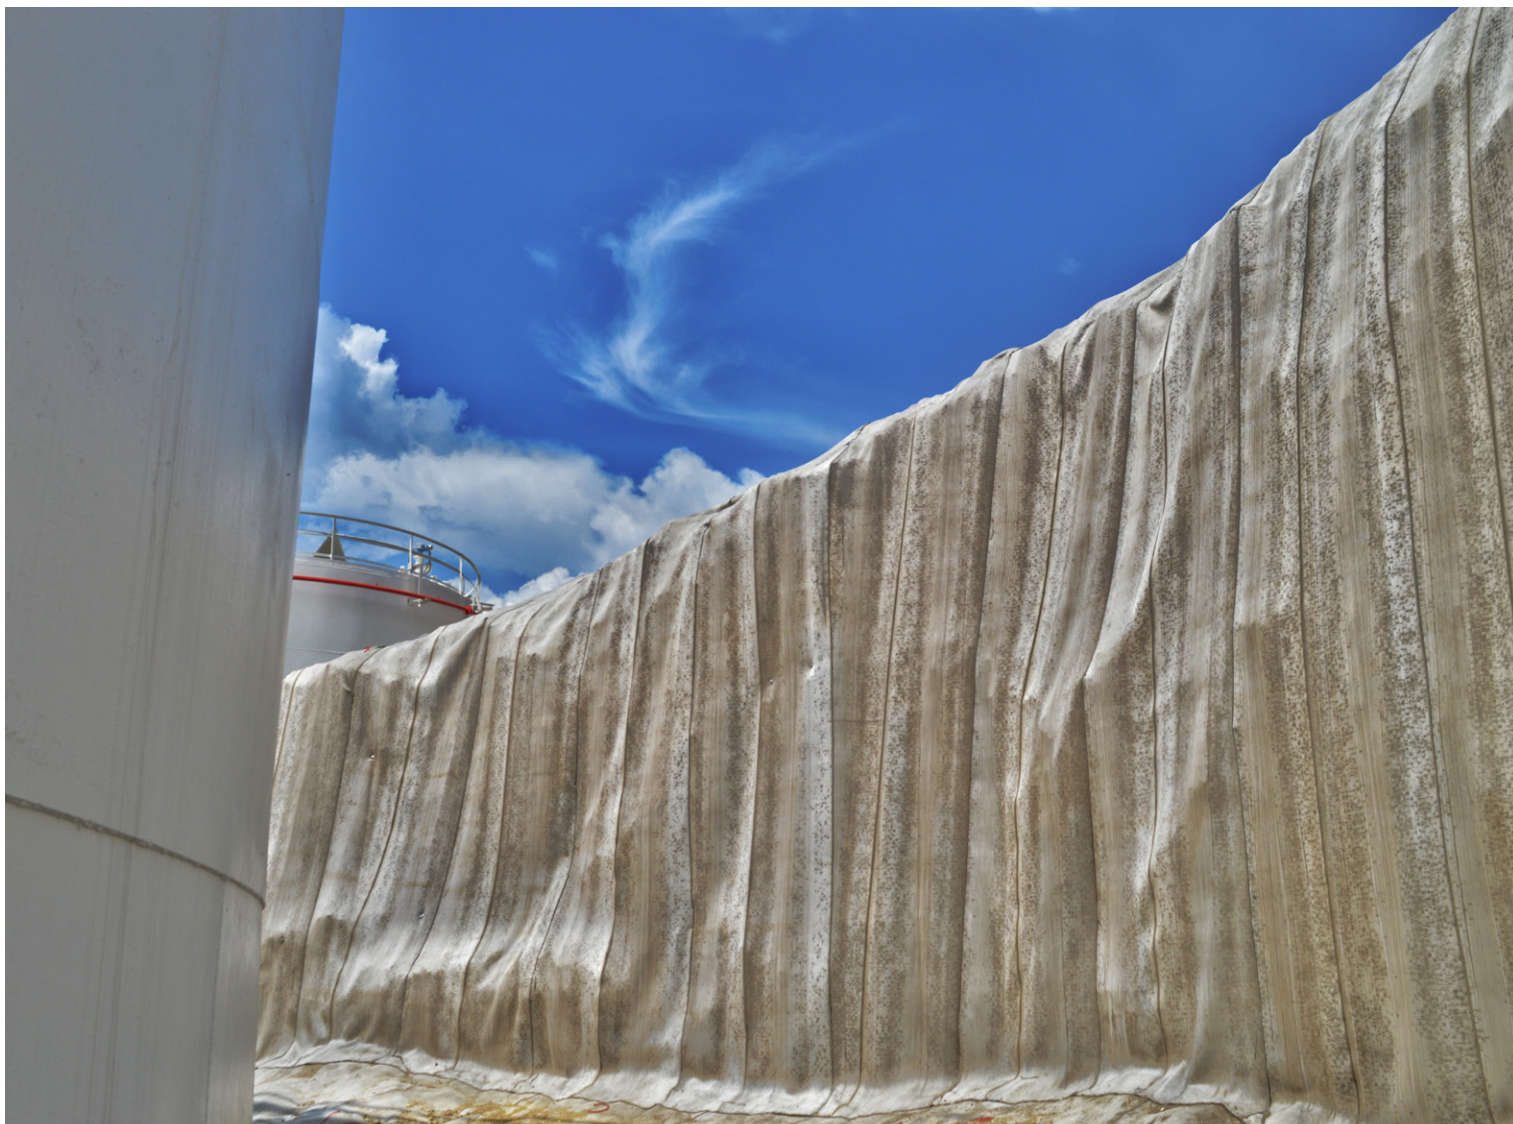
*Completed installation section*

A total of 5,600m² of CC5™ were installed in 14 days by a team of 9 people in inclement weather due to consistently high temperatures and intense rainfall, and despite limited access on site.
