-   01 / 06 / 20
-   CCH8™ Custom Bulk Rolls
-   900m<sup>2</sup>
-   Transverse layers
-   Logan Reservoir, Lanarkshire, Scotland
-

George Leslie Ltd & Sean Carr Lining Technology
-   CCH Hydro™ used to line a by-wash channel at the Logan Reservoir to reduce leakage and mitigate further erosion

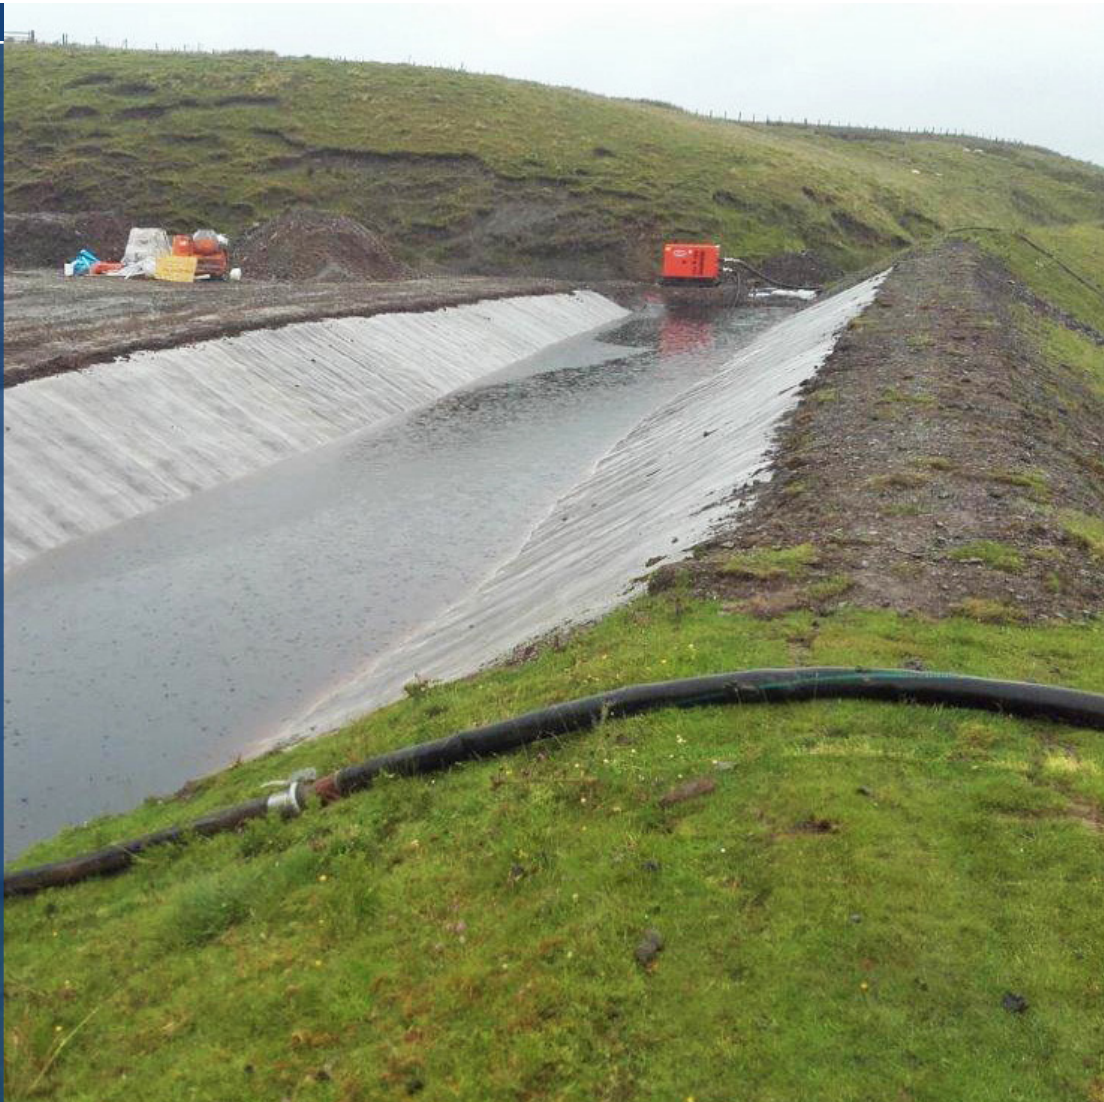
*Completed CCH channel lining installation at Scottish Water's Logan Reservoir in Scotland*

900m<sup>2</sup> of CCH8™ was installed within 2 weeks with an installation crew of 4 people despite the difficult to access site and inclement weather conditions. The material will provide long-term erosion control for the by-wash channel, reducing leakage which could have potentially led to the possible collapse of the by-wash embankment. The CC Hydro™ material is being considered by the consultant and client for similar schemes in the future.

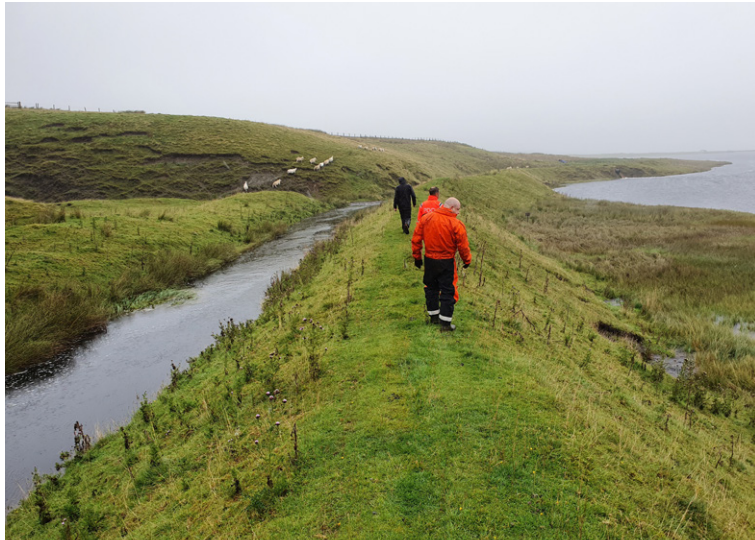
During the site walkover substantial leakage was observed flowing from the downstream toe of the embankment into the reservoir. The leakage was located over an approximately 50m length of embankment.

The leakage flow appeared to have been ongoing for some time with established leakage paths and had caused erosion of the downstream face of the by-wash embankment. There was a risk that as the leakage continued through the embankment erosion may continue and cause the embankment to become unstable.

*Leakage at the downstream toe of by-wash embankment*

It was likely that the leakage path started from the invert of the by-wash channel and to mitigate the risk of continued erosion, leading to possible collapse of the by-wash embankment and uncontrolled inflows in to the reservoir, it was recommended that remedial works were carried out to reduce the leakage.

Therefore, it was decided to line the invert of the by-wash channel with an impermeable barrier over a 50m length and in January 2020 900m<sup>2</sup> of Concrete Canvas Hydro (CCH) GCCB\* material was specified to reduce the leakage and mitigate the risk of continued erosion.

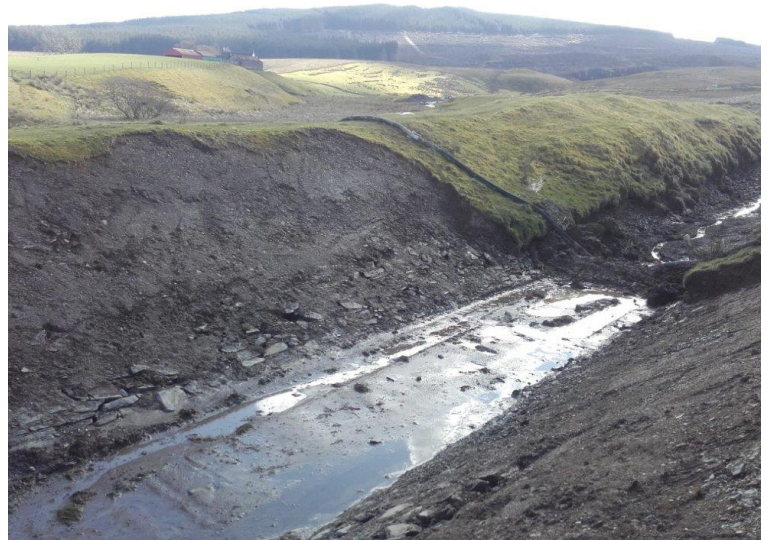
*Draining & excavation of by-wash channel*

To prepare it for installation, the channel was dewatered and re-profiled to achieve a constant fall, graded and then compacted using plate compactors. 150mm anchor trenches were then prepared on both sides of the channel for the CCH termination. The CCH was then deployed transversely across the channel and cut to length with the leading and trailing ends captured within the anchor trenches and secured to the substrate using steel ground pegs.

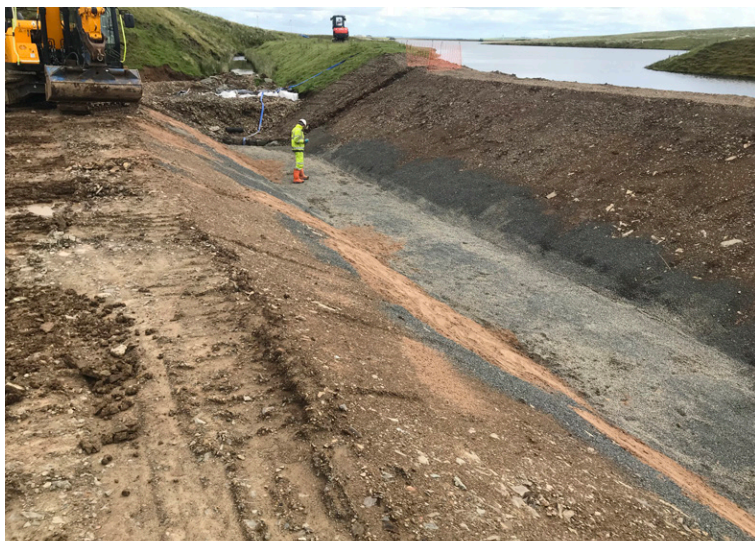
*Regading the by-wash channel*

Gravel and cobble alluvial deposits at the confluence of the by-wash channel with the Blaeberry Burn were observed to have altered the profile of the by-wash channel.

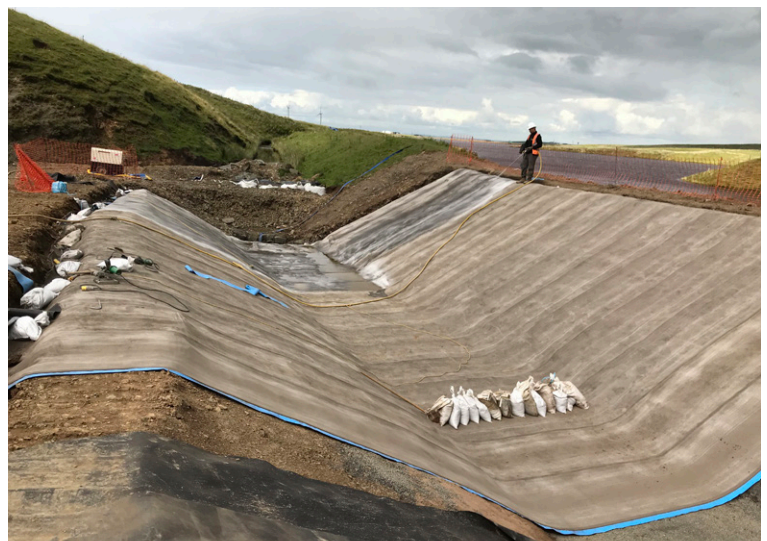
*CCH transverse layout*

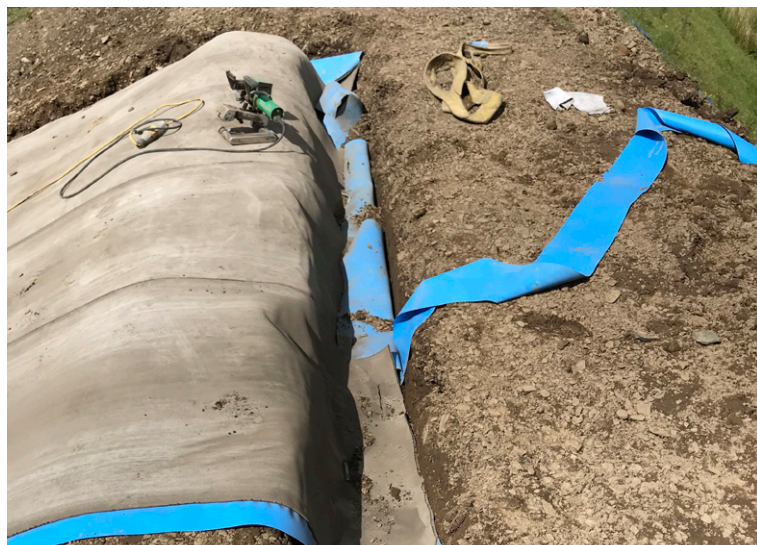
CCH terminated into 150mm anchor trenches prior to backfill

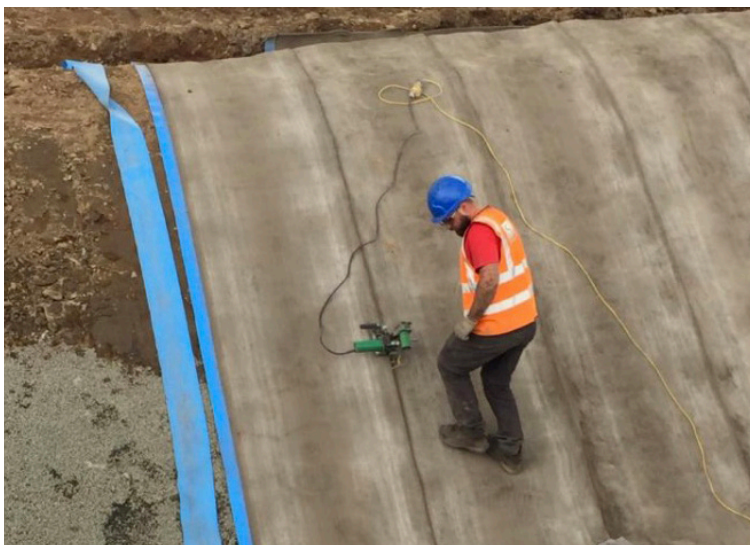
Thermal welding of CCH overlaps

After laying a section of CCH, the PVC backing of the layers were wiped clean and the joints thermally welded with a double-track air channel with a speed setting of 1.8m/min and temperature of 500°C. A hand-held heat gun fitted with a perforated slot nozzle was then used to bond the concrete surfaces together which provided additional protection to the CCH membrane from environmental exposure and resulted in a neater finish. The edges of the CCH were then captured in the pre-dug anchor trenches, which were backfilled to prevent water ingress and provide a neat edge termination.

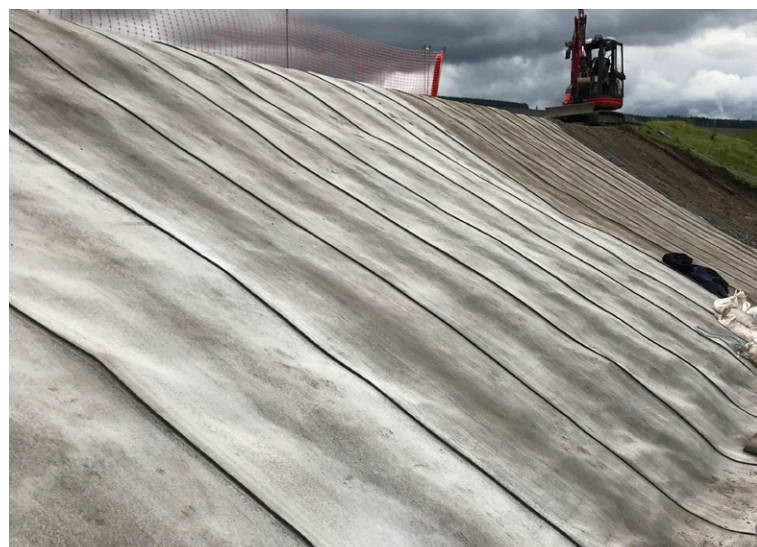
Completed joint detail

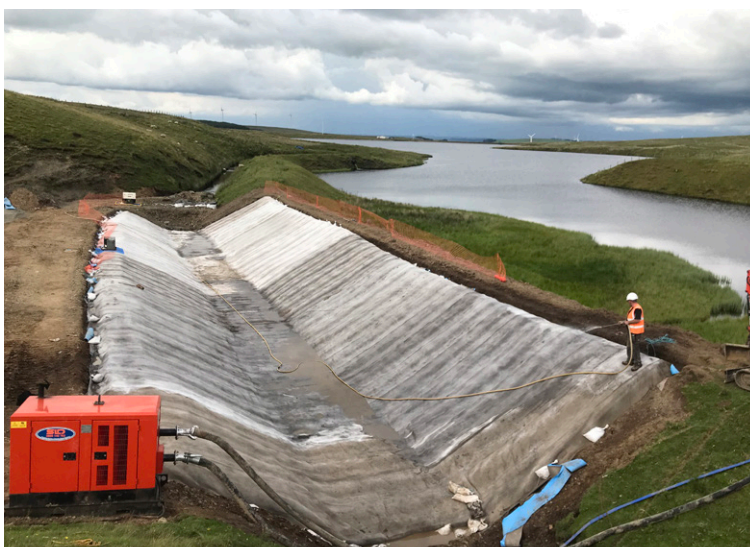
Hydrating the CCH material

The material was hydrated using a pump and hose with a diffused spray nozzle from a local watercourse. When the CCH had set, the anchor trenches on the leading and trailing edges were filled with poured concrete to ensure no water ingress and provide a smooth transition from the CCH lined channel into the unlined section of channel.

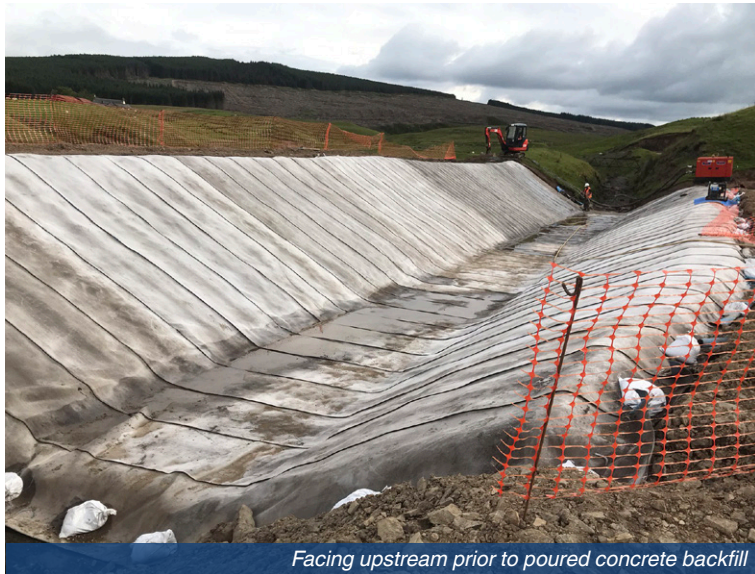
*Facing upstream prior to poured concrete backfill*

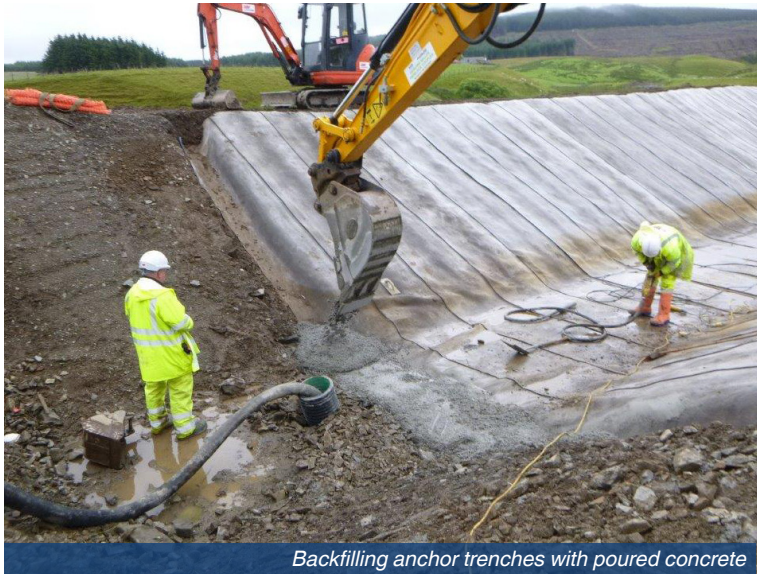
*Backfilling anchor trenches with poured concrete*

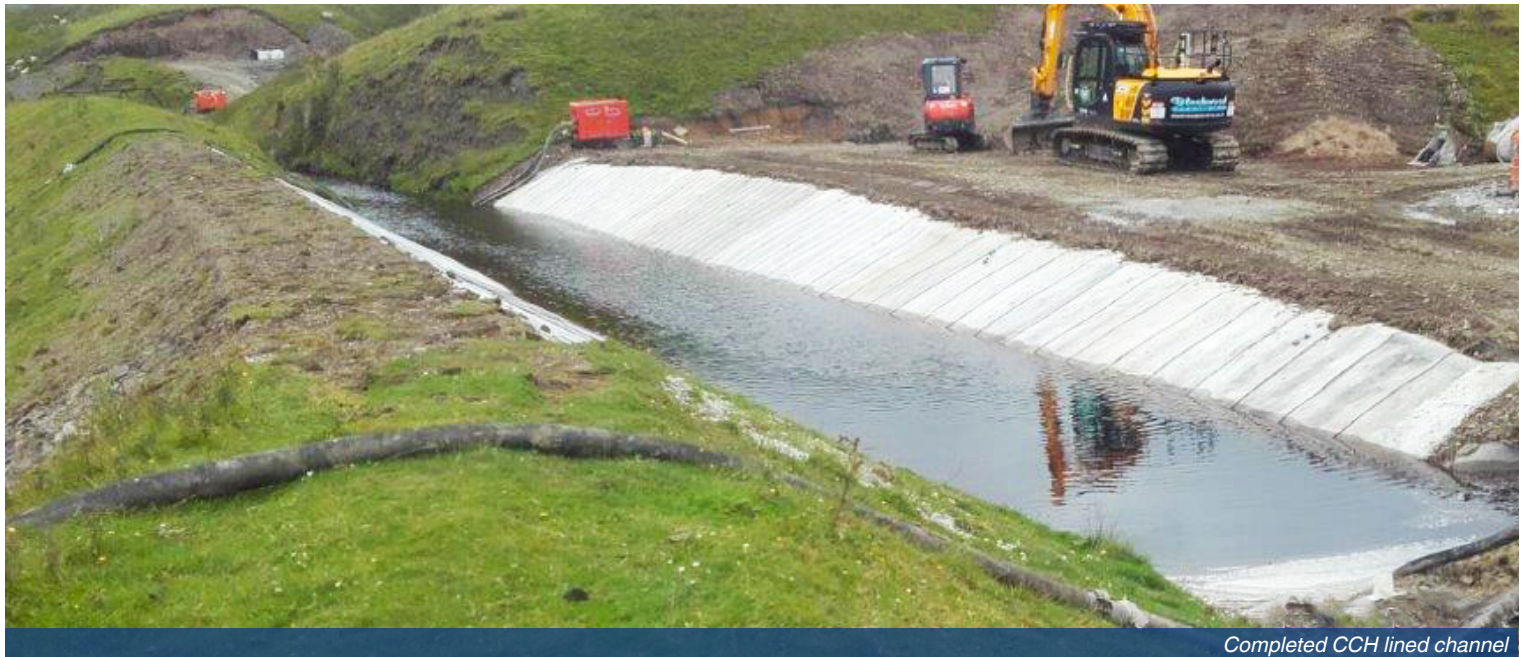
*Completed CCH lined channel*
