CCH8™ Bulk Rolls

CCH8™ was used to remediate a gravity thickener tank floor to extend its operational life and ensure efficient functioning at a mine in South Africa.

In November 2016, CC Hydro™ was used to line a gravity thickener tank floor at Exxaro's Grootegeluk mine in Lephalale, South Africa.

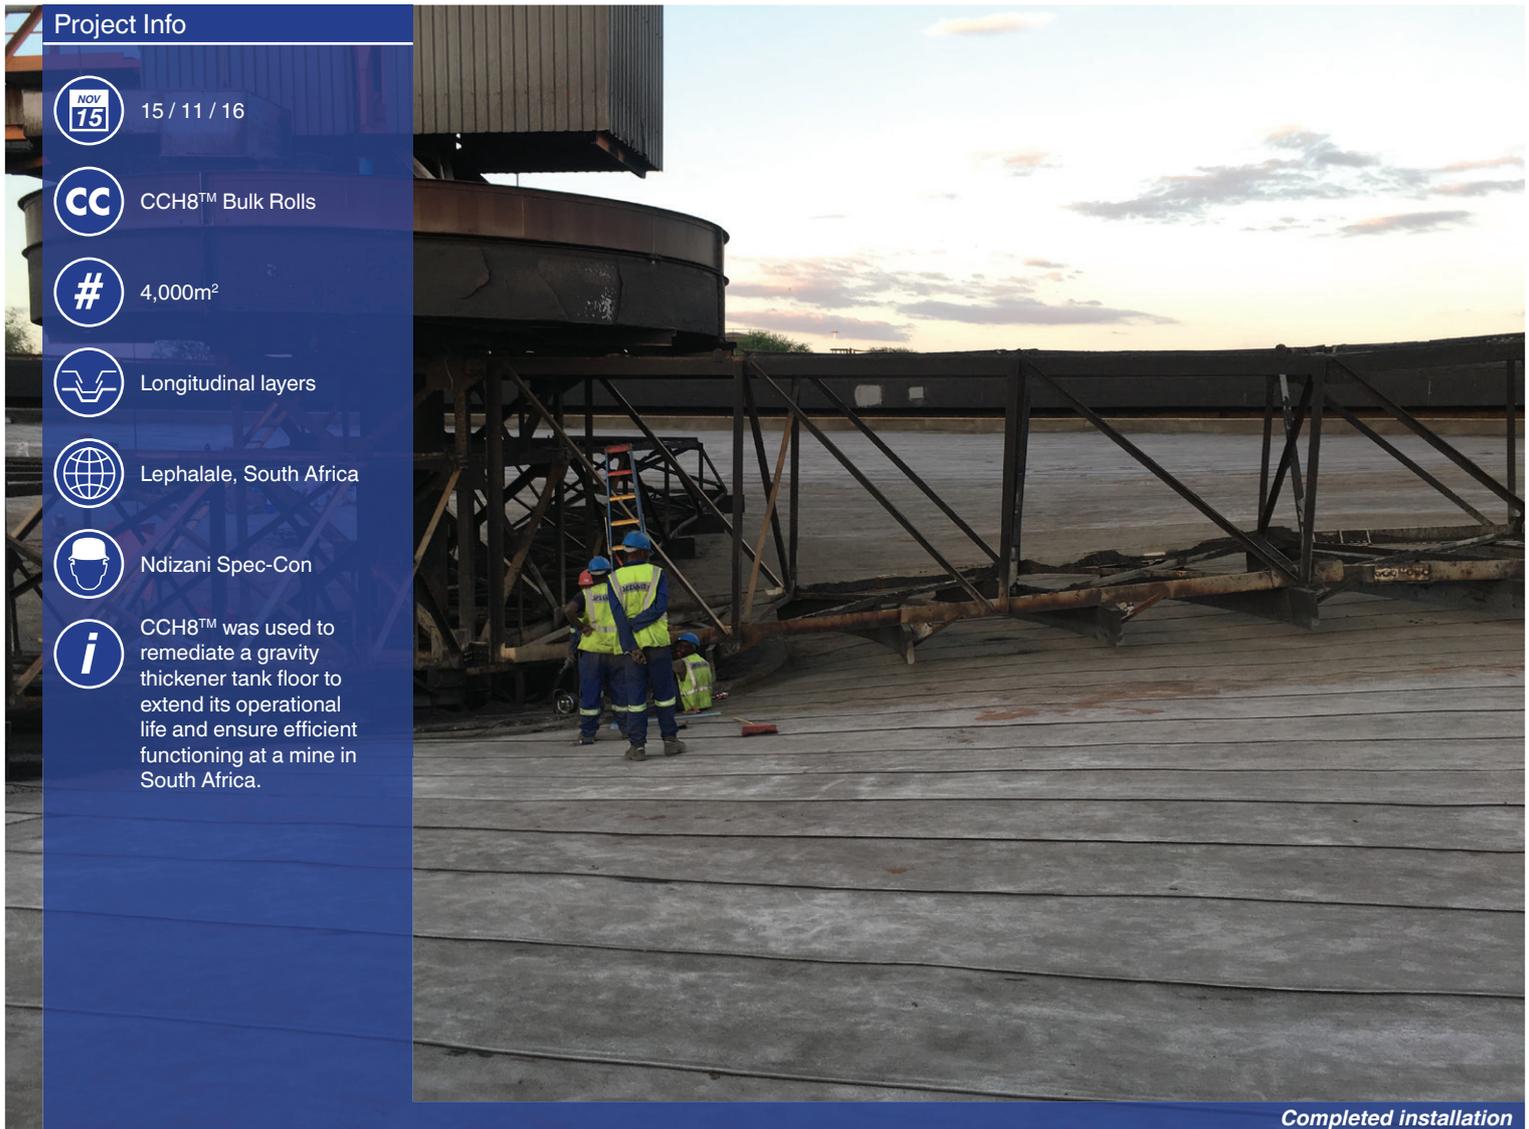
Completed installation

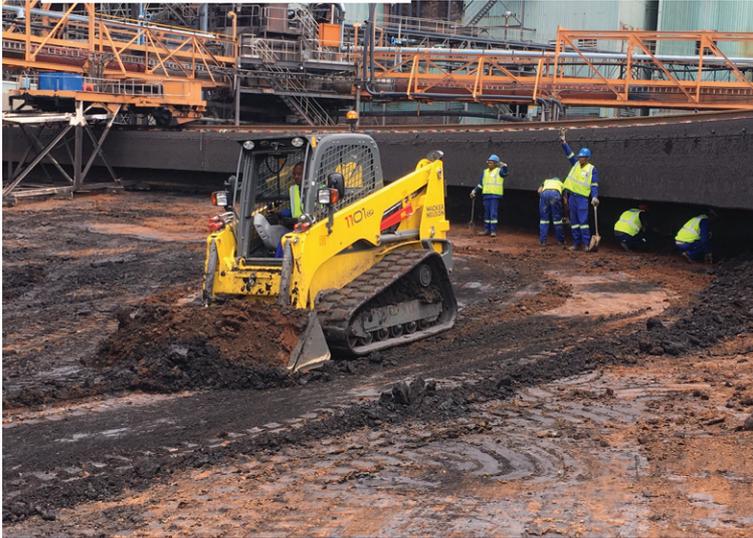
The tank was drawn down and sediment removed before installation

Within the 3-week maintenance period the tank has to be drawn down, sediment removed and the current gravel wearing course re-graded and compacted prior to any lining. However, the timeframe allocated to the installation of CCH8™ was just 7 days due to the limited time remaining in the program after completion of other items.

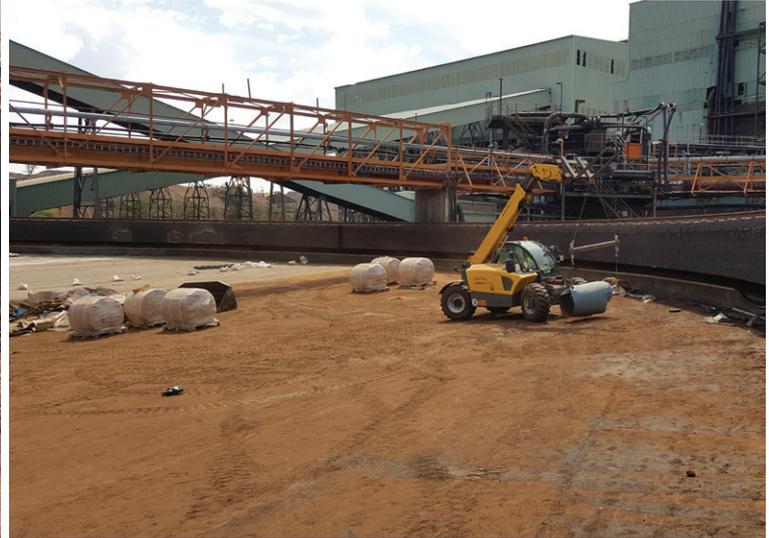
The CCH was delivered to site in bulk rolls

Once the ground preparation had been completed, the CCH8™ was delivered to site in bulk rolls. These rolls were then lifted into the tank and manipulated on site in accordance with stringent occupational health and safety standards. Once unrolled and positioned, thermal welding of the geomembrane was conducted and the welds pressure tested. Once welding was completed, the CC Hydro™ was hydrated.

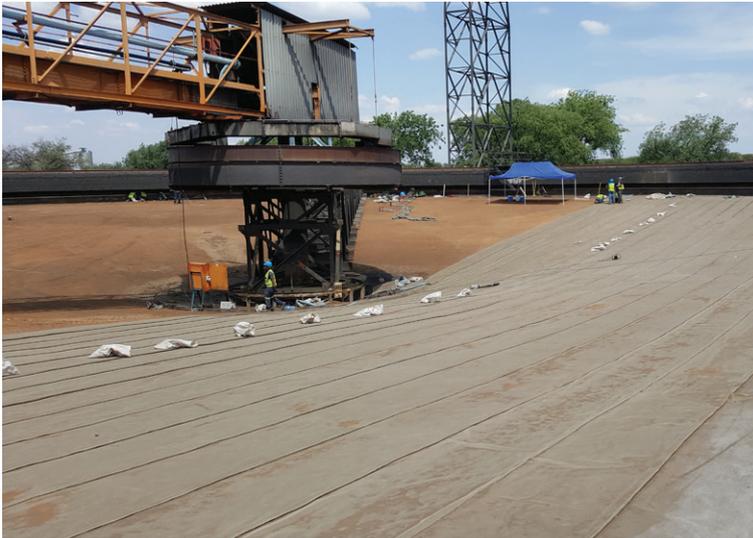
The CCH was installed over 7 days

In total, around 4,000m<sup>2</sup> of CCH8™ was laid within the allocated 7 days without any interruption.

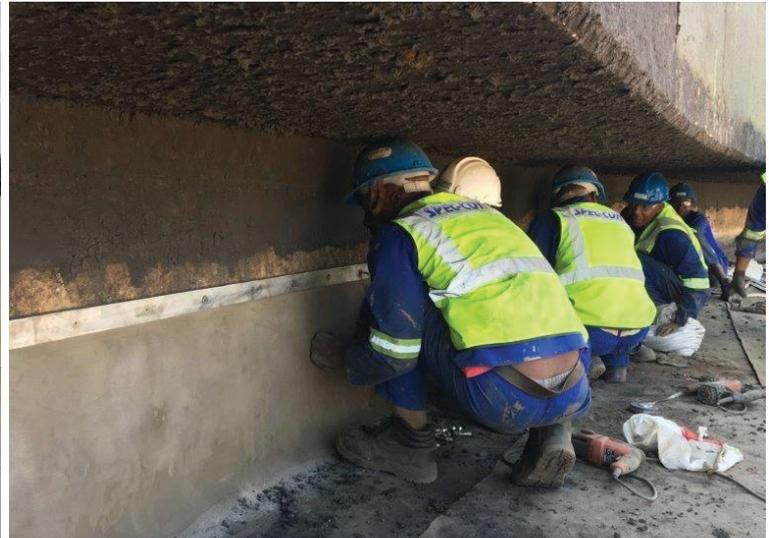
Fixing the CCH to the tank walls

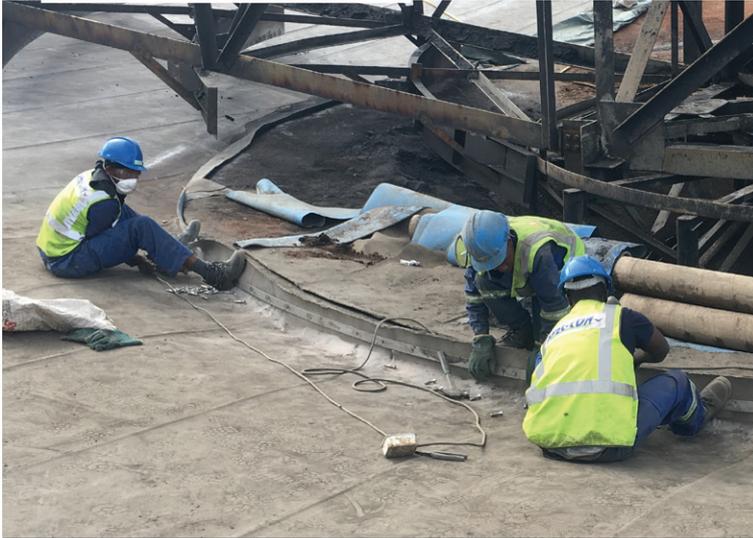
The flexible CC was easily fitted to the complex shape of the tank

The client was satisfied with the outcome of the installation, and impressed with how easily CC Hydro™ could be cut to fit the tank without any kinking or rippling. The tank is once again operational.

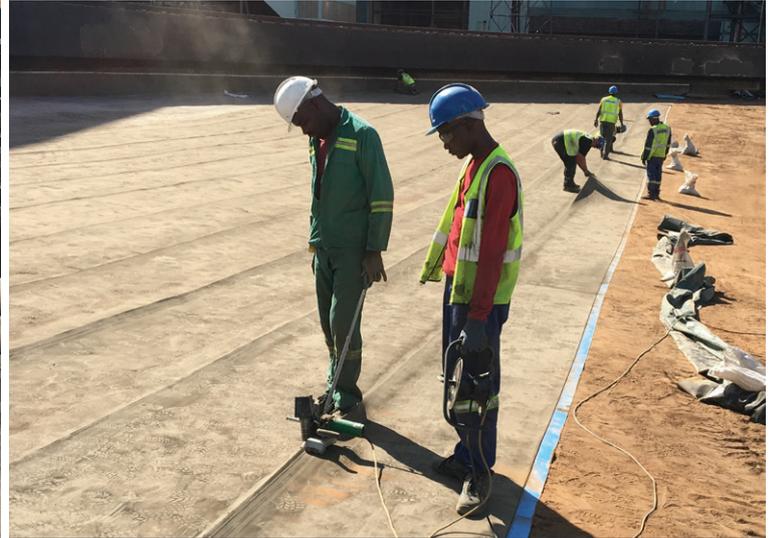
Thermal welding

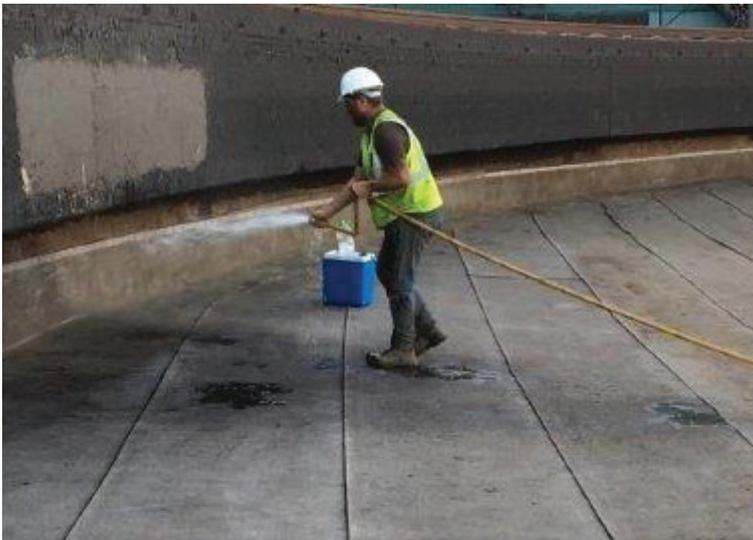
Hydration of the CC Hydro™

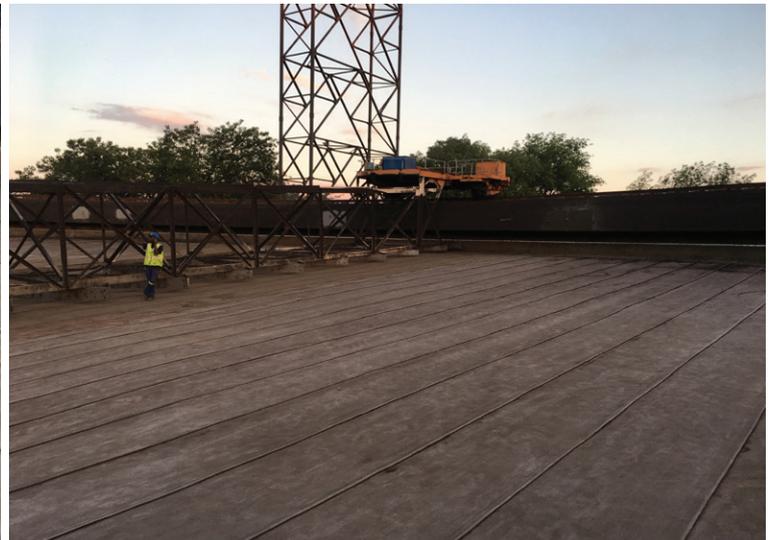
Completed installation
