CC Hydro™ used to remediate the walls of a concrete digestate tank to prevent further leakage into the local environment

Completed CCH digestate tank remediation

In July 2019, CC Hydro™ was chosen to remediate a leaking concrete digestate tank at an undisclosed Biogas plant in Central Europe.

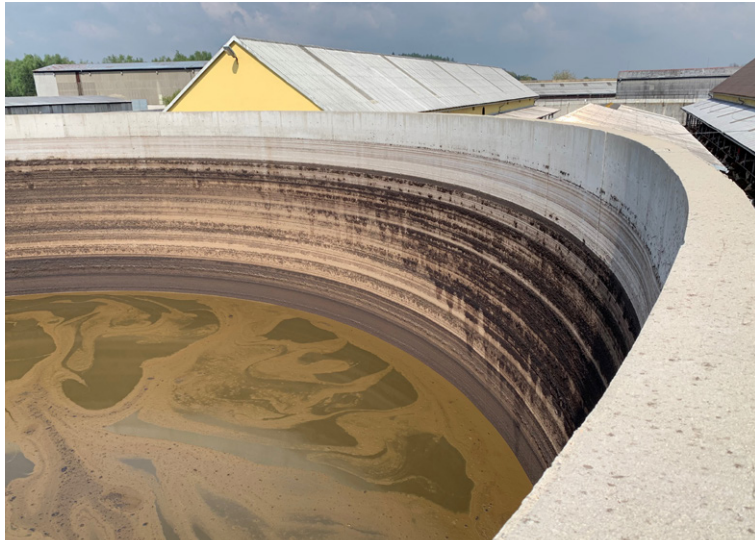
The digestate tank measured 9m high and had 300mm thick walls

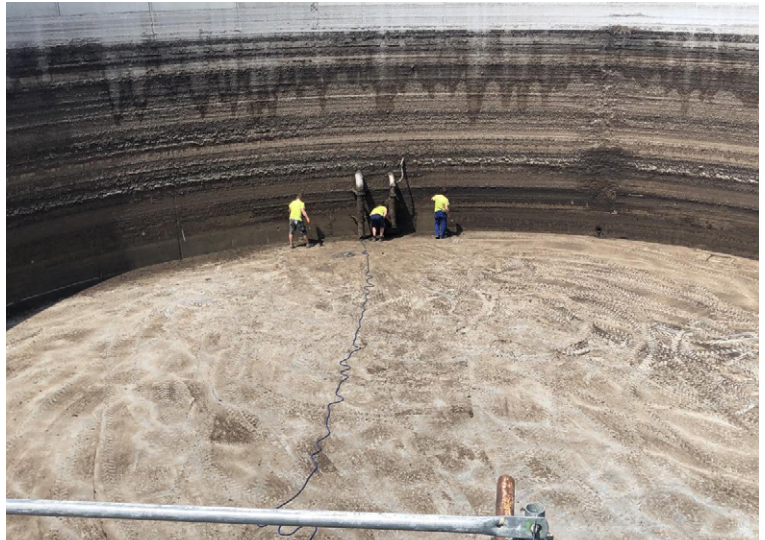
Clearing digestate from walls following emptying of tank

Prior to installation, the tank was emptied, scraped clean and then pressure washed to remove the digestate. Any large cracks were then repaired using a mortar cement to eliminate any potential voids below the CCH material.

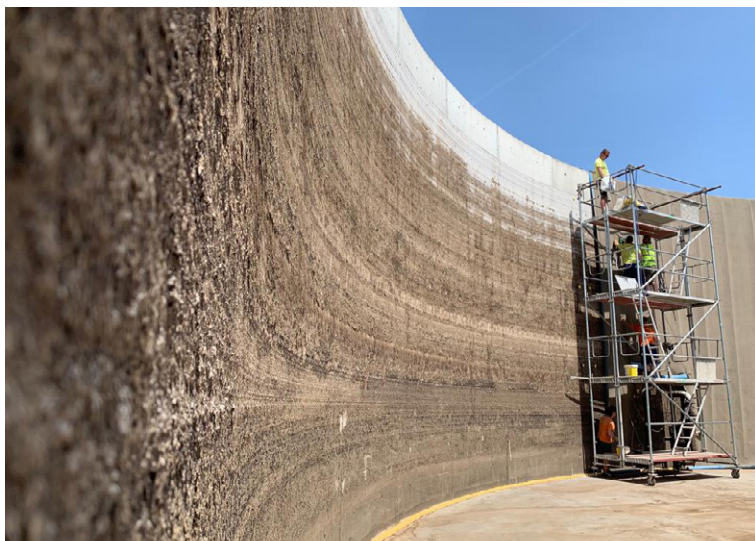
Walls were degrading due to varying levels of stored leachate

The tank had numerous cracks greater than 0.2mm and was leaking digestate into the local environment. As a result, the local environmental agency demanded for the tank to be remediated.

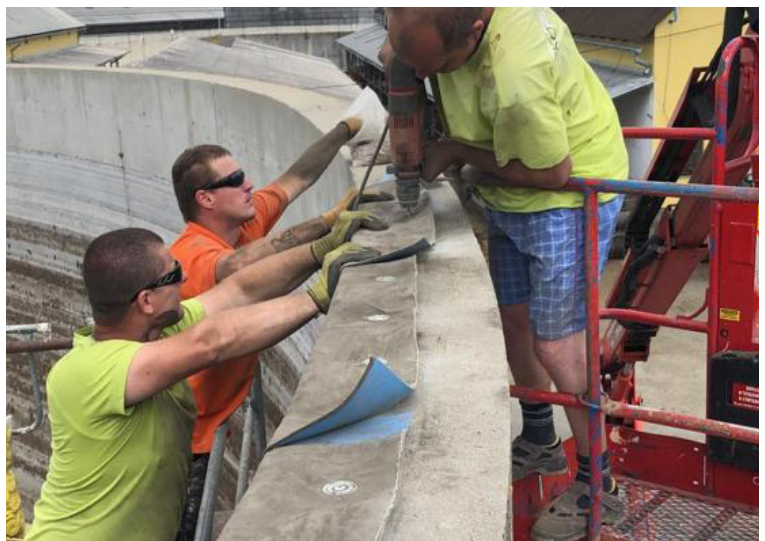
Leading edges were secured to wall top with SS bolts

At the top of the tank, the CCH5™ material was laid flat onto the 300mm wide tank wall and mechanically fixed using stainless steel bolts and washers. The CCH was again bolted to the tank wall at the base, and a concrete plinth measuring around 300mm high by 500mm wide was poured following completion of the installation to ensure good anchorage of the material.

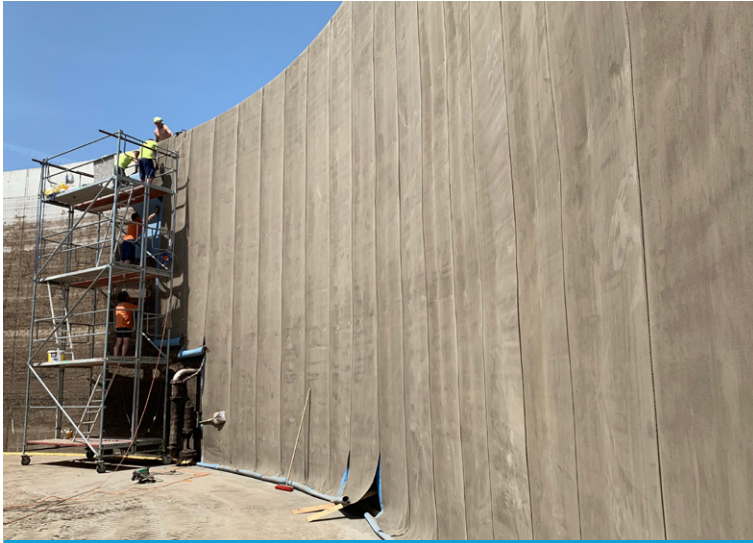
Installation was carried out using a portable scaffolding tower

Due to the height of the tank, which stands at 9m, a mobile scaffolding tower was constructed within the tank and moved along the wall as the installation progressed. This allowed the welding device, a Leister Twinny S with triple track adaption, to be guided down the length of the wall by operators without a stop-start process.

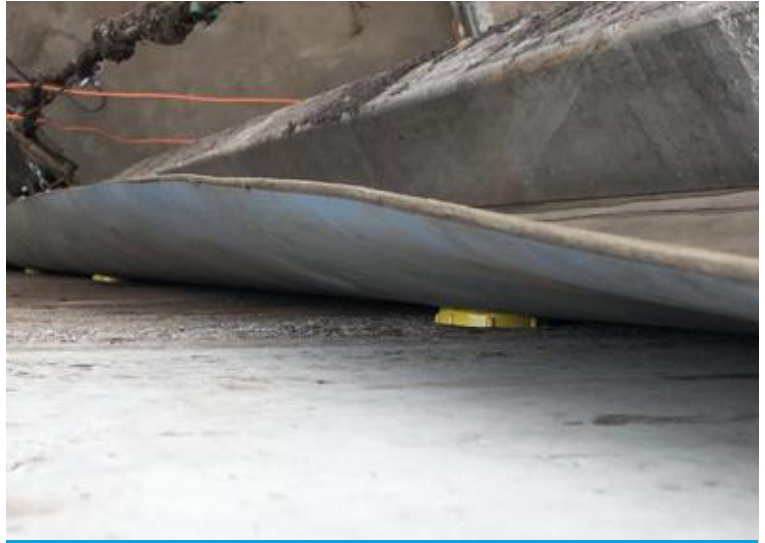
CCH was welded to Sika WP discs to ensure flush contact with the wall

To ensure the CCH sat flush to the vertical wall, four Sika WP Discs were secured to the wall per square metre to which the CCH was then welded.

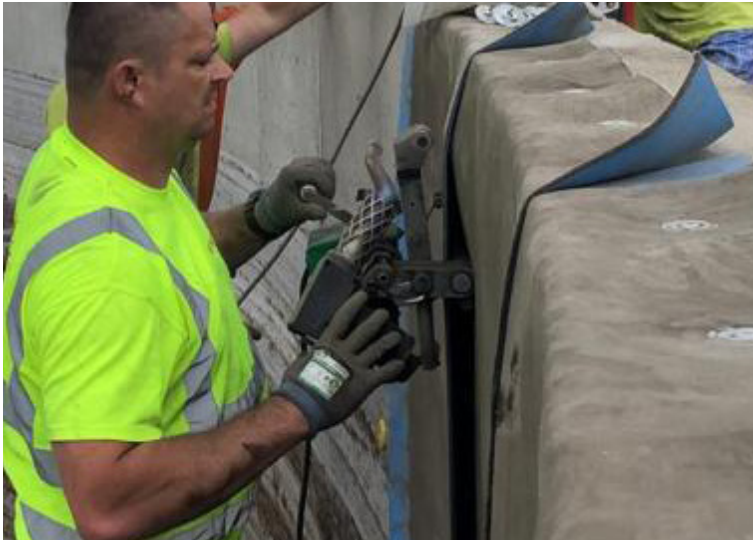
Lengths of CCH were welded together using a Leister Twinnys S

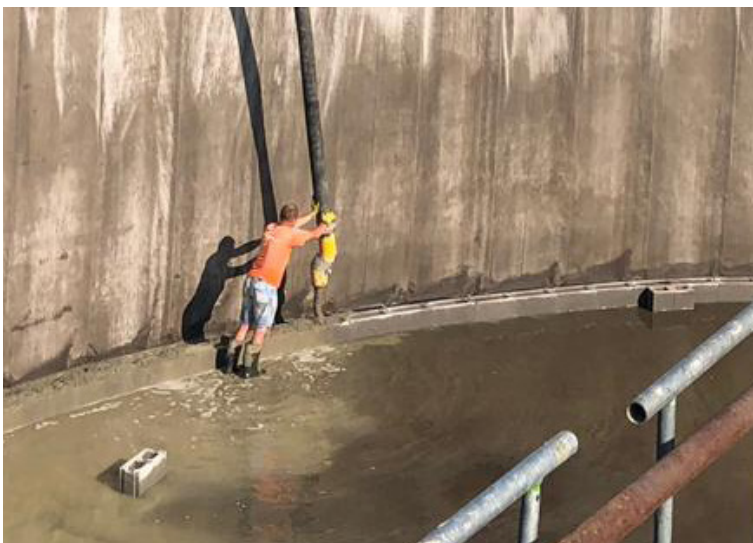
Pouring the concrete curb

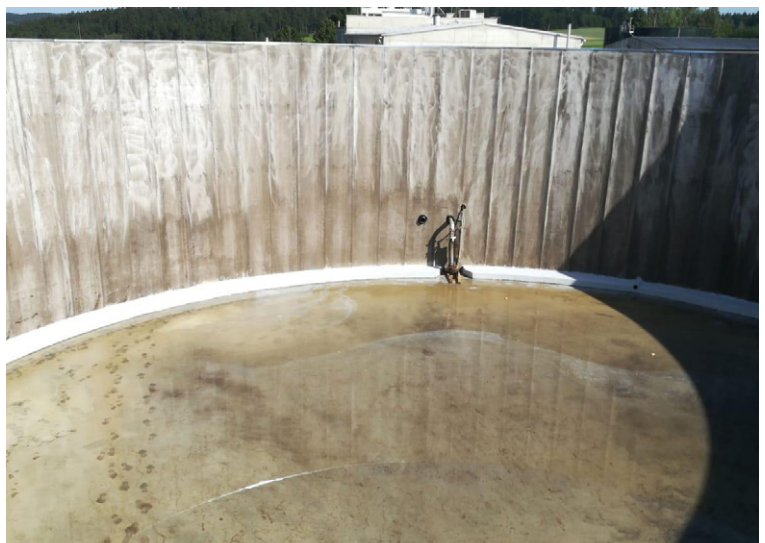
Completed installation

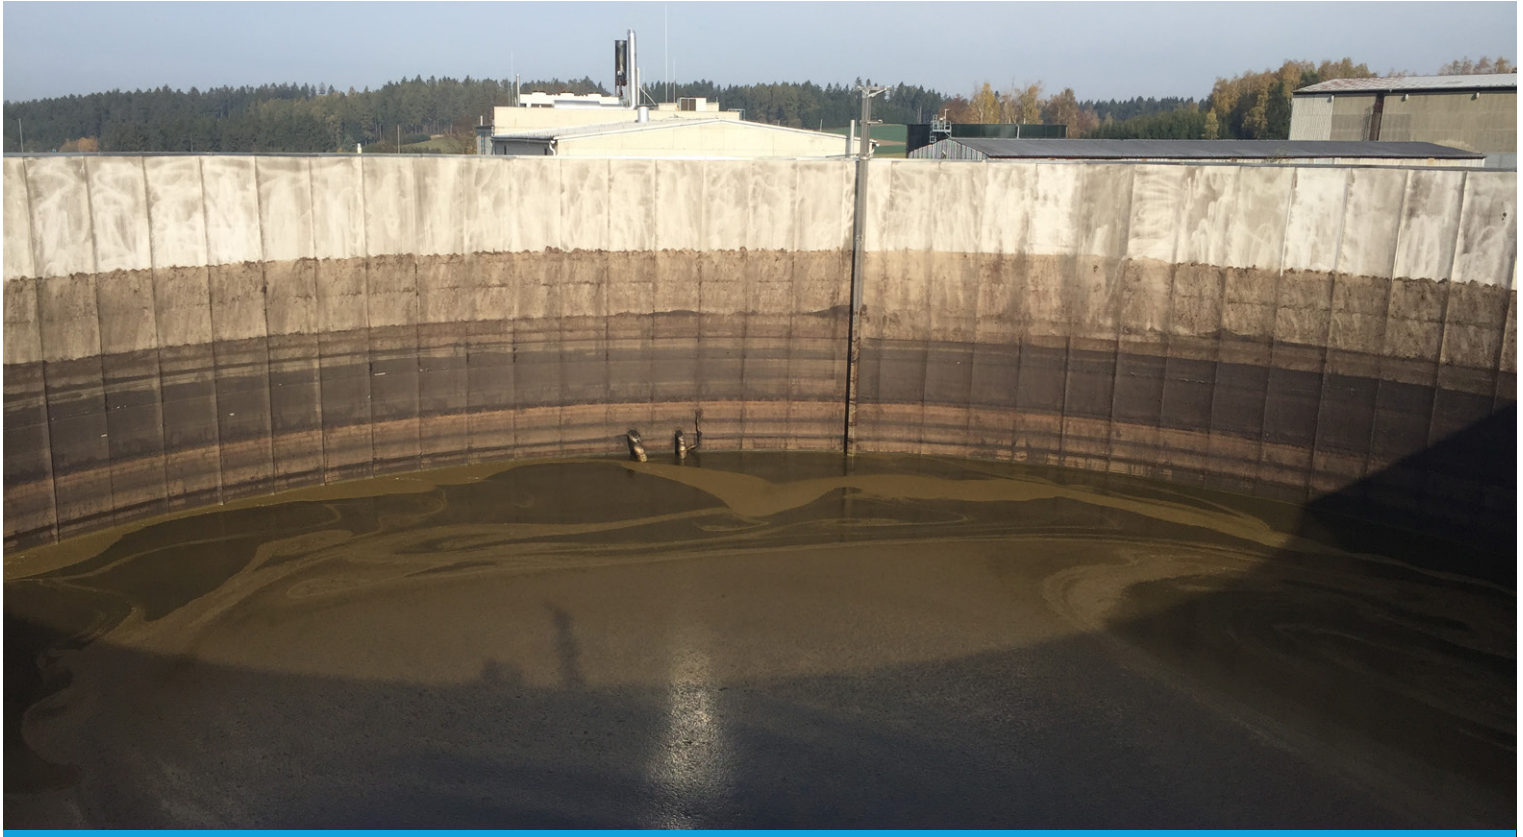
Tank back in use
