CC5™ Bulk Rolls

Houston, Texas

Providing erosion protection to berms and pond slopes.

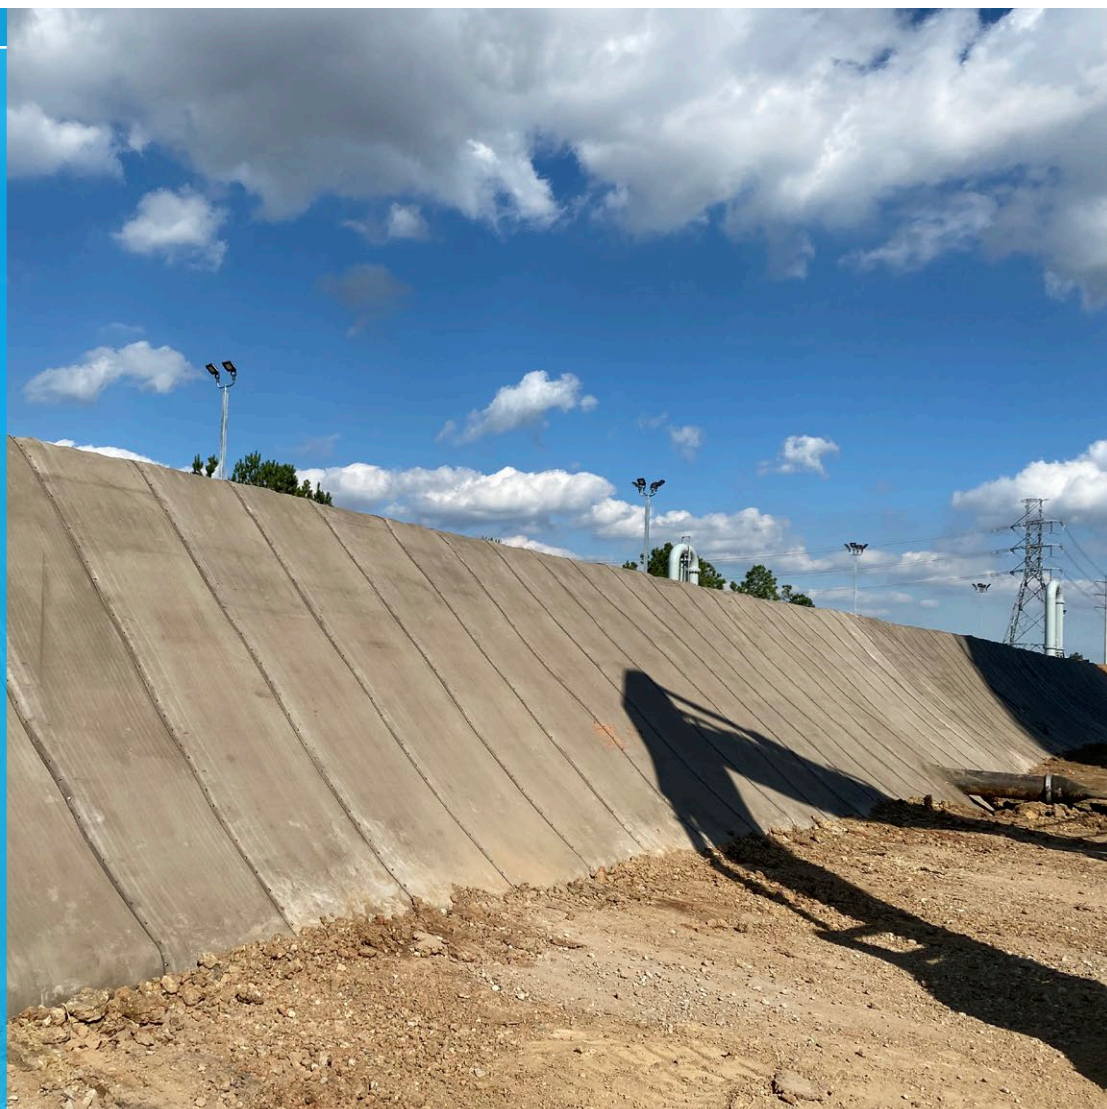
Completed works

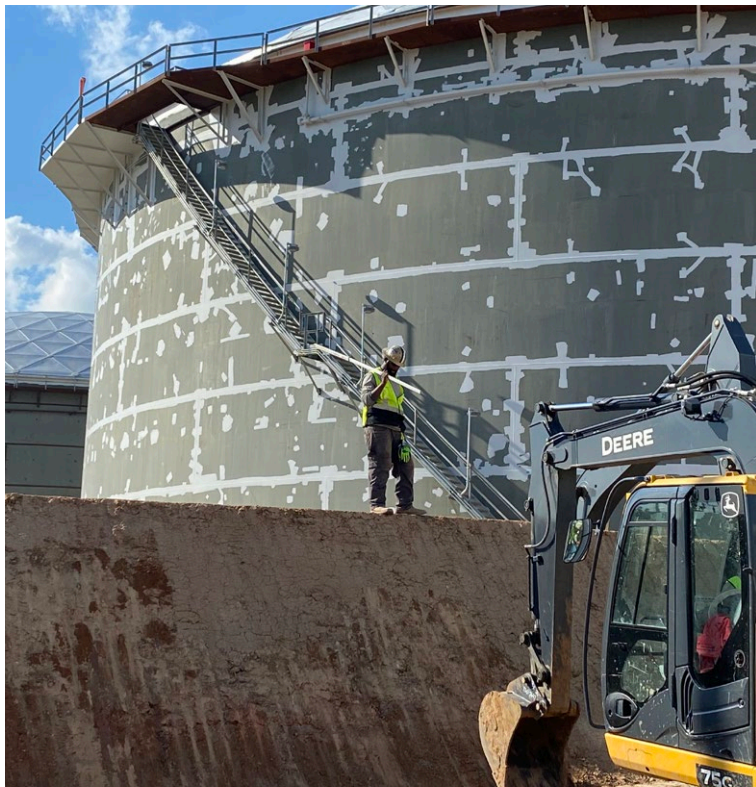
Slope re-profiled

Before the installation of the CC5™ material, ground preparation needed to be carried out. Vegetation was removed and the slopes were re-graded. Voids created by the removal of vegetation and protruding rocks were filled, thus creating a smooth surface. Once the ground was prepared, anchor trenches were dug at the crest of the slope. Bulk Rolls of CC5™ were brought into place with the use of an excavator, un-rolled and cut to fit. The panels were installed transversely on the slope with the leading edge of the material secured with pegs within the anchor trench.

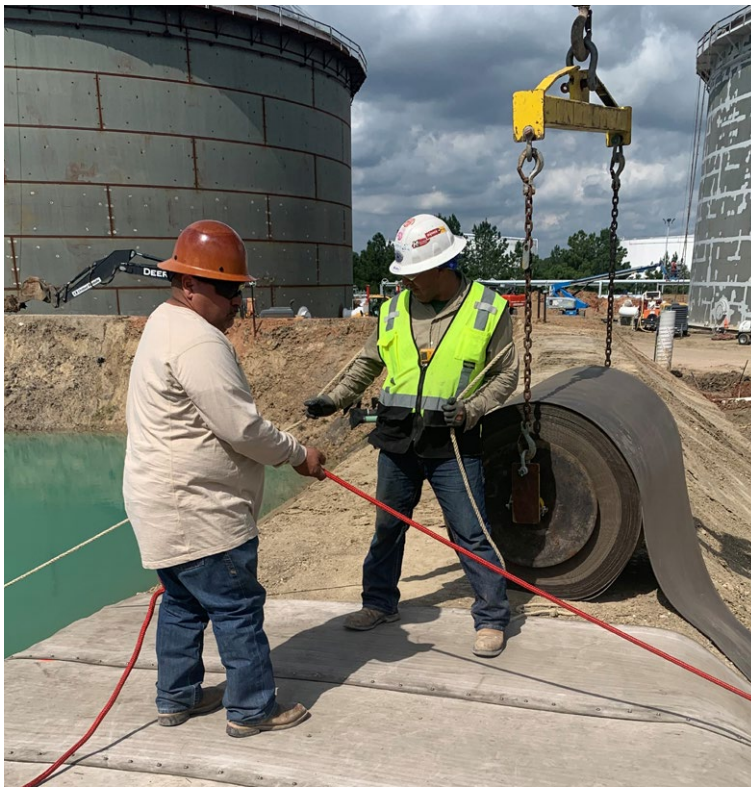
CC5™ installed with a spreader bar

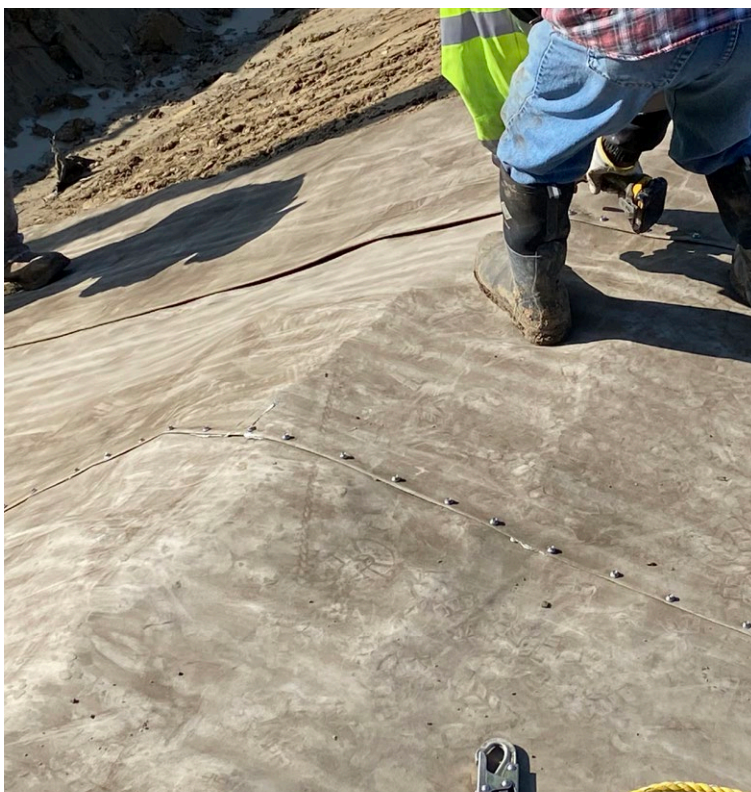
Overlaps secured with 1.25-inch self-driving stainless steel screws

The adjacent layers of CC5™ were then overlapped with the edges secured with waterproofing sealant and 1.25-inch stainless steel self-drilling screws with neoprene washers installed every 4-inches. Once the layers were secured, the CC5™ was hydrated using a water truck and hose - with the material hydrated daily. When the material had been fully hydrated the anchor trenches were then backfilled to prevent any wind or water ingress under the material.

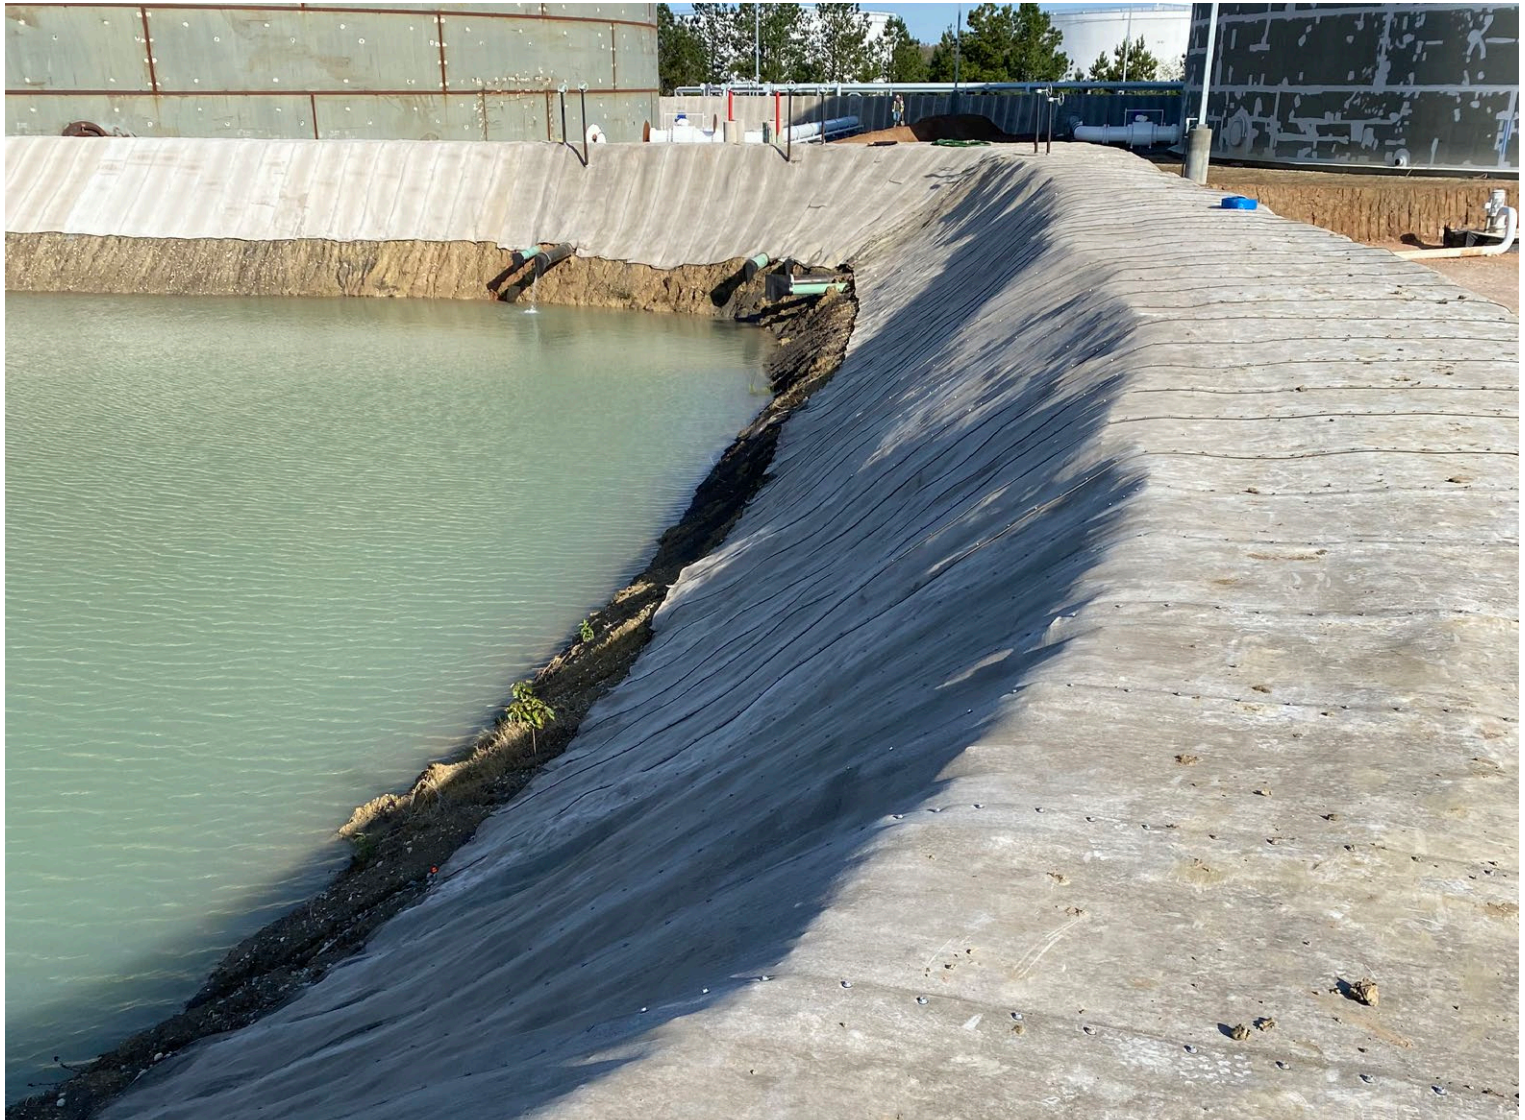
*Completed slope protection works with overlaps secured with 1.25 inch screws*
