DITCH LINING

In 2017, work was carried out to install 1,200 sf of Concrete Canvas CC8™ to provide erosion control to a ditch that was being used to relieve a flood prone area and convey stormwater to a nearby bayou in New Orleans, LA.

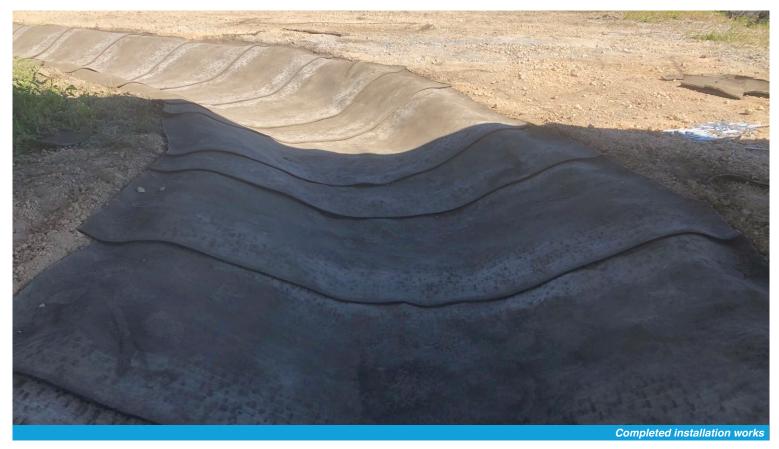
Before the installation of CC8TM commenced the ditch was first re-profiled using an excavator to create a uniform surface. Bulk Rolls of CC8TM were put onto a spreader beam and were lifted into position with the use of an excavator. Once in position the CC8TM material was rolled out and cut into 10' lengths. Each layer of the material was then laid transversely across the ditch with the overlaps laid in the directional flow of water. The leading edges of the material were secured in anchor trenches located at the crest of each side of the ditch. To prevent the overlapped layers of CC8TM from lifting each of the overlap was secured with adhesive sealant and stainless steel screws positioned every 4-inches , 1.2 - 2 inches from the overlapped edge.

After installation was completed the CC8™ material was hydrated using a portable water tank which was brought to site. An excavator was used to lift the tank and a hose attachment was used to spray the material. SLFPA-E were extremely impressed with the material and the speed in which it was installed.

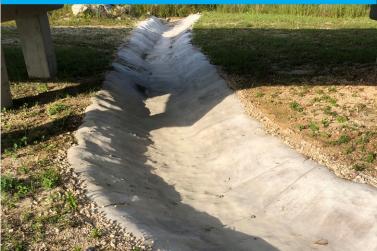
Ditch channel still functioning as expected

Since its installation in 2017, the CC8™ material is still performing. After a site visit in November 2022, SLFPA-E is still impressed with the results of the project 5 years after it was initially installed. Now the client is considering CC™ for another project at a different location.

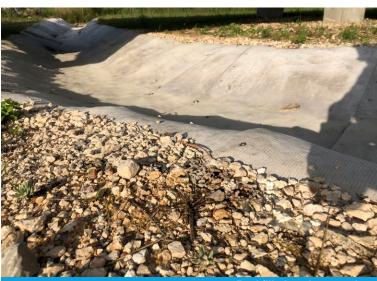
Backfilled anchor trenches

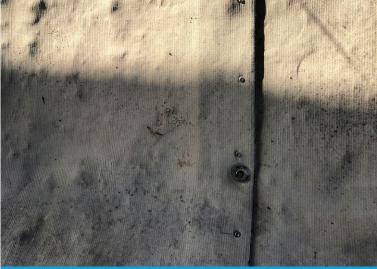
Overlaps secured and continuing to function

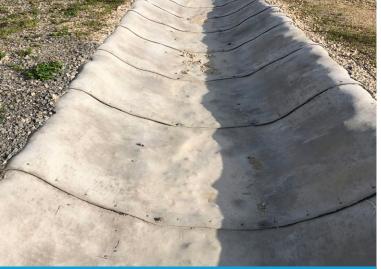
Ditch has not required maintenance
