CC8™ Batched & Bulk
Rolls

Pasadena, Texas

Providing erosion
control to an already
existing ditch.

Completed works

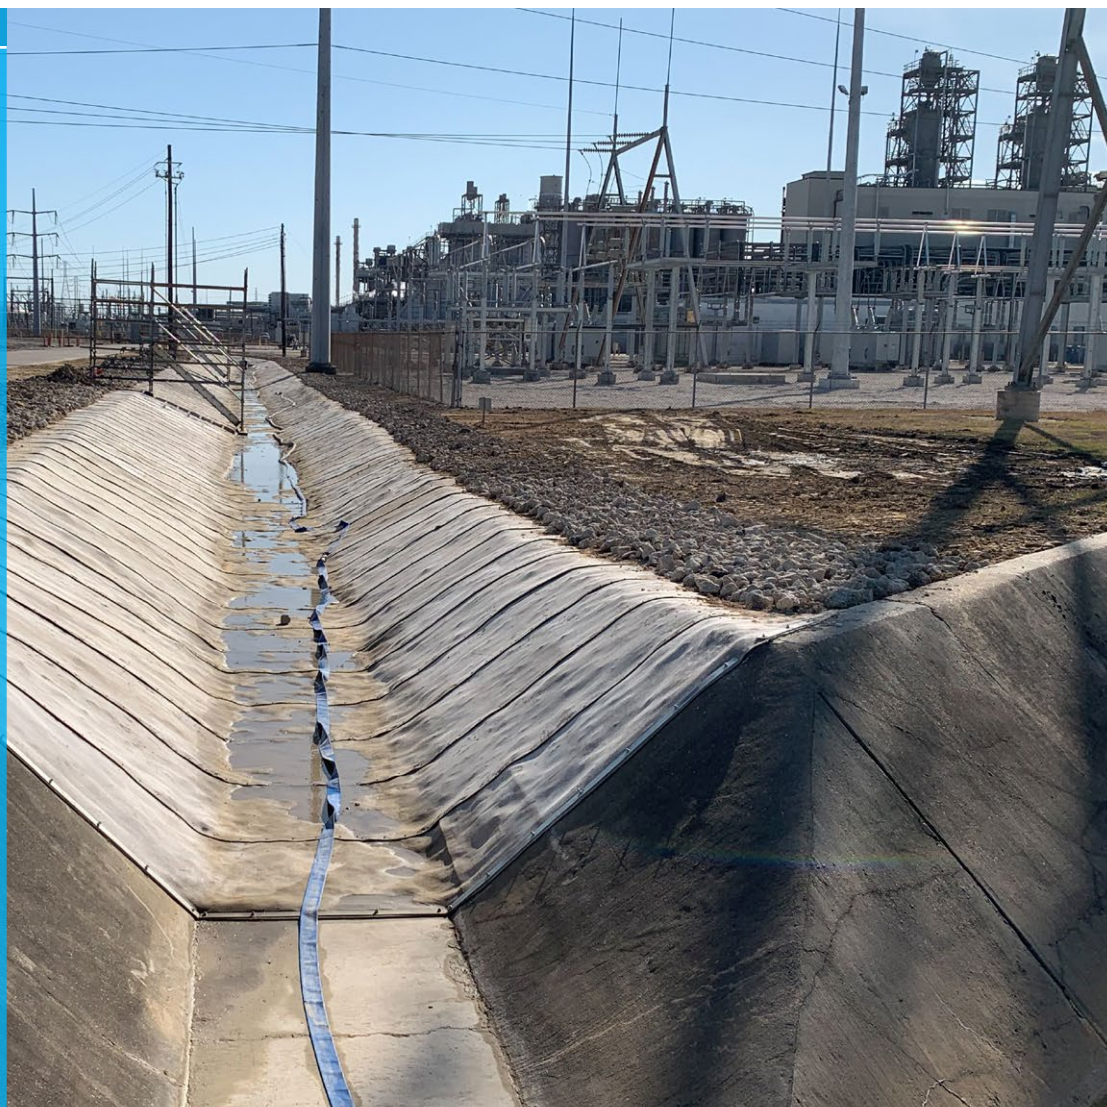
In December 2020, work was carried out to install 10,980 sf of Concrete Canvas® GGCM* CC8™ to provide effective erosion control to an already existing ditch located at a petrochemical plant in Pasadena, Texas.

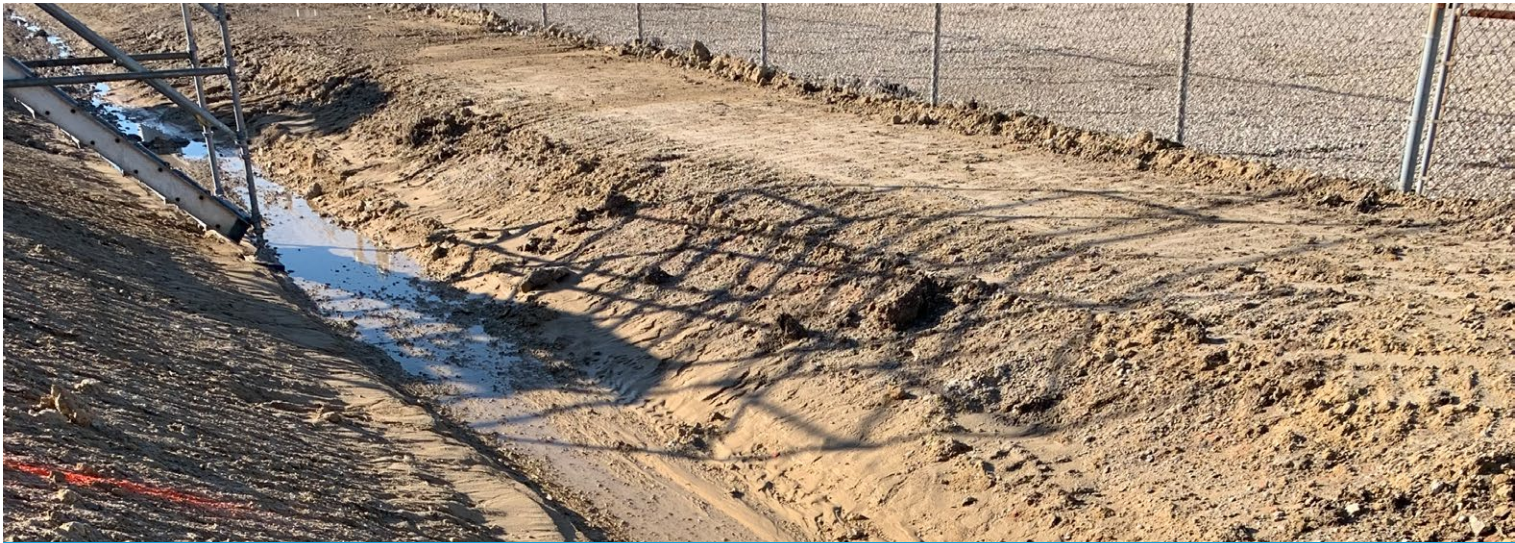
Ditch before re-grading

The ditch, located alongside the plant, was becoming increasingly damaged due to erosion from rainfall and water runoff which caused the bottom of the ditch to fill with soil and restrict water flow. To rectify the issue, a number of alternatives were considered, including slope paving. However the requirements for a concrete company to gain access to the site made this option difficult and expensive. A vegetated solution was undesirable due to the need for ongoing maintenance. CC8™ was chosen as the preferred solution due to its ease and speed of installation, the need for less machinery and man power, and the long-term zero maintenance requirement.

Before the CC8™ could be installed, the ditch needed to be re-profiled using a small excavator to compact the soil at the sides of the slope and at the base of the ditch. The Bulk Rolls of CC8™ were rolled out and cut to 28ft lengths, with the leading edge of the material secured in anchor trenches located at the crest of each side of the slope. Additionally, 12-inch Gripple Twist Anchors were used to secure the CC8™ at the crest and toe of the slope at each overlap. The layers of CC8™ were overlapped and joined using waterproofing sealant and secured with 1.25-inch stainless steel self-drilling screws with neoprene washers every 4-inches on the overlapped edge.

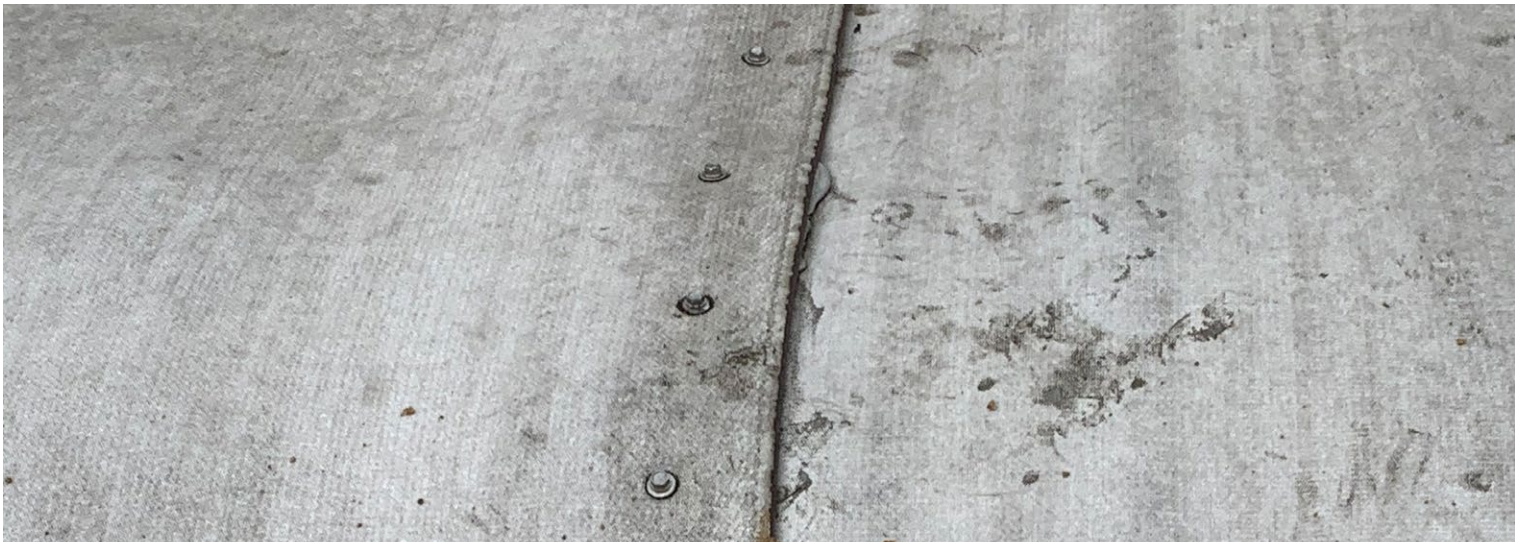
1.25-inch stainless steel screws and sealant used to secure CC8™ overlaps

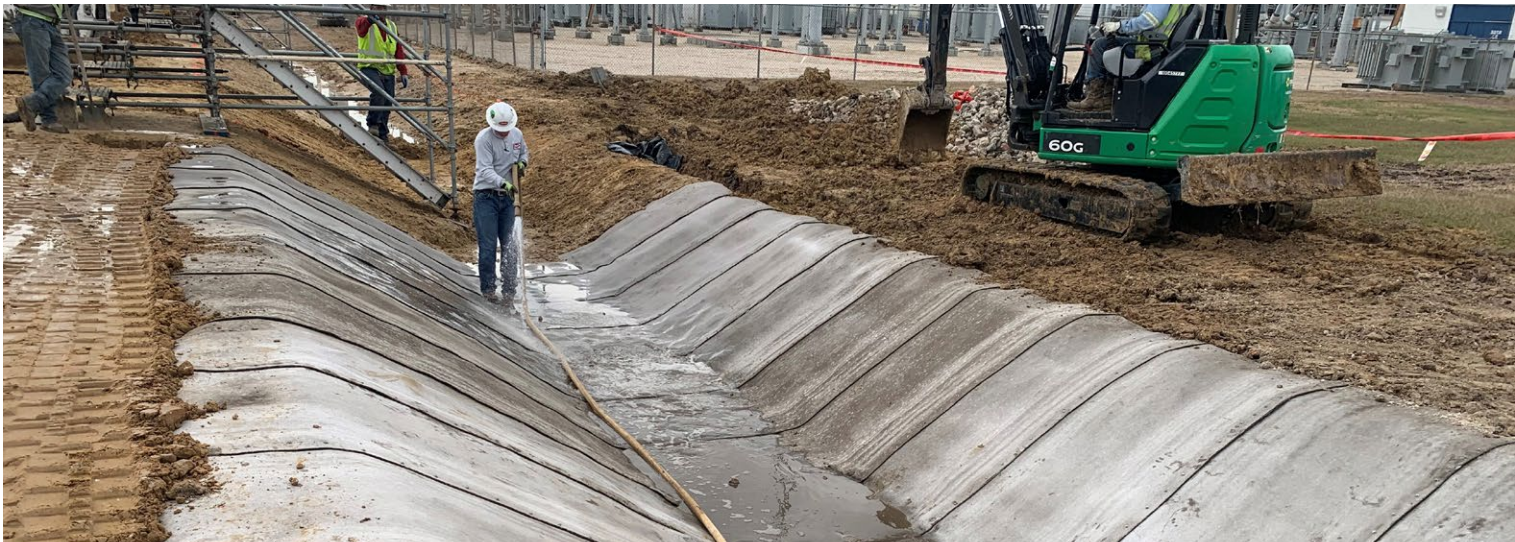
CC8™ being hydrated

Once the installation was completed, the material was hydrated using water from an adjacent ditch which was pumped, allowing the CC8™ to be hydrated daily. Finally, the anchor trenches were backfilled with soil.

This installation was carried out during the winter season, however temperatures didn't drop low enough to affect the installation or hydration process. There were days of rain, but the CC8™ was protected onsite to prevent the material from hydrating prematurely. Once the material was installed, daily hydration removed this concern. The ditch was semi-active during the install with a limited flow of water running through the ditch. To prevent water flowing freely, the contractor built a small dam each day but opened it up in the evening.

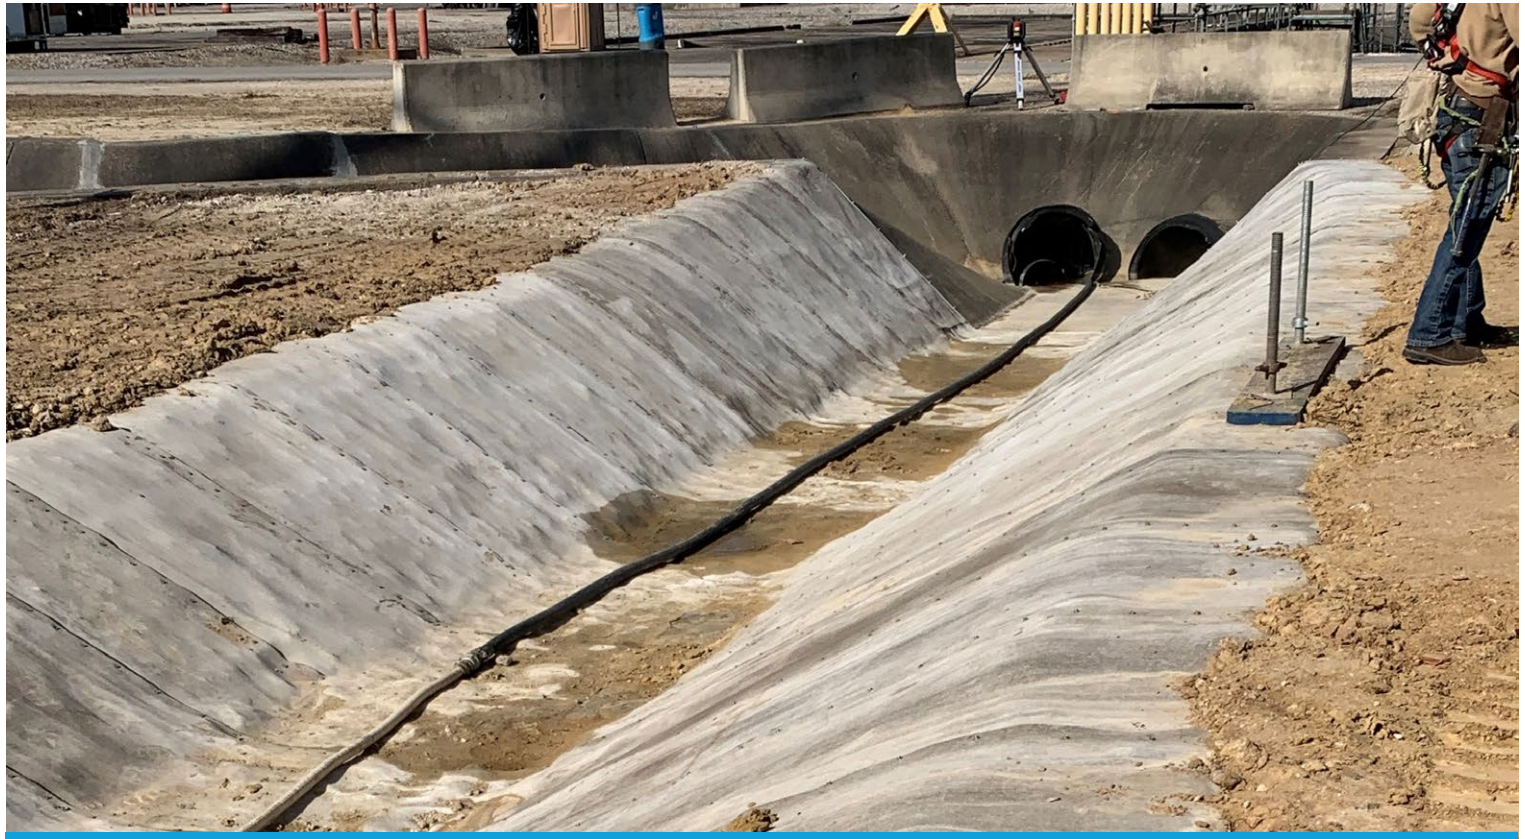
Completed ditch lining works

Due to two national holidays, the project took longer than expected with the total CC8™ install time being approximately 3 weeks. It is estimated that the installation works could have been completed in 7 to 8 days with the crew installing approximately 1 Bulk Roll per day on average. The client was very happy with the outcome and has planned for additional projects using CC in 2022.
