In December 2022, CCX-MAT™ GCCM* (CCX-M™) was used as an emergency remediation solution for an existing concrete canal in Chongón - Cerecita - Playas - Ecuador. The existing canal had been built 25 years ago to channel raw water for purification in the cities of Playas and El Morro in the Province of Guayas, but to also provide irrigation to adjacent farms. The existing concrete had cracked with significant seepage losses causing undermining, erosion and collapse of the canal invert. Upon draining of the canal a 2m long by 1m wide hole was discovered. This hole resulted in water losses in the region of 50 liters/sec.

REMEDIATION

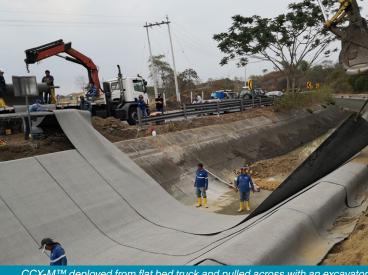
CCX-M™ material secured using J-pegs within anchor trenches

Prior to installation, the existing canal had to be prepared by draining, clearing away debris and drying. The hole within the channel was then backfilled with compacted earth. Anchor trenches were excavated along each edge of the existing concrete canal profile.
