CCX-M™ Custom Rolls

Abergavenny, Wales

Concrete Canvas Ltd.

CCX-M™ installed on a trial basis to establish its resistance to puncture from cattle traffic

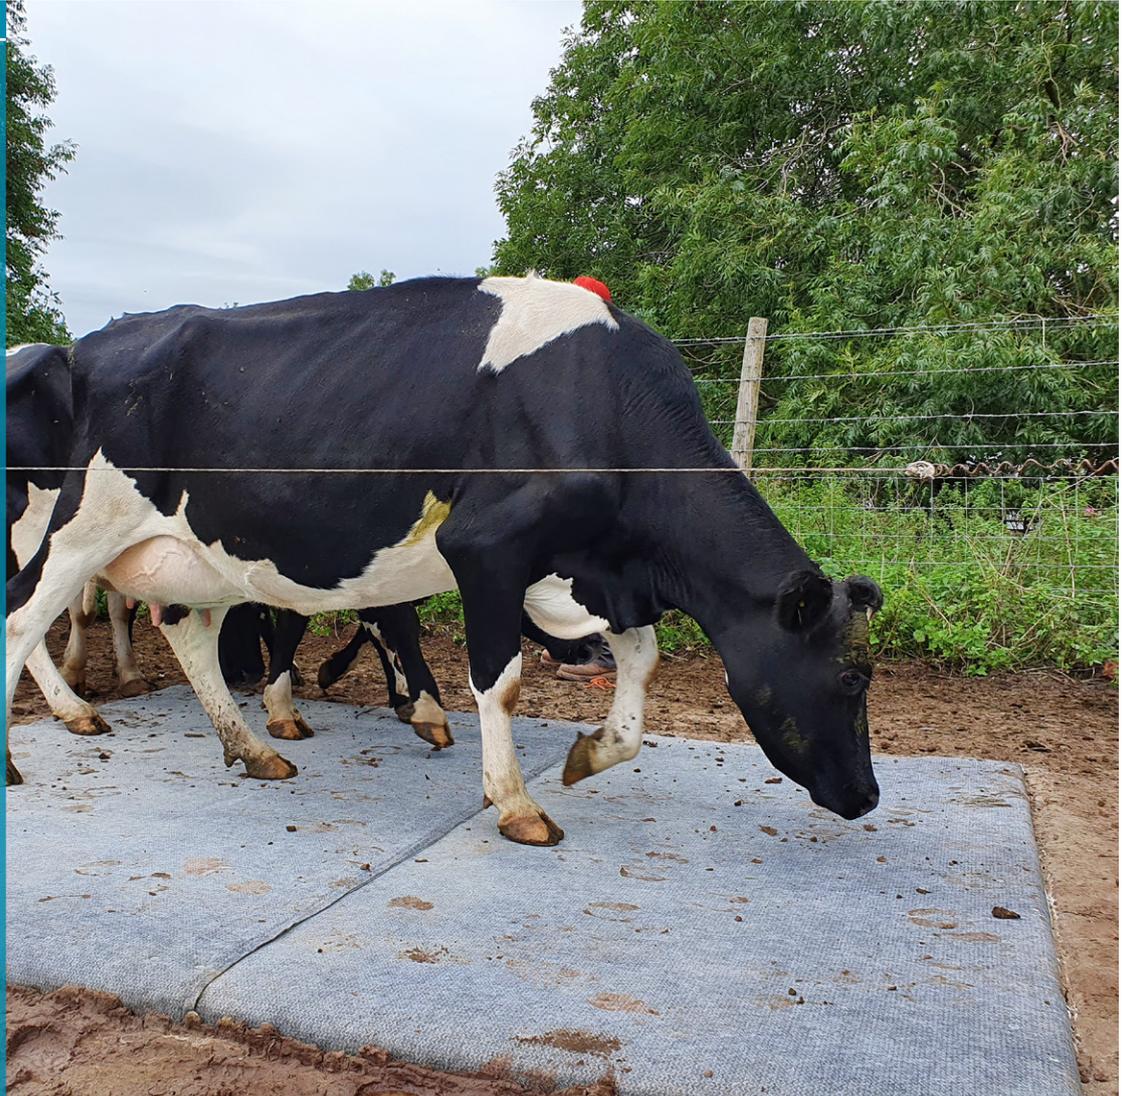
Cattle loading pad in use 24 hours after installation

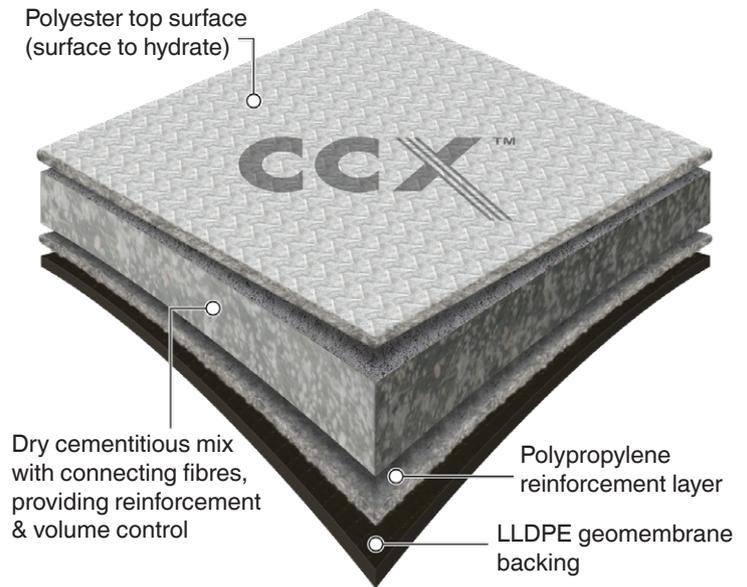
CCX-M™ consists of two interconnected layers of geotextile that encapsulate a specially formulated dry concrete mix. A 0.3mm thick LLDPE geomembrane backing ensures the material has high impermeability whilst the composite geotextile reinforced concrete top cover provides a high degree of long-term durability.

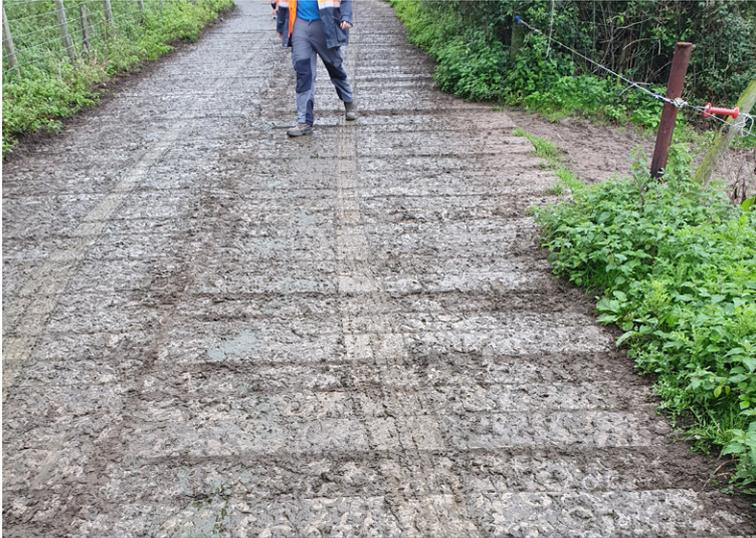
Site prior to installation

The pre-existing access to the dairy is covered with precast concrete railway sleepers approximately 2m long by 0.2m wide and 0.2m thick. These sleepers are laid side by side to effectively create a hard-wearing surface. The benefit of these sleepers is that they are easy to install but are very costly.

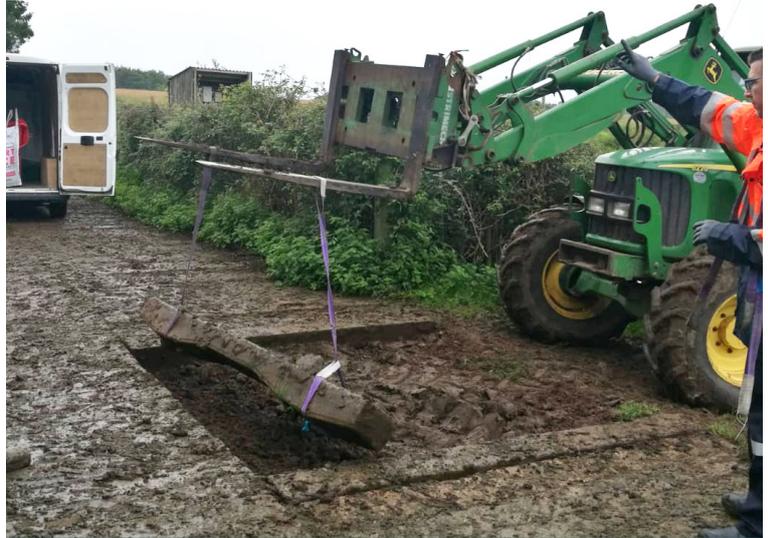
Removal of sleepers

Dairy farms are typically quite messy with waste and slurry generated by cattle. On the day of the installation, all waste material had to be cleared, the sleepers removed and the void left by the sleepers backfilled to create a well compacted pad.

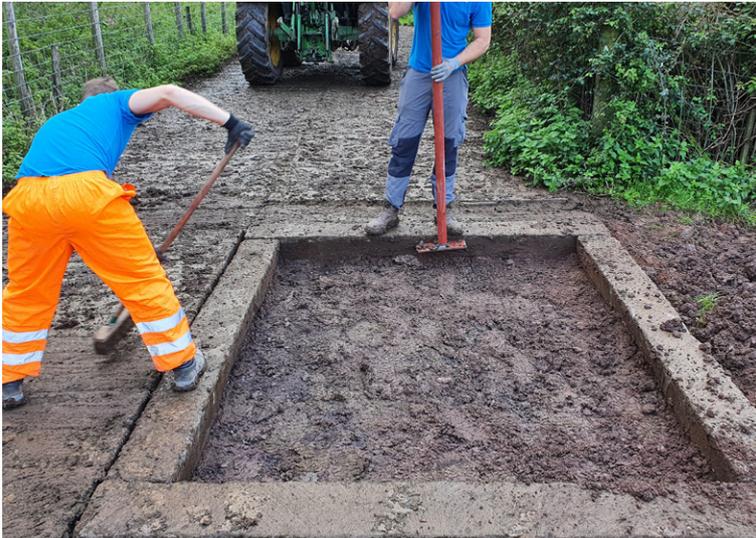
Realignment of outer sleepers and compacting substrate

In order to improve the stability of the substrate, it was first hand compacted at the level of the pad base. The void was then backfilled with a well-graded gravel which was then also hand compacted and covered with a low-grade geotextile layer. Finally, a layer of sand screed was installed and covered with a second layer of geotextile.

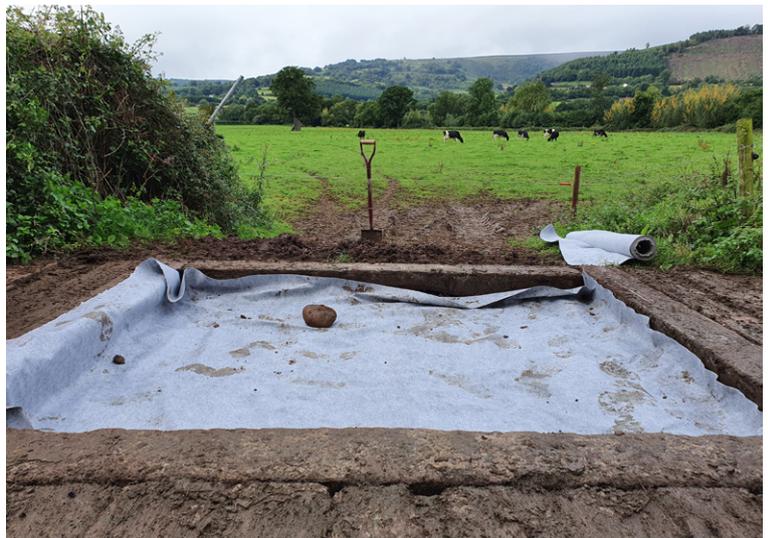
Installation of geotextile separation layer

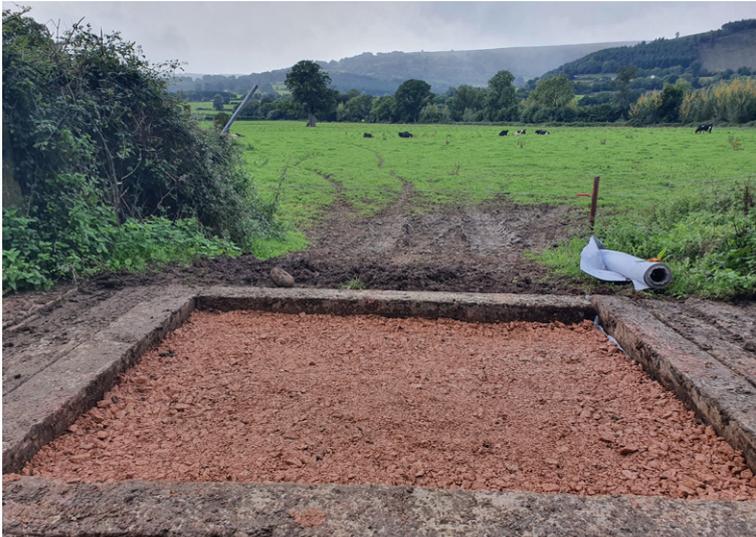
Gravel compacted

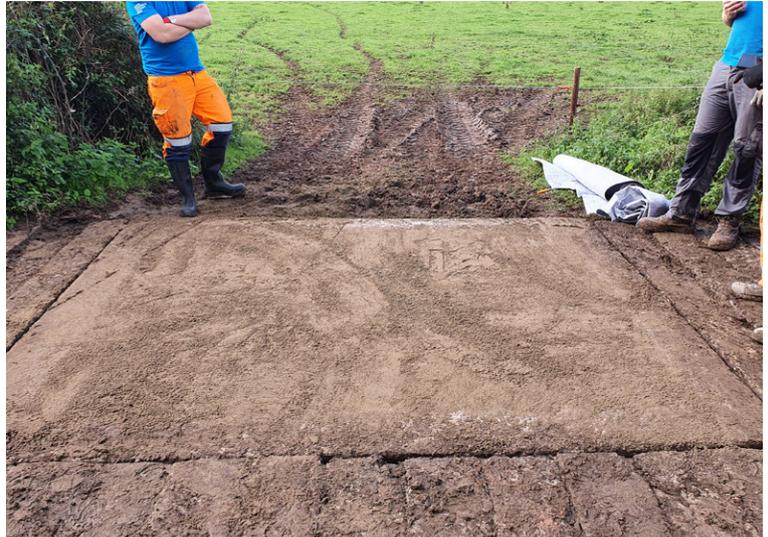
Sand screed layer

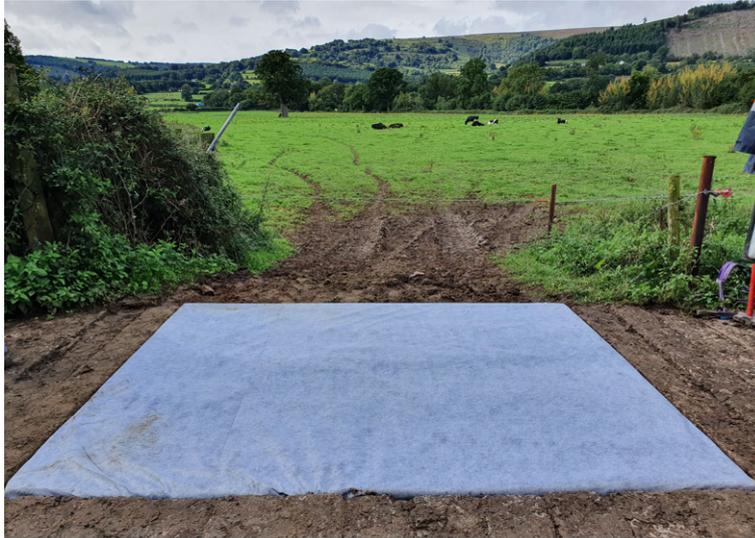
Second layer of geotextile

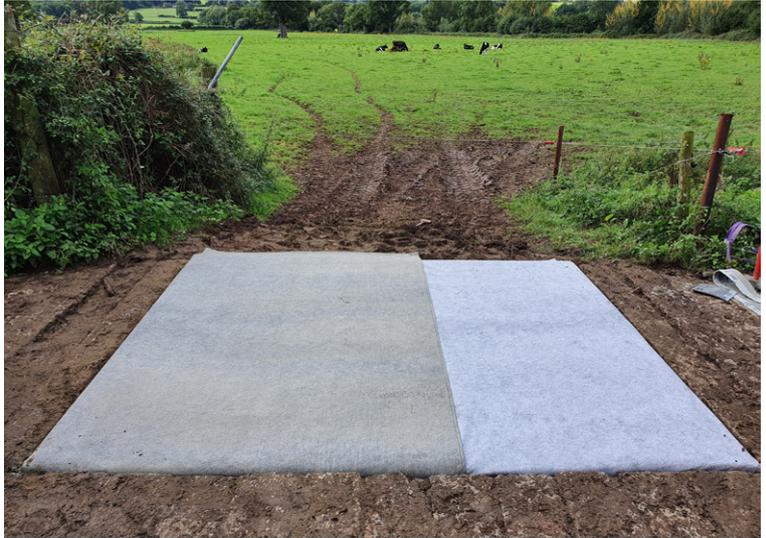
Installation of CCX-MTM

Once the ground preparation was completed, the CCX-M™ was laid by hand to form a transverse joint mid-way across the pad, perpendicular to the direction of cattle traffic. The outer edges of the CCX-M™ were then tucked over the sides and fixed with countersunk wedge anchors to the top of the sleepers. An overlap of approximately 250mm was created to determine how the exposed overlap edge performs under hoof. Adhesive sealant was applied to this overlap before it was mechanically fixed with a double row of screws at 100mm spacing in a staggered configuration.

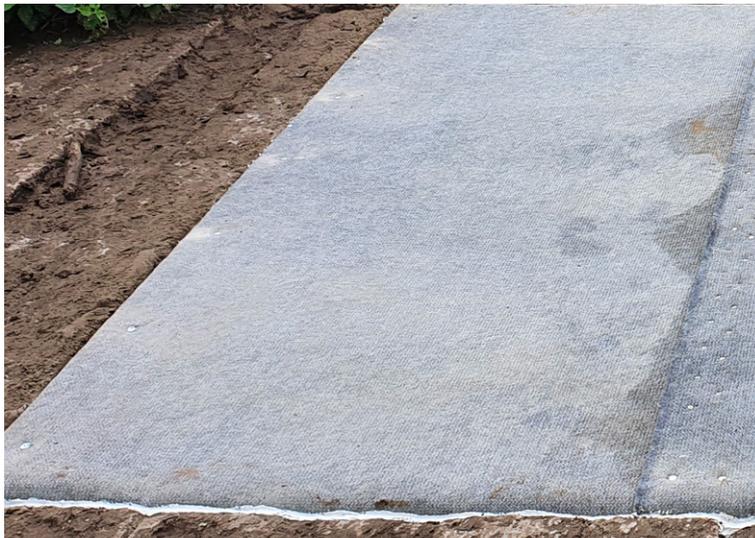
Edges sealed and underlap hydrated prior to jointing

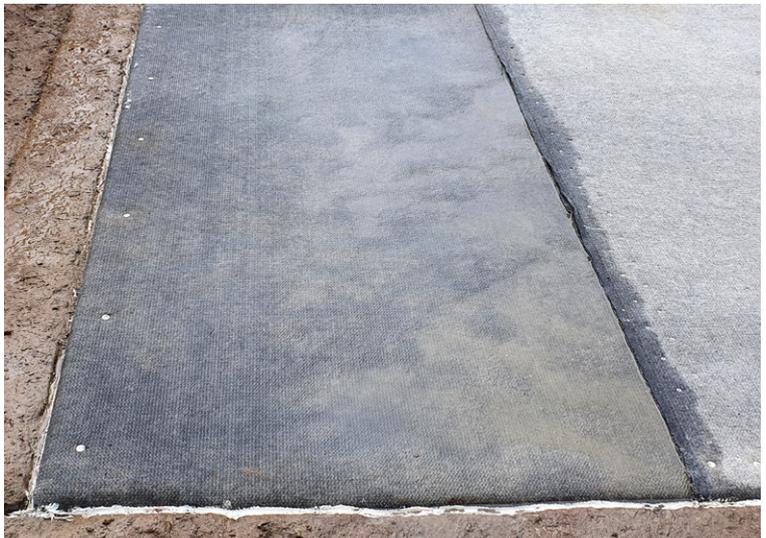
Overlap jointed and edges fixed to concrete sleepers below

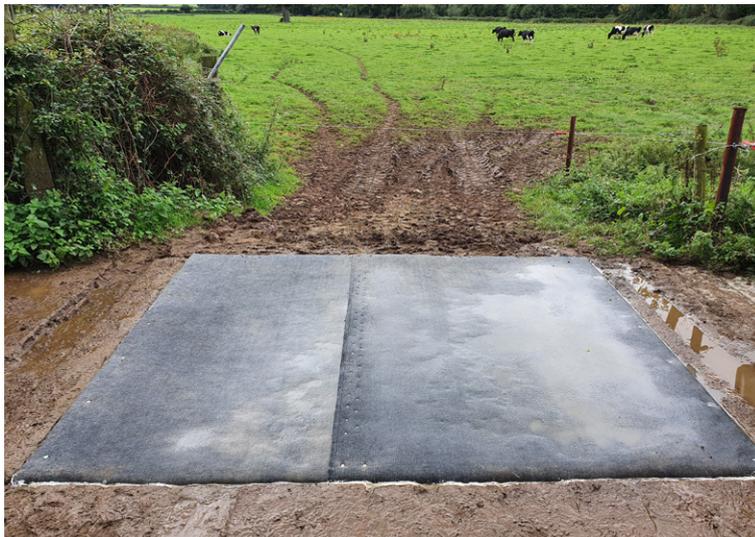
Installation completed and hydrated

CCX-M™ was hydrated by hand using a watering can. The surface was hydrated 3 times at approximately 15-minute intervals to ensure sufficient saturation.

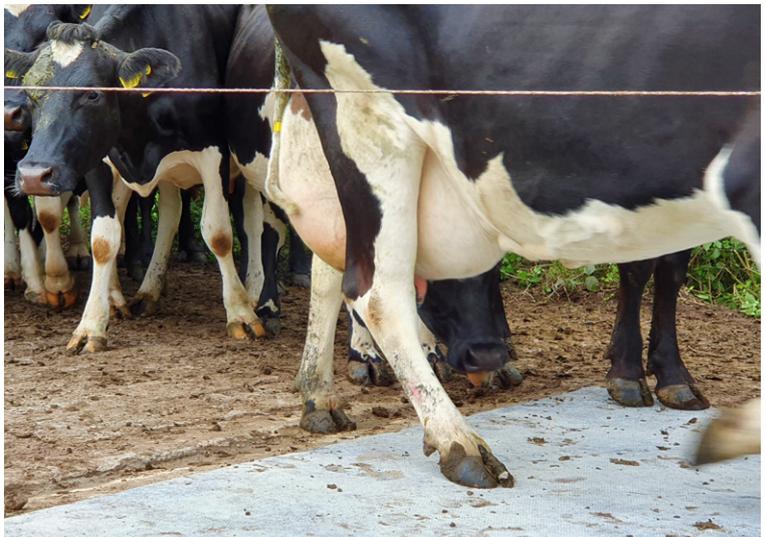
Loading pad in use

The pad was left to cure for 24 hours prior to opening it to cattle traffic. Monitoring of the pad under loading began immediately, with no evidence of any puncturing, cracking or other forms of degradation observed.

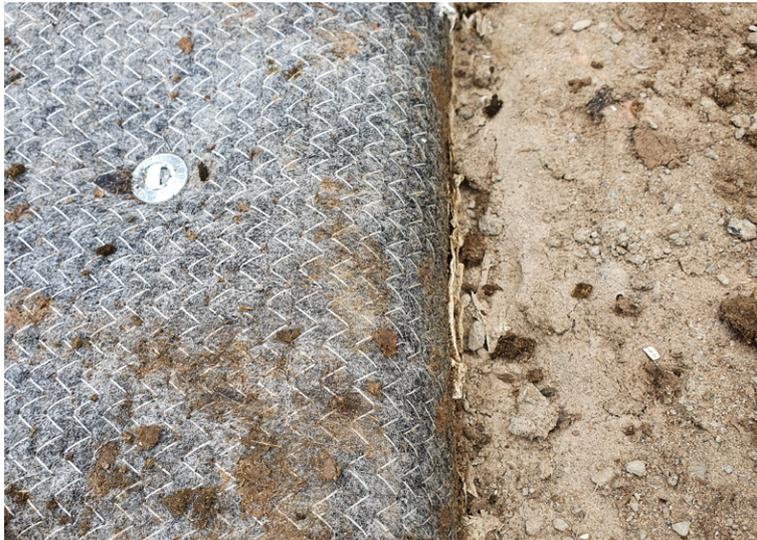
No evidence of scuffing, puncture or damage after 100 passes

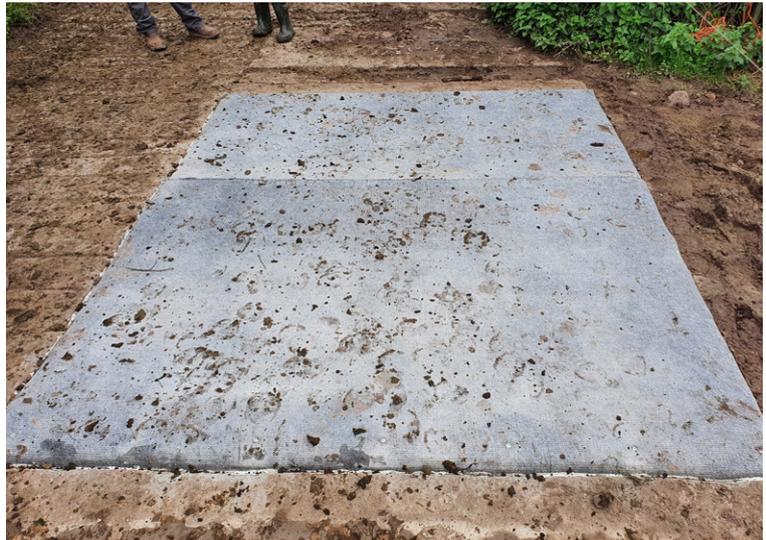
CCX-MTM installation intact after 100 passes

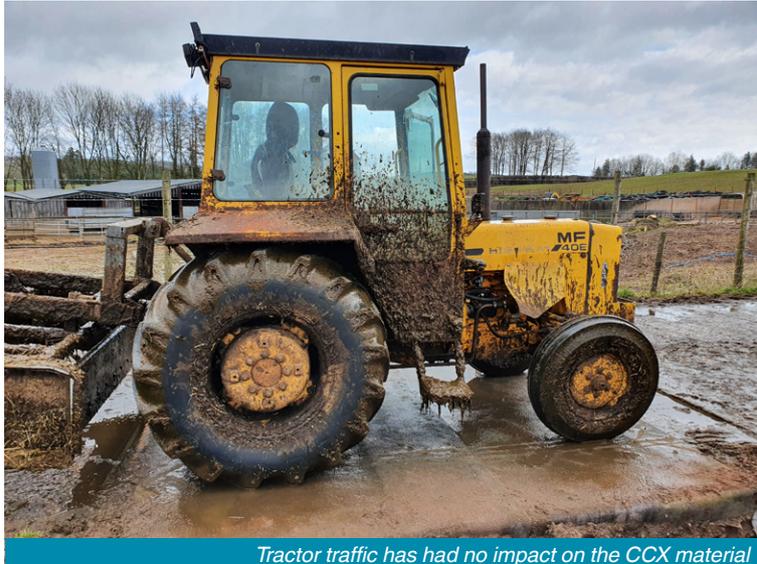
Tractor traffic has had no impact on the CCX material

Six months after completion of the project, we returned to inspect the material. It was found to be performing as intended, with no signs of erosion or damage despite six months of cattle use, trafficking by tractors and snow and freeze-thaw weather events over the winter.

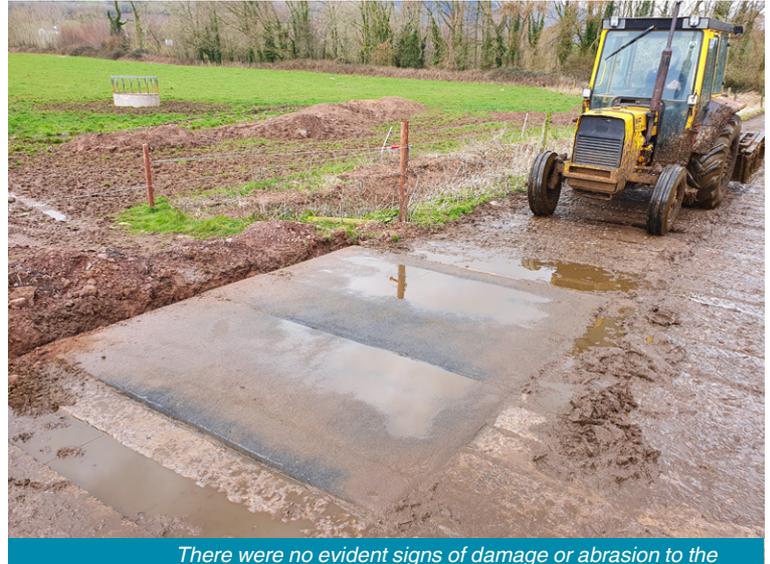
There were no evident signs of damage or abrasion to the
