SLOPE PROTECTION

In October 2017, Concrete Canvas® GCCM* (CC) was used to protect a bund slope at the Maasvlakte Oil Terminal (MOT) in Rotterdam, in the Netherlands.

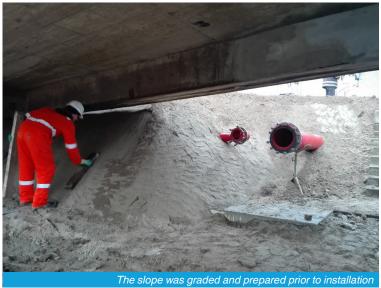
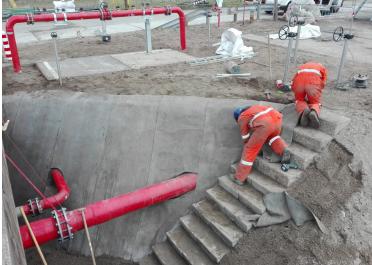
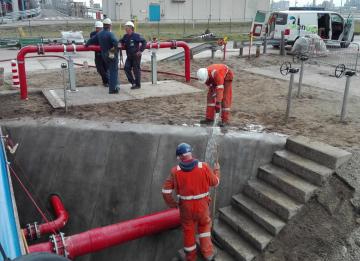
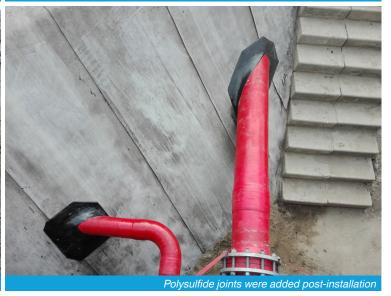
was easily cut to accommodate existing infras

Prior to installation, the slope was prepared and anchor trenches were dug at the crest and toe. A bulk roll of CC5™ was then delivered to site and mounted onto a spreader beam hung from a crane for easy dispensing. The CC was then unrolled and laid vertically down the slope, with subsequent layers overlapping the previous by 100mm. The overlaps

were sealed with Sealfix adhesive sealant and jointed using collated screws and concrete nails were necessary. Where needed, the CC could be easily cut to accomodate existing infrastructure such as protruding pipework. Polysulfide joints were produced post-installation to fit around these sections to prevent ingress. This was repeated around the length of the slope before the edges of the CC were captured in the anchor trenches, which were backfilled for neat termination and to prevent ingress at the edges. Once installation was complete, the CC was hydrated.

50m² of CC5™ were installed in 3 days by a team of 2 people despite tight time constraints and limited site access. The client was very impressed with the speed of the installation and has proudly revealed the innovative solution to it's shareholders on the opening of the newly renovated jetty.
